**SUSQUEHANNA MARINE**  
**SURVEYS**

**Report of Marine Appraisal Survey for the Motor Vessel**  
**With HIN # FWNCM092J495**

The survey inspection of the Motor Vessel *with HIN FWNCM092J495* was conducted while it laid in it's trailer on land for the hull survey on June 6, 2026 at the boat owner's residence located at [REDACTED] by the undersigned surveyor.

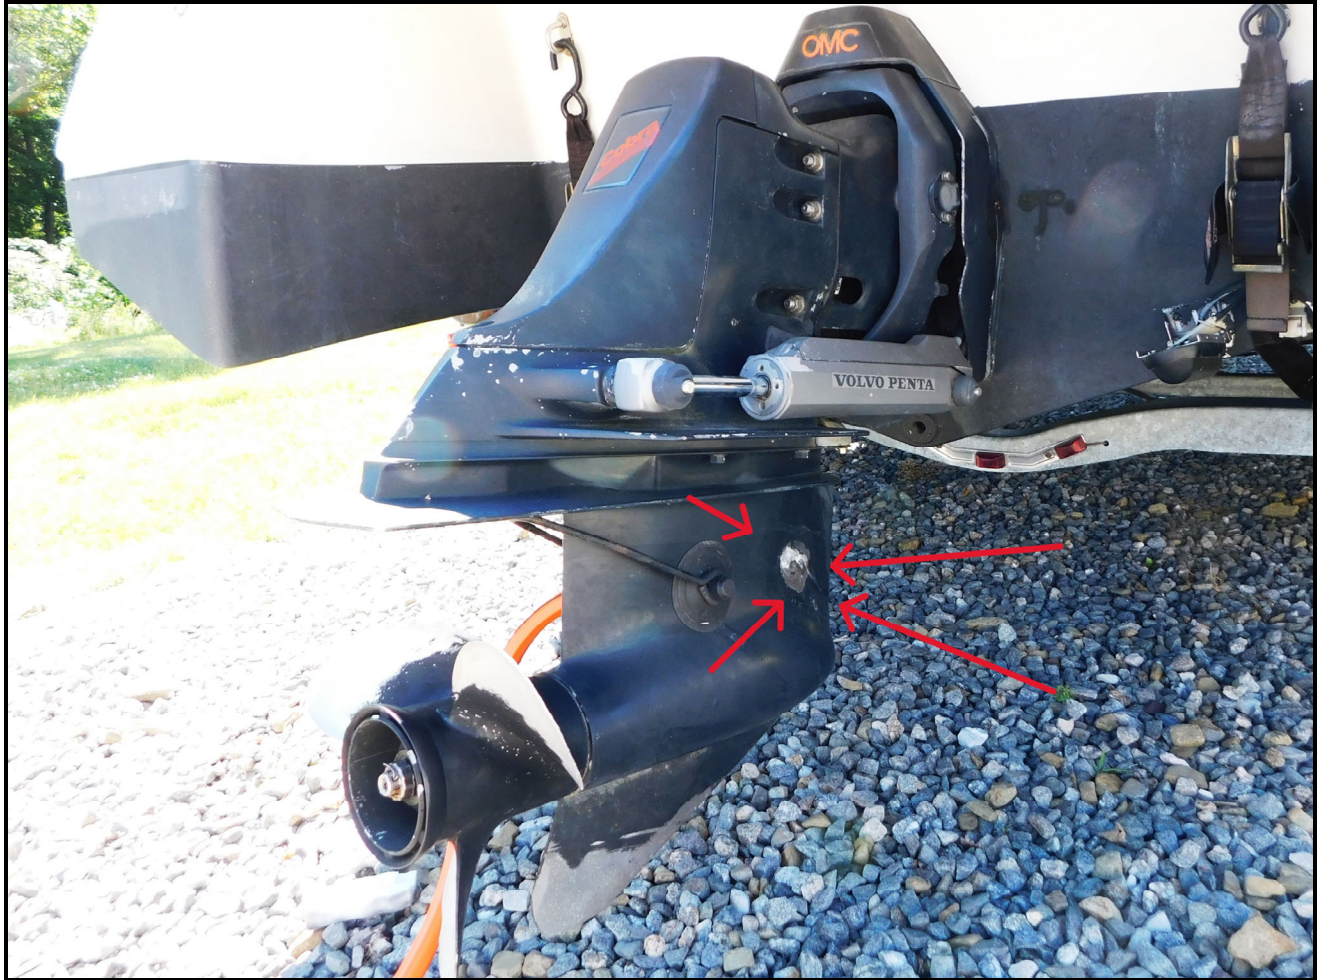
Shows sterndrive unit. Arrows point to observed corrosion spot on lower unit

- A. It is recommended that the engine and sterndrive unit be further inspected and serviced for the 2026 boating season by a qualified Certified OMC (Volvo Penta) technician. The engine was reported as rebuilt due to a prior overhear issue. Other maintenance components such as trim actuators and hydraulic lines etc., had also been recently replaced. These items were verified as such. The lower unit exhibited a corroded area on its starboard forward area. This corrosion should be further diagnosed and repaired as found necessary.  
The propeller showed multiple impacts and in below average condition. It is recommended that the propeller should either be reconditioned or replaced.

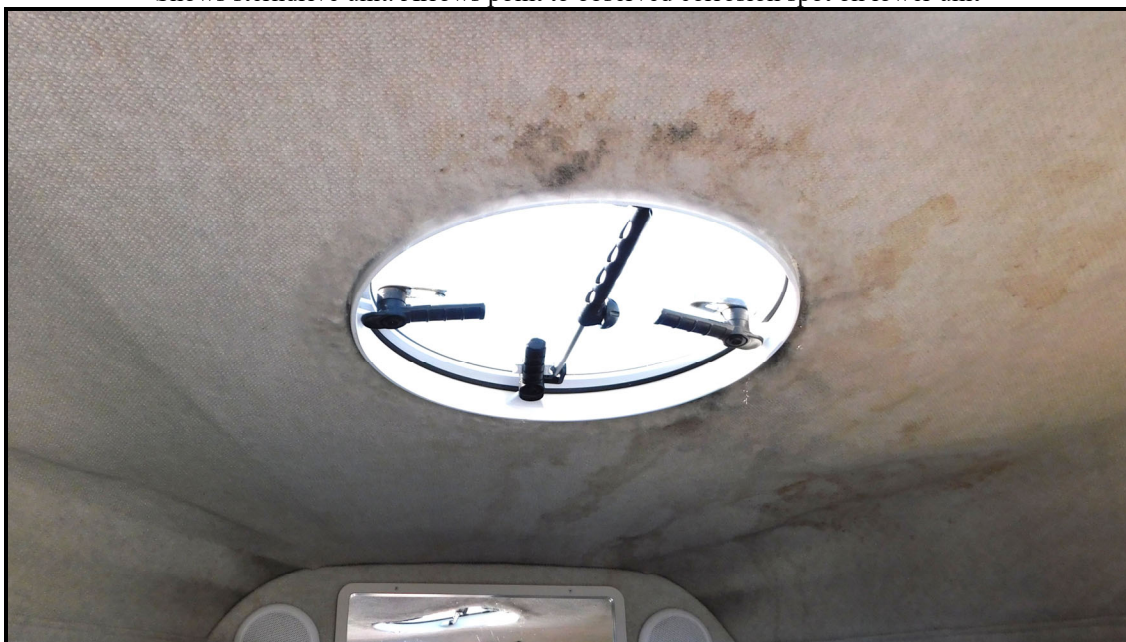
- B. INTERIOR.....DESCRIPTION.....The interior is finished in what appears as cloth and vinyl upholstery. Fit and finish are average and the hardware, fixtures and fabrics appear in average condition.
- CONDITION.....The interior showed in below average condition.
- STORAGE.....fair and in average condition
- VENTILATION.....Forced and natural through opening ports and hatches. All appear in average condition.
- WATER INTRUSION.....There was evidence of past water intrusion found. This water intrusion had caused excessive staining on the cabin headliner.

Shows observed water stain in cabin headliner from prior water intrusion

- D. It is recommended that the observed evidence of water leakage at the forward cabin hatches be further diagnosed and repaired as found. It was reported that the leak was from a damaged forward hatch which was replaced. The previous water intrusion has left water stains in the cabin headliner. No evidence of core material deterioration was currently observed or noted. The foredeck core should be monitored and inspected each year for signs of possible core deterioration.

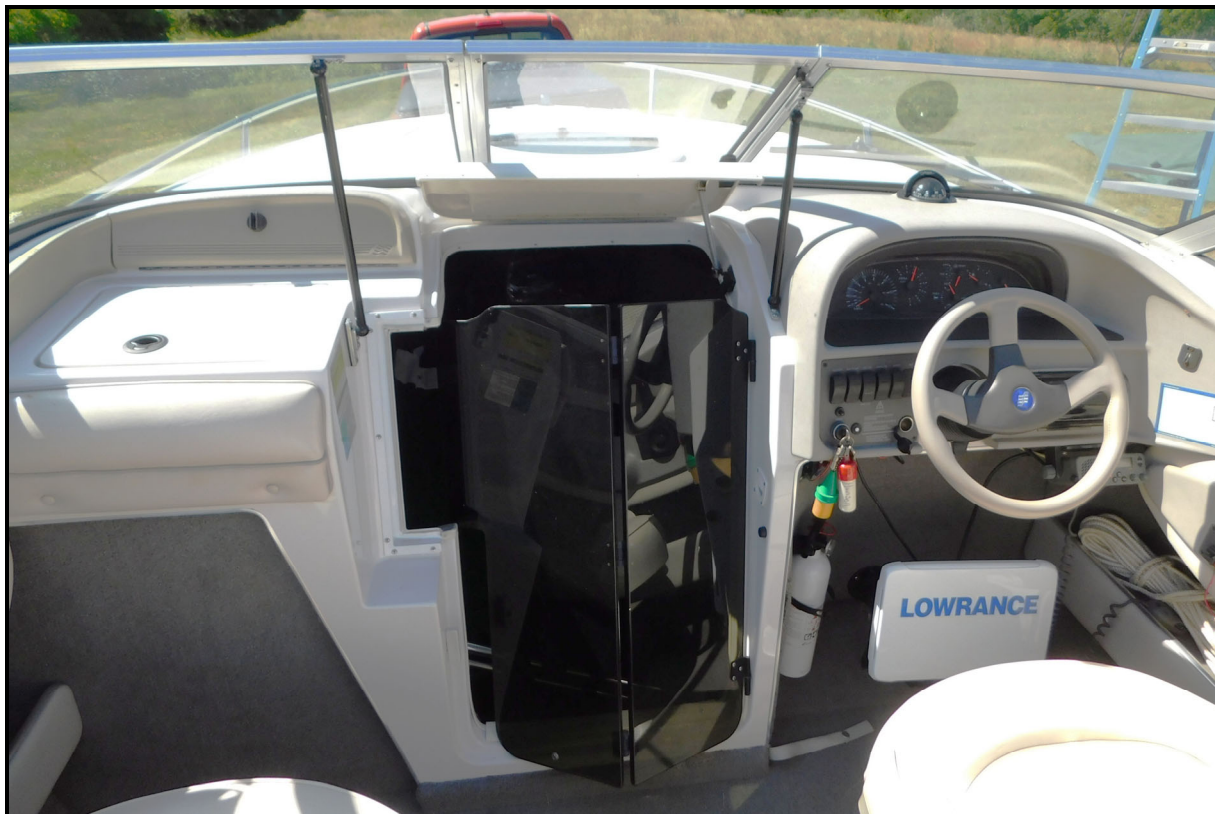
Shows midship cockpit area and cabin companionway

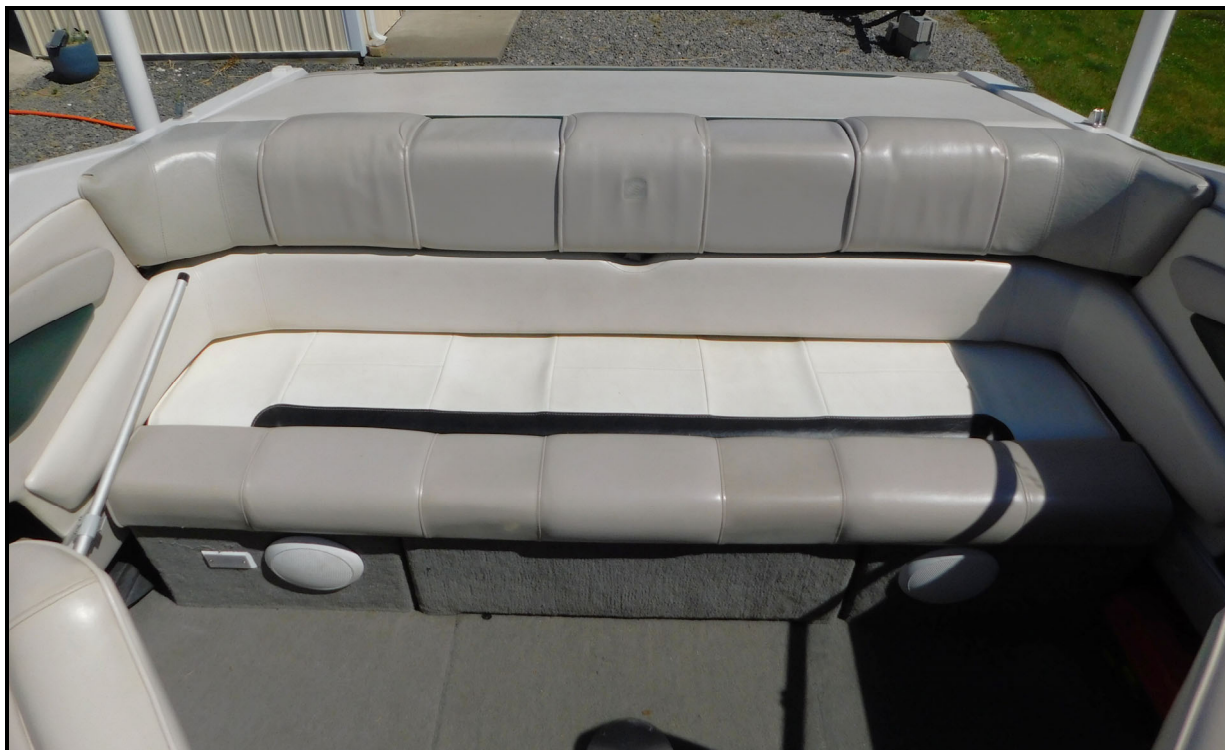
Shows aft cockpit area

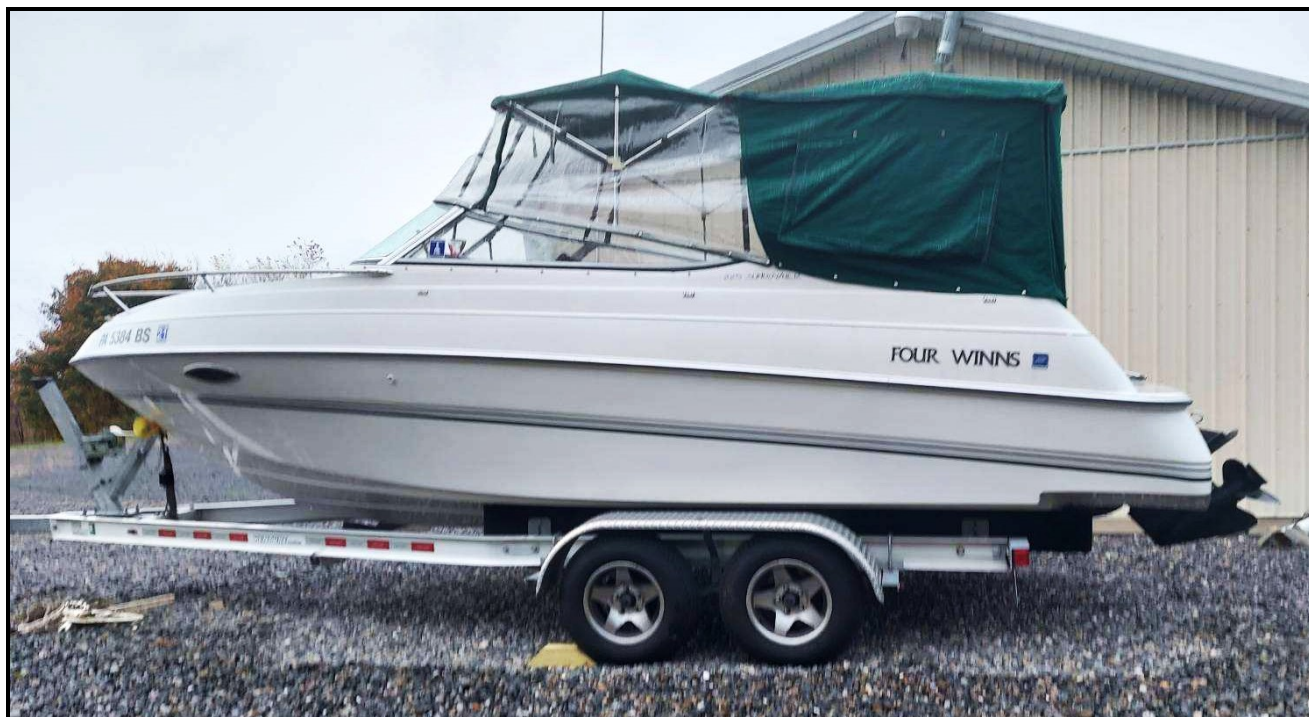
Shows recently installed camper canvas option
