BOLZ MARINE SURVEY & CLAIMS, LLC
MARINE SURVEYOR AND CONSULTANT

1988 20' Champion Fish and Ski

Report of Marine Survey

September 19, 2023

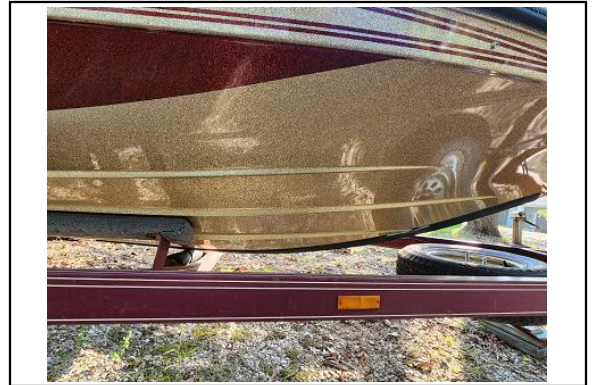
The exterior hull is gel coated with custom graphics paint. The gel coat is slightly oxidized. and I did not see any signs of joinery stress at the hull to deck joints.

The gel coat is slightly oxidized

(B.1) Forward stem view

FINDINGS	RECOMMENDATIONS
The gel coat is slightly oxidized	No recommendations.

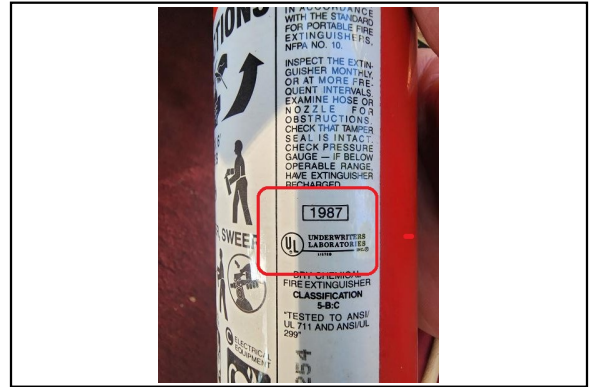
A single hand held extinguisher is mounted under the helm. The extinguisher is expired past twelve years.

(A.1) Expired past twelve years

FINDINGS	RECOMMENDATIONS
The extinguisher is expired past twelve years.	<i>Comply with USCG Code (46 CFR 25) Fire extinguishers must be current within 12 years. Vessels 26' to less than 40' with no fixed or expired fixed system require 2 B-I or 1 B-II.</i>

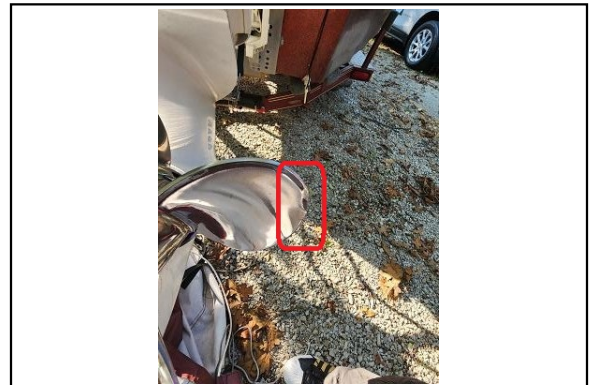
Stainless prop has slight dog ear bends at the tip on at least two of the blades.

(B.2) Slight dog ear on prop

FINDINGS	RECOMMENDATIONS
Stainless prop has slight dog ear bends at the tip on at least two of the blades.	No recommendations.

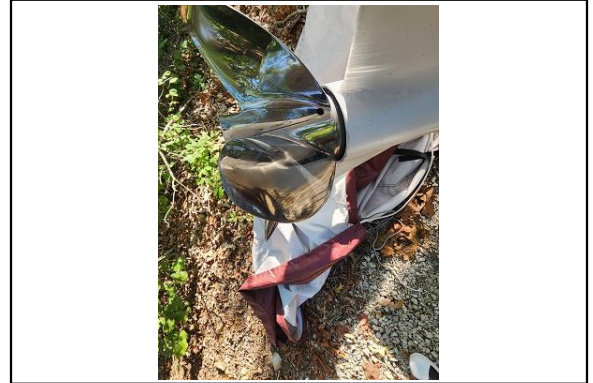
Prop seal appears secure

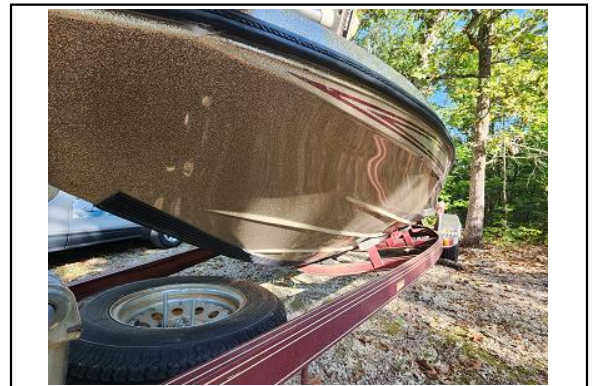
The overall condition of the bottom hull appears in above average condition with no signs of cracking, damage or blistering.

Bottom hull in good condition
