Insurance C&V Survey Report

“GOOD NEWS”

1986 Pearson 303 30' fiberglass sloop

6 August 2024

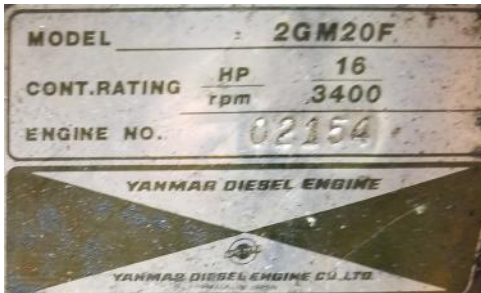
Propulsion is by a Yanmar two cylinder fresh water cooled diesel engine. The engine could use a cleaning. The paint is in good condition except at areas of minor to moderate rust. The engine is supported by four flexible mounts on fiberglass beds. No deficiencies were observed.
