Valuation of a 2003, SSi 22' Chaparral Bow rider

**Franklin Barron
S.A.M.S.-A.M.S. #1121
Blue Water Marine Services**

Date: 25 September 2023

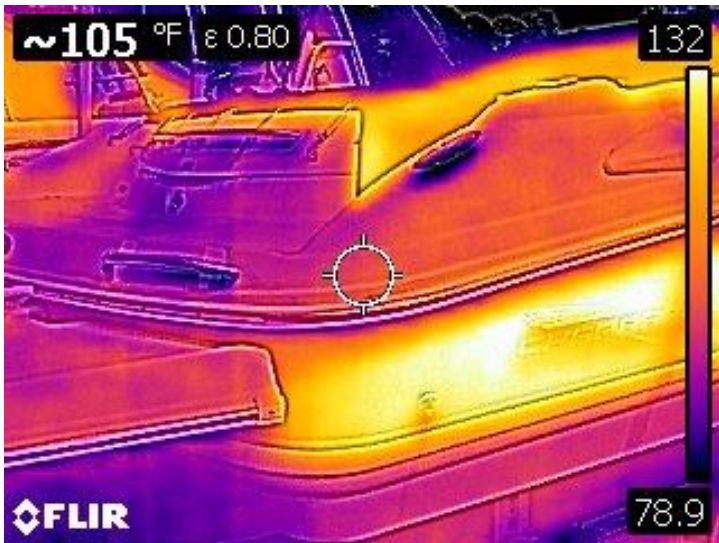
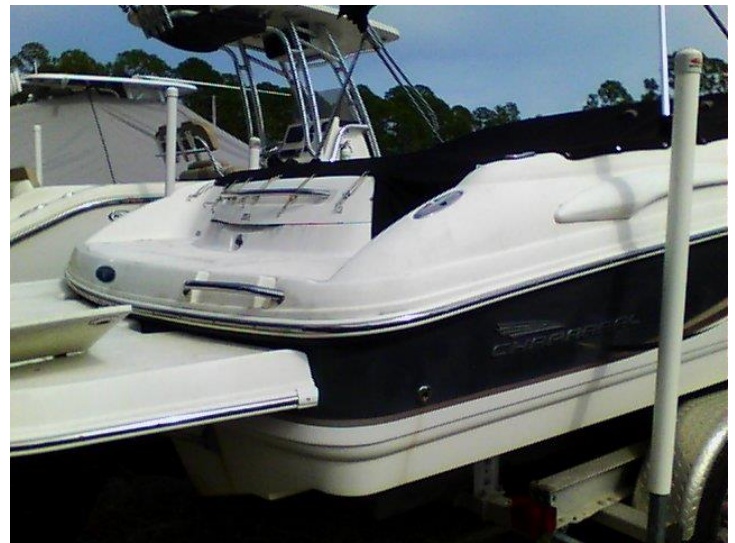
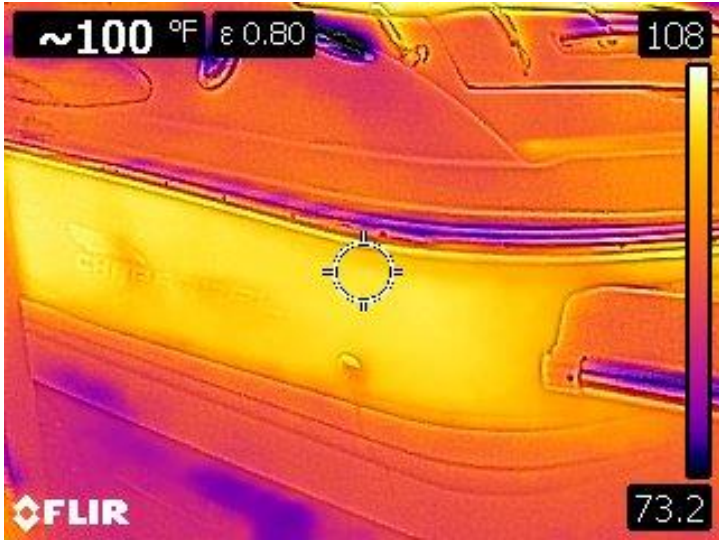
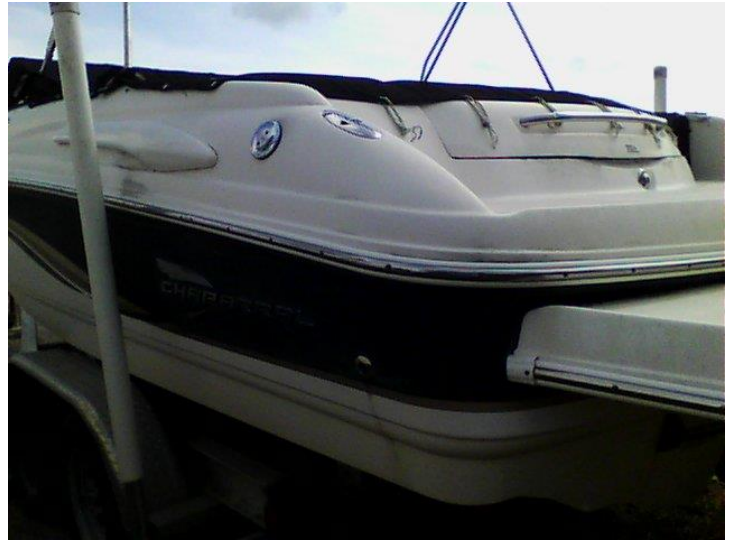
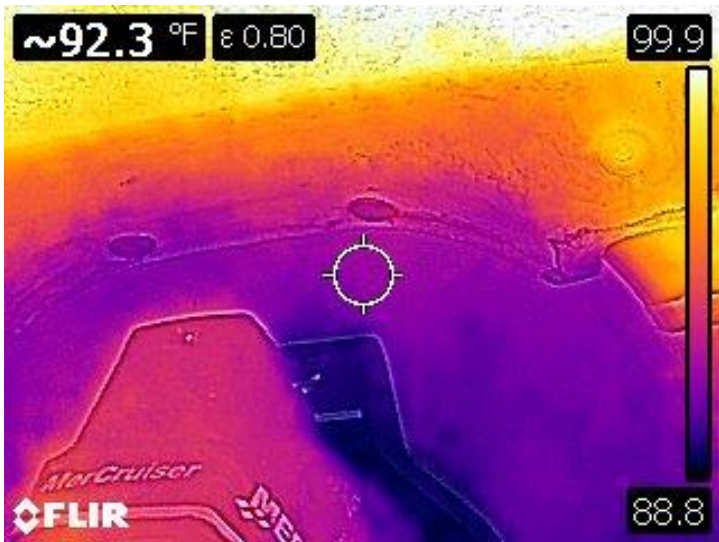
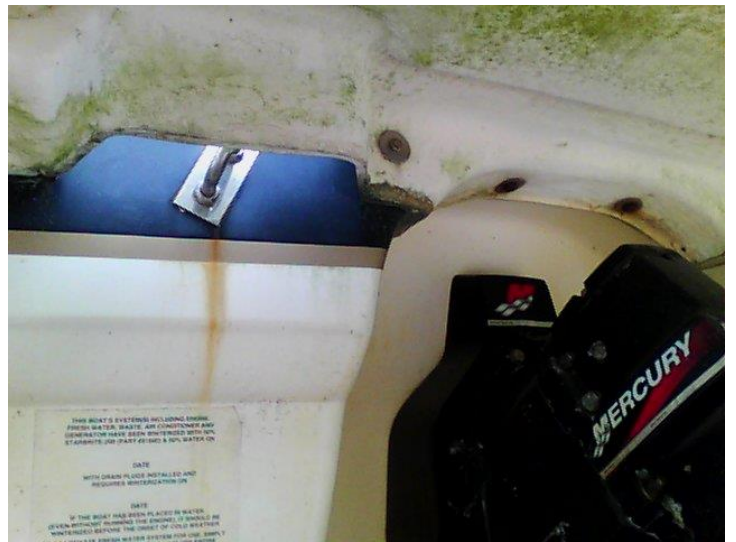
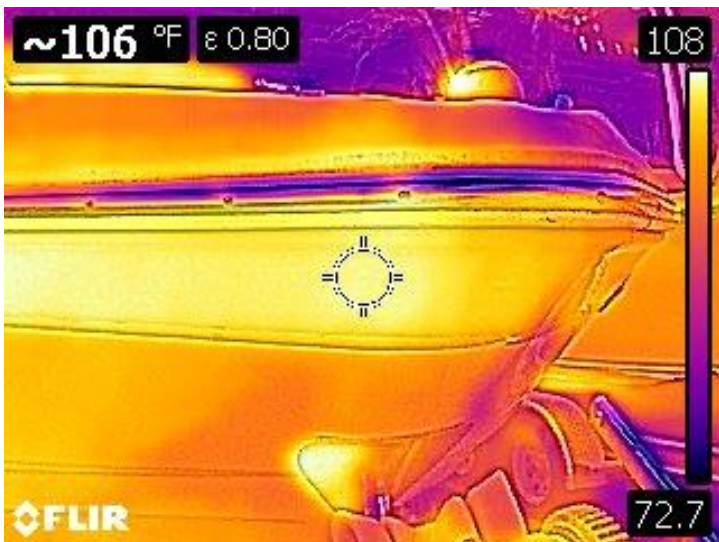
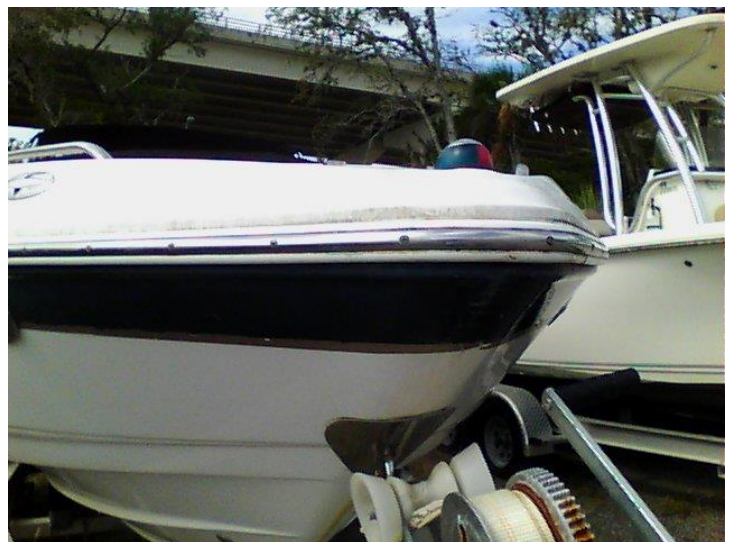
Note – No crack or weak areas noted.
