**1980 39'9" Irwin Citation 39 Shoal**  
**"Archipelago"**

# **Report of Condition & Value Marine Survey**

**1980 39'9" Irwin Citation 39 Shoal**

Inspection performed on: 11/18/22

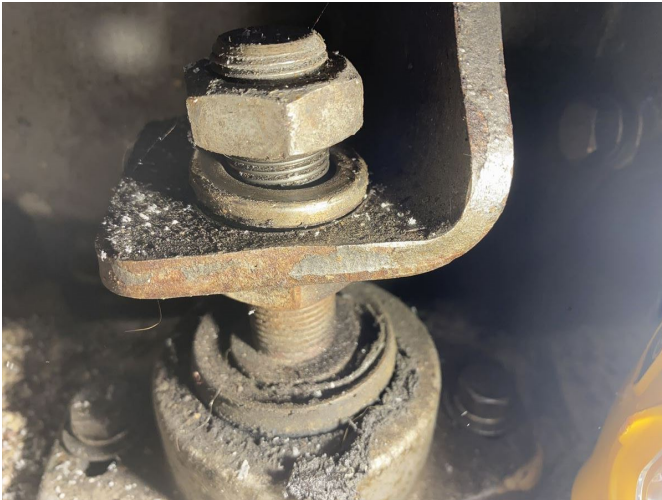
Both aft motor mount securing nuts were loose and need tightening.

### **RECOMMENDATION**

Service motor mounts as necessary.

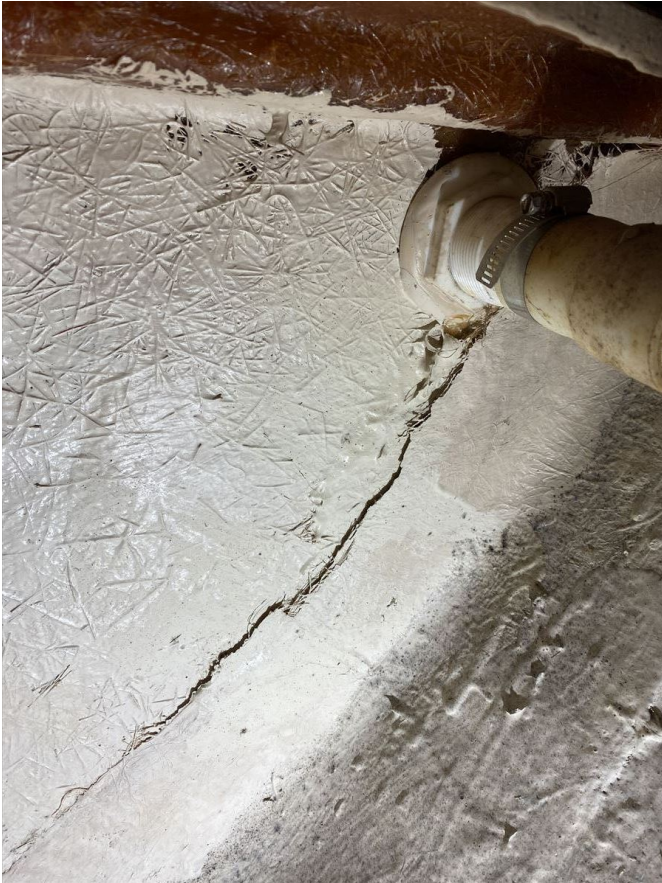
Fiberglass tabbing separation was observed on the bulkhead under the v-berth sleeping bunk (starboard side only).

Repair in accordance with good marine practice, as necessary.
