Vessel Name: M/Y "DIXIE"

REPORT of APRIL 23 & May 10, 19 & 24, 2021 INSPECTIONS

"CONDITION AND VALUE INSPECTION"

DESCRIPTION OF VESSEL: Down East style Wooden Picnic Yacht with Black topsides and tan decks powered by a Single Mercruiser 5.7L Gas Inboard Engine (2016).

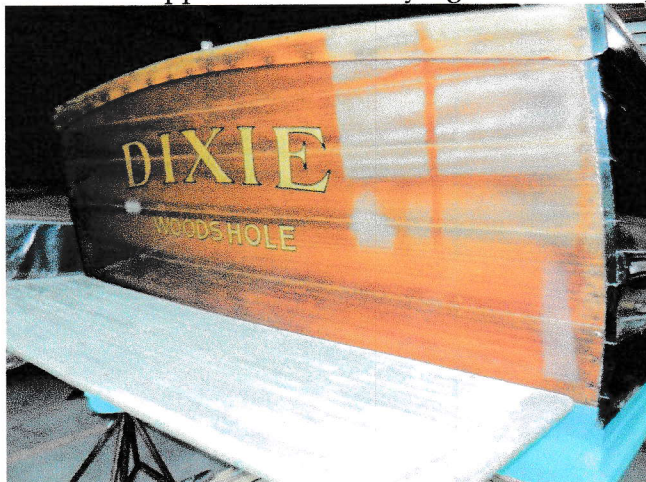
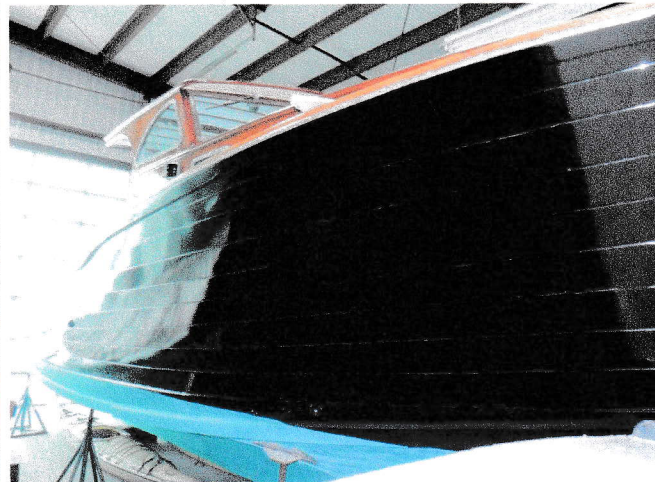
Taken April, 2016

She was constructed with a raked stem, hard chines, full keel with skeg and a full varnished mahogany transom. There were no visible signs of the hull working and the hull was randomly sounded with a rubber mallet and all appeared reasonably tight and will require time to swell, as usual.

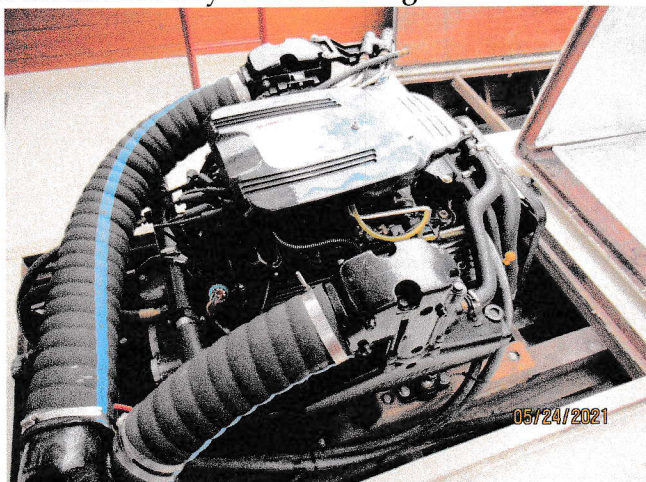
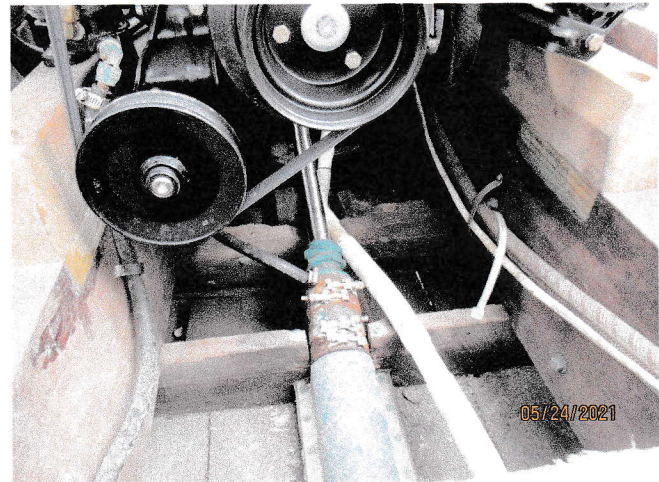
A new Mercruiser 383 MAG, 8 cylinder, fresh water cooled gas engine which develops 350 hp @ 4300 rpm. Serial number: not seen. It was reported to have been installed new during the Spring of 2016. The hour meter indicated 72.6 hours. The engine is fresh water cooled with a raw water wet exhaust through the transom and is mounted on heavy wooden stringers and flexible mounts.

- 2.* Insure all US Coast Guard required equipment is current and aboard at all times.
- 3.* Insure the engine is serviced per Mercruiser specs, check rusty port forward freeze plug for water leak and inspect shaft log hose clamps for rust, replace as needed.

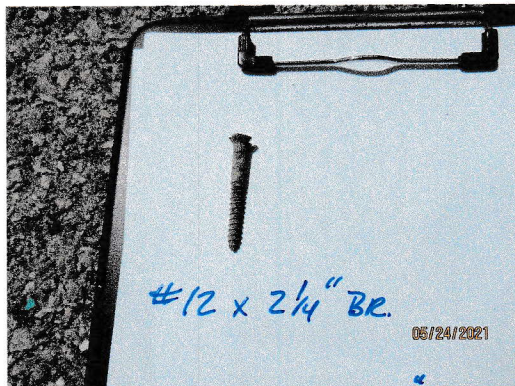
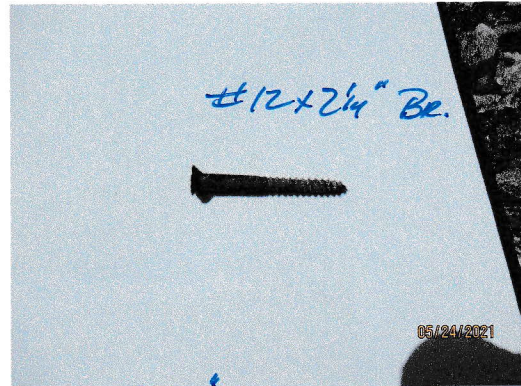
"NO WASTENg NOTED"
