REPORT OF MARINE SURVEY

VALUATION APPRAISAL INSPECTION.

of the vessel
"The Rocket"

CONDUCTED BY:
Capt. Edward M. Torre.
on
November 7th, 2023

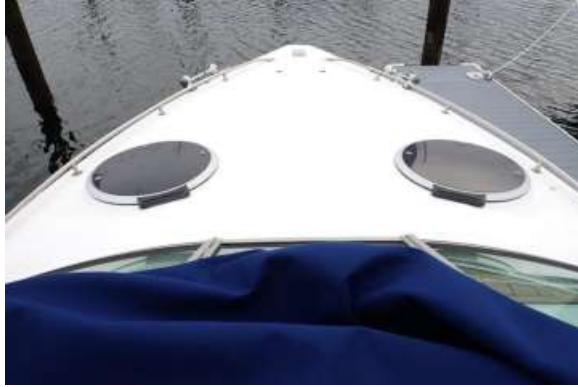
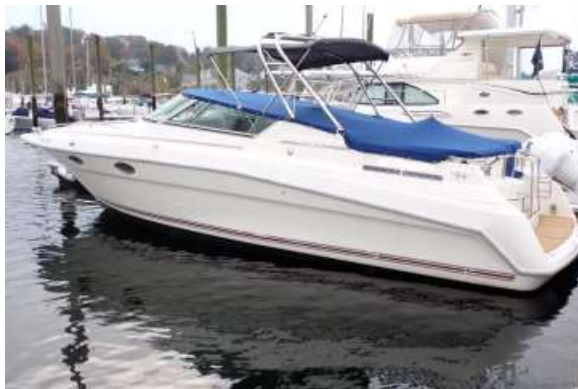
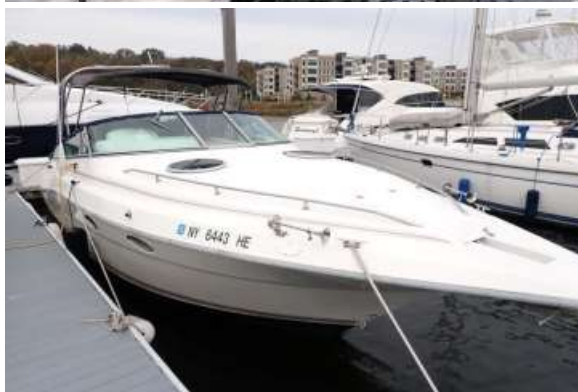
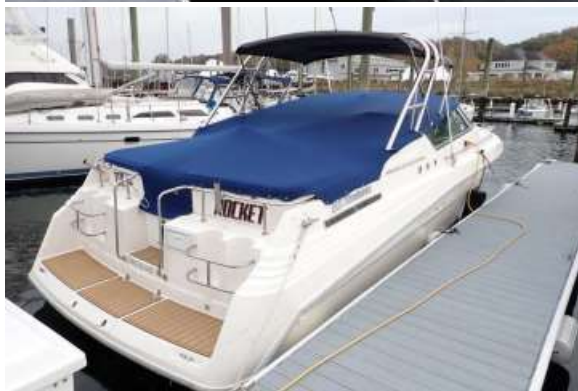
- White gelcoat above and below the grey, rubber rub rail. Hand laid and molded fiberglass - (exact layup unknown)
- Hull cosmetics were found to be in generally good condition with nicks, scrapes and scratches not unusual for a vessel of this age.
- The FRP topsides above the waterline were sighted and found to be fair and sound with no visual evidence of hard spots. A phenolic hammer was used to check for delamination on the foredeck and no anomalies were found. (moisture meter not used) The deck was solid underfoot with no sponginess.
- A Fortress FX-11 danforth anchor with about six feet of chain and synthetic rode appeared to be in serviceable condition
- SS grab rails were secure
- Windshield was wrap around type with walk thru center panel. No cracks or separations were noted.

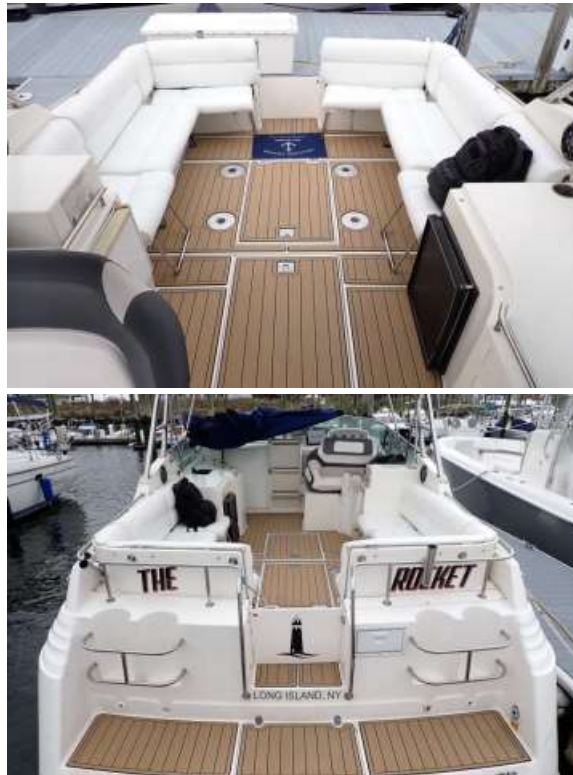
- Fiberglass, with Sea Deck overlay was in good condition - serviceable.
- Wetbar to port with refrigerator unit and ice maker to stbd (not tested)

All cushions were in generally fair to good condition with no obvious rips, tears, or observable staining noted .

Canvas: Blue mooring cover and grey bimini top were in good serviceable condition.

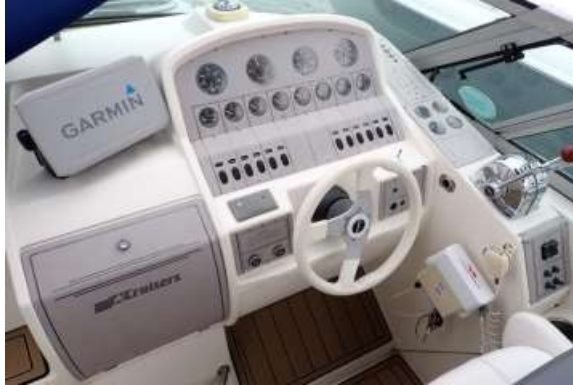
Dual Combined Morse throttle/shift levers / Separate analogue gauges for port and stbd engines: Fuel/V/Temp/Oil and RPM ; magnetic compass (heading agreed with app) ; Garmin multi function chart plotter (powered up) / depth finder / VHF (powered up)

Horn ; blowers (powered up) ; bilge pumps ; cockpit lts ; navg lights ; trim tabs ; wipers.

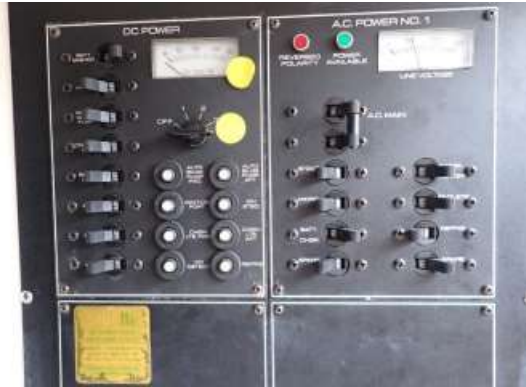
- Vessel was fitted with a 12 Volt system with a distribution panel and rotary selector switch.
- Battery Sets: Three (3) 12V Marine batteries located in the engine compartment
- Each battery was stowed in its own tray securely and conductors were properly color coded and secure. Recommend ensure the positive terminals are fitted with rubber boots and only max four (4) conductor terminals on a single battery terminal
- Charging system: Engine mounted alternator // battery charger - (powered up)
- Breaker(s)/fuse(s): D.C. circuits appeared adequately protected by branch or switched breakers and DC electrical system appeared to be tied into vessels electrical ground system using the engines as a common ground.

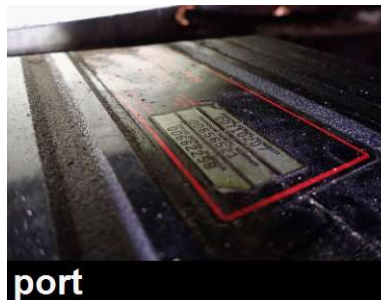
port

- Engine specifications Twin MerCruiser 7.4L/V8 engines ; dom of '91
- Engine serial no(s):
Port: OD710207 // Stbd: OD710232
- Engine(s) hours: (as sighted on helm gauges)
Port: 354.2 // Stbd 947
- Engines fitted with flame arresters

The engine(s) and machinery were not operated for the purposes of this survey. Furthermore it is understood that the attending surveyor is not an engine/transmission surveyor. As such, I recommend that if desired, engines and transmissions be inspected by a qualified expert engine surveyor/mechanic who use sophisticated electronic tools specific to the make/model of engine(s) to determine the internal condition of engine performance and determine any repairs necessary of the engine(s), transmission gears, and pumps, heat exchangers, coolers, etc.
