1974 33 Viking Boats Sloop Rigged Sailboat

"Compromise"

Underwriter's C&V Survey Report

Date Of Survey: April 19, 2025

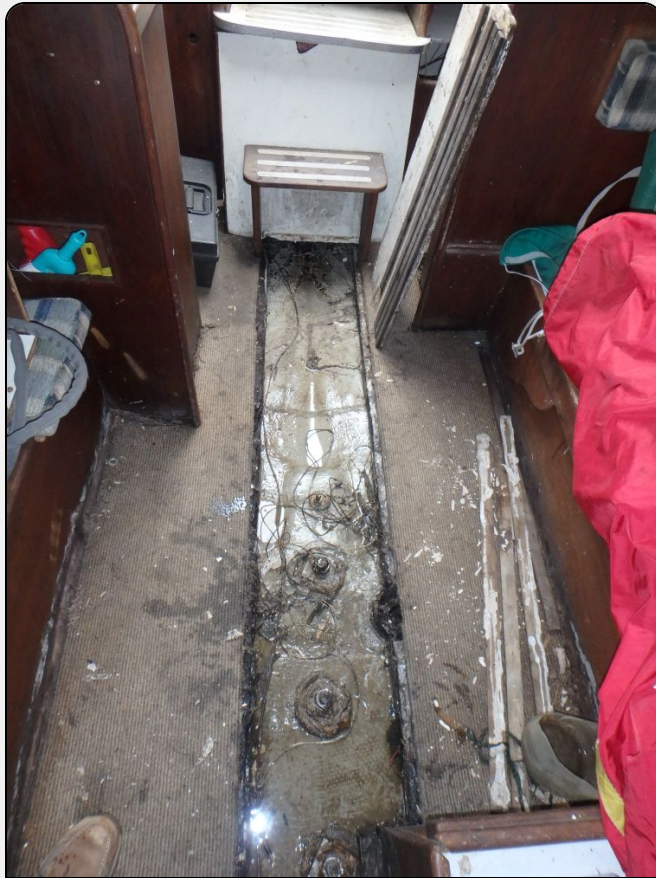
The bilge was exposed in the salon. It could use a good cleaning and the sole flooring should be replaced prior to use to allow for easy maneuverability while under way.

Photo 1: The bilge area in the cockpit.

Replace the floor board so the crew can safely maneuver inside the cabin

Install an adequate 12v bilge pump with automatic float switch. Consider adding a secondary bilge pump and float switch in the engine compartment as a backup.

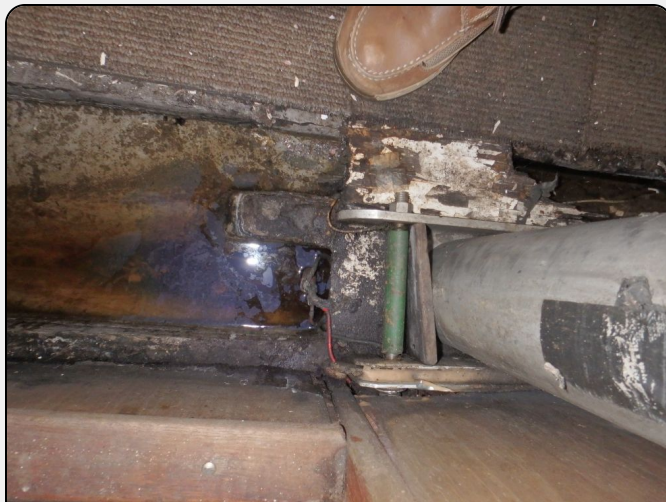
Photo 3: The bilge near the mast step.

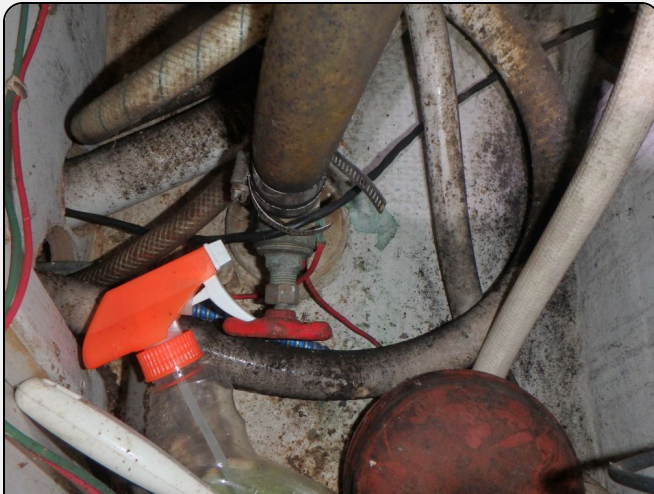
All of these seacocks utilized a gate valve to close off the flow of water. All of the seacock valves were seized and could not be open or closed by hand. Recommend to replace all seacocks with appropriately sized ball valves designed for marine use. It's also recommended to evaluate the hoses going to the seacocks and to replace with PVC / Vinyl reinforced flexible hose.

Photo 4: Gate valve in the head - used for the sink drain.

Replace all seacocks with marine grade ball valves and review and asses the hoses going to the seacocks and replace if it's beyond it' ervice life

Follow these ABYC Standards H-27.7.1 when replacing the seacocks: A seacock shall be securely mounted so that the assembly will withstand a 500 pound (227 Kg) static force applied for 30 seconds to the inboard end of its connection fitting, at any point in its most vulnerable direction, without the assembly failing to perform as intended).

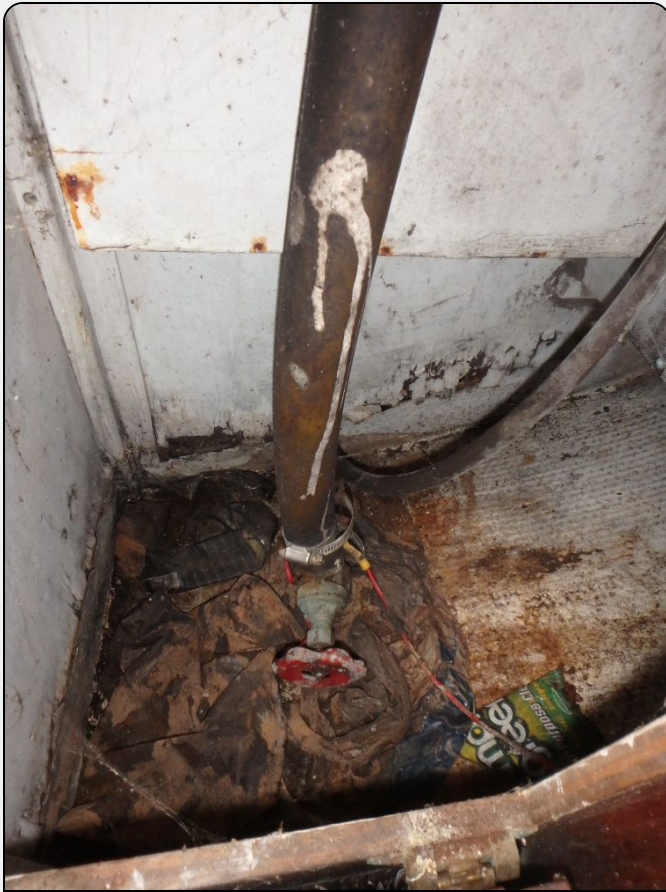
Photo 6 Gate valve in the galley for the sink drain

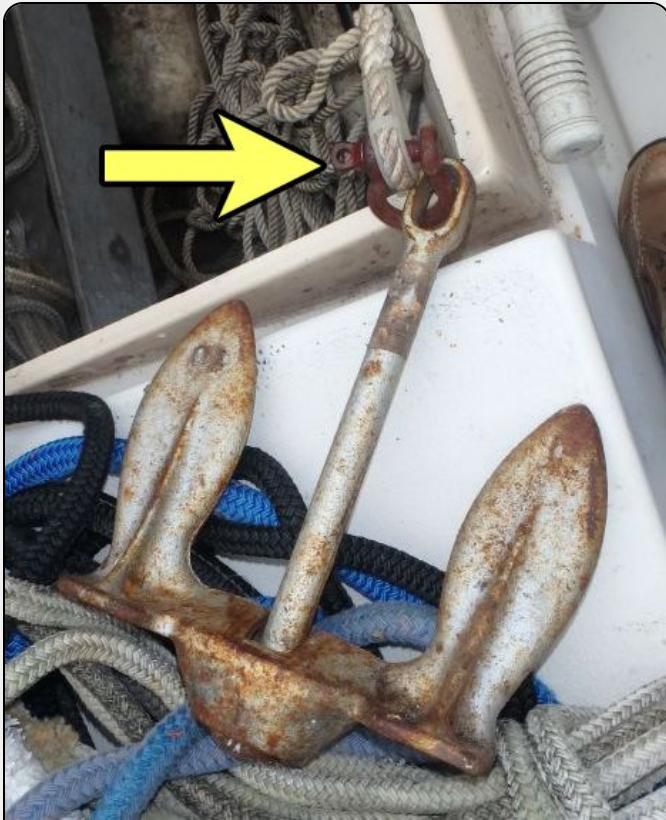
A 10lbs. Navy Style anchor was in the starboard side aft storage locker. It was galvanized coated with some minimal signs of surface rust. It had a steel shackle attached to the anchor line.

Photo 7: Add thin safety wire through the hole in the anchor pin.

Properly install safety wiring (seizing wire) to prevent accidental anchor loss.

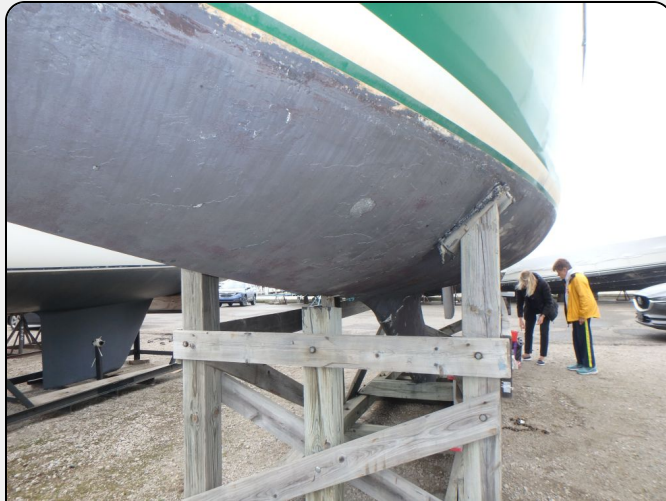
Photo 8 Signs of the boat needed new bottom paint

Reapply bottom paint.

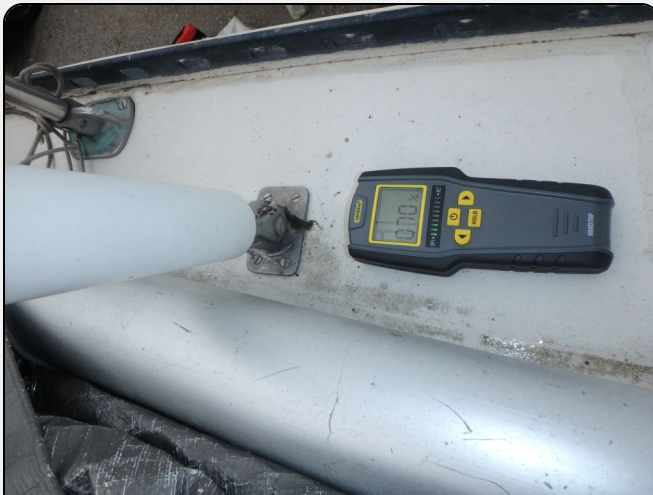
The deck was sounded with a phenolic hammer and tested with a moisture meter and was found to be mostly solid, however areas around the chain plates showed delamination and high (70-80%) moisture content. This is likely due to water intrusion through the mounting hardware.

Areas of delamination and high moisture were found around the chain plates and stanchions.

Photo 9: Moisture meter showing a 70% level of moisture around this chainplate penetration on the port side.

Investigate further and repair in accordance with good marine practice as necessary. This will involve removing the chain plates and faulty stanchions, repairing the damaged area(s) and re-bedding the hardware.

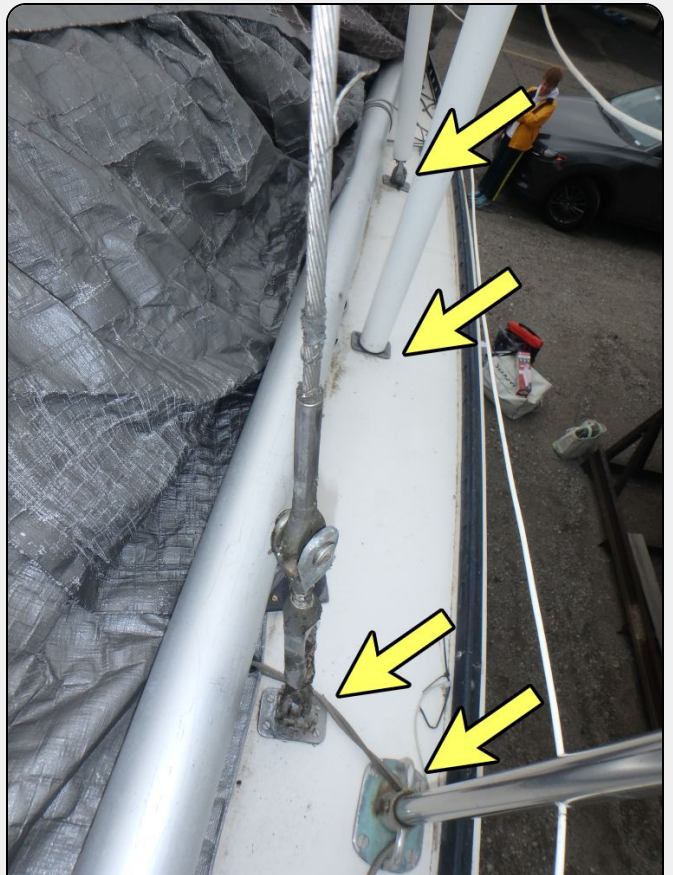
Photo 10: Areas of elevated moisture and delamination were found on the port side decks

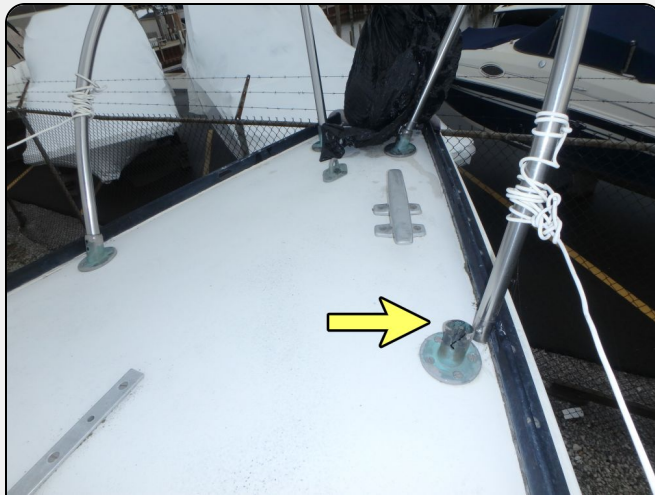
The stanchion bases and lifelines had significant play and flex during the survey. It's noted the lifelines were not fully setup and established during the survey since the boat was in winter storage.

Photo 11: Stanchion base is cracked allowing the stanchion support to come out

Follow ABYC H-41 standards to ensure the lifelines can Lifelines must withstand a transverse load of 400 pounds (1,780 N) applied at the midpoint without failing or deflecting excessively

The system (including stanchions, pulpits, and attachment points) must be designed to handle dynamic loads from crew leaning or falling against it.

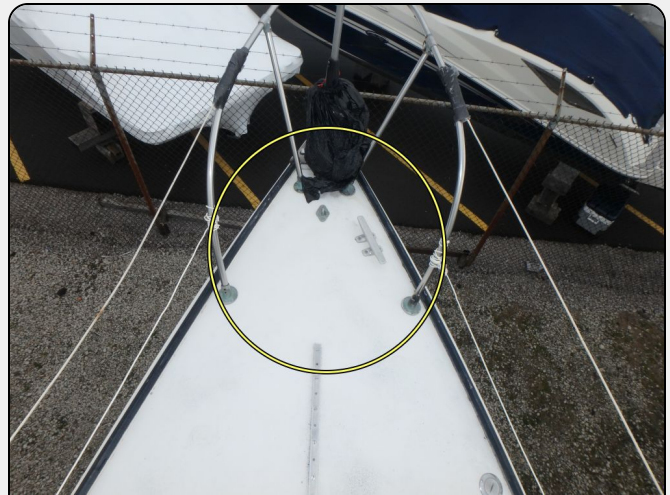
Safety lines and stanchions ran the perimeter of the boat and were not fully setup due to the boat being in winter storage. During the survey the stanchions and lifelines were pretty flexible and not secure. Some of the stanchions on the bow of the boat were loose and need attention.

Photo 12: The stanchion bases on the bow should be tightened or rebedded or replaced if necessary

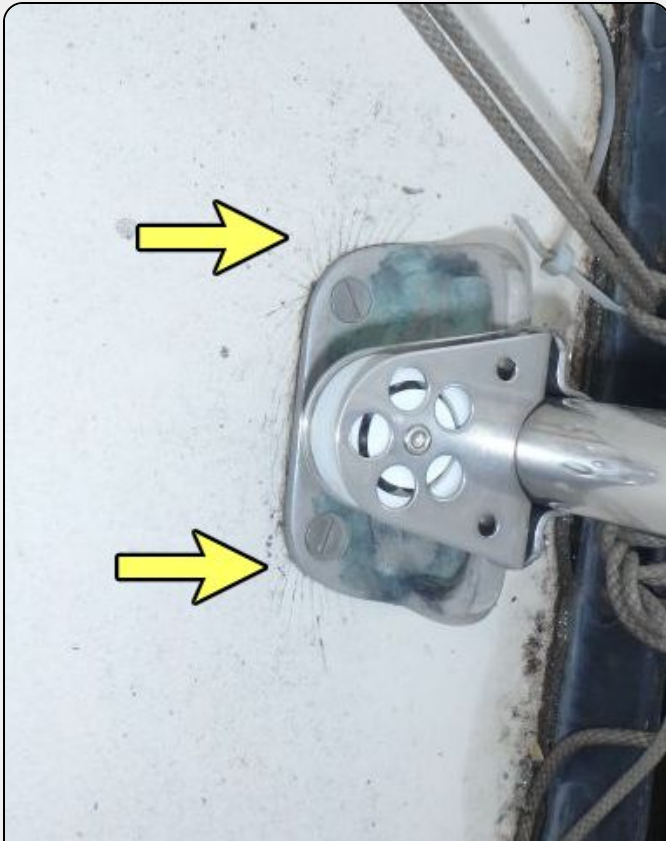
Photo 13: Small "spider-cracks" coming from the stanchion mount

The crack highlighted were consistent with the placed on the lifelines and stanchion. I recommend to monitor the area to be sure the gelcoat cracks don't spread or become worse. These types of cracks are consistent with a vessel of this age.

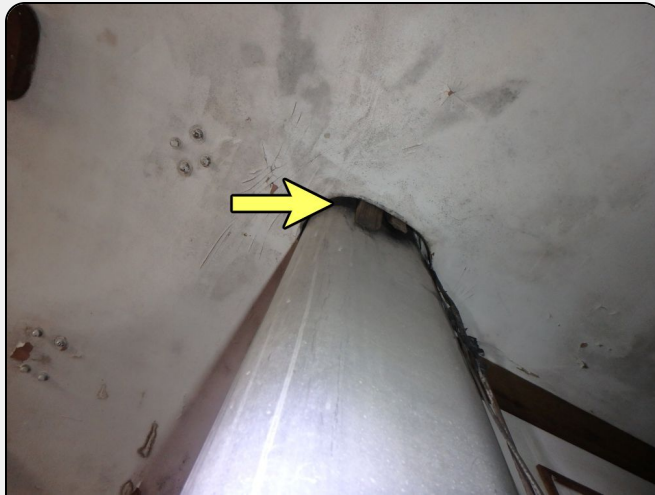
Wood shims are acceptable for temporary use only.

Photo 16: View of the mast where it penetrates the cabin.
The wood shims are visible.

Suggest to have a qualified rigger inspect the mast if the main sail will be used.

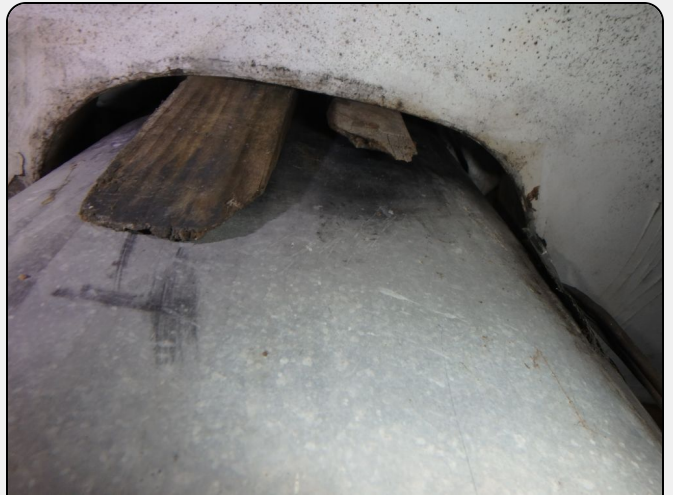
Photo 17: Closer view of the wood shims.

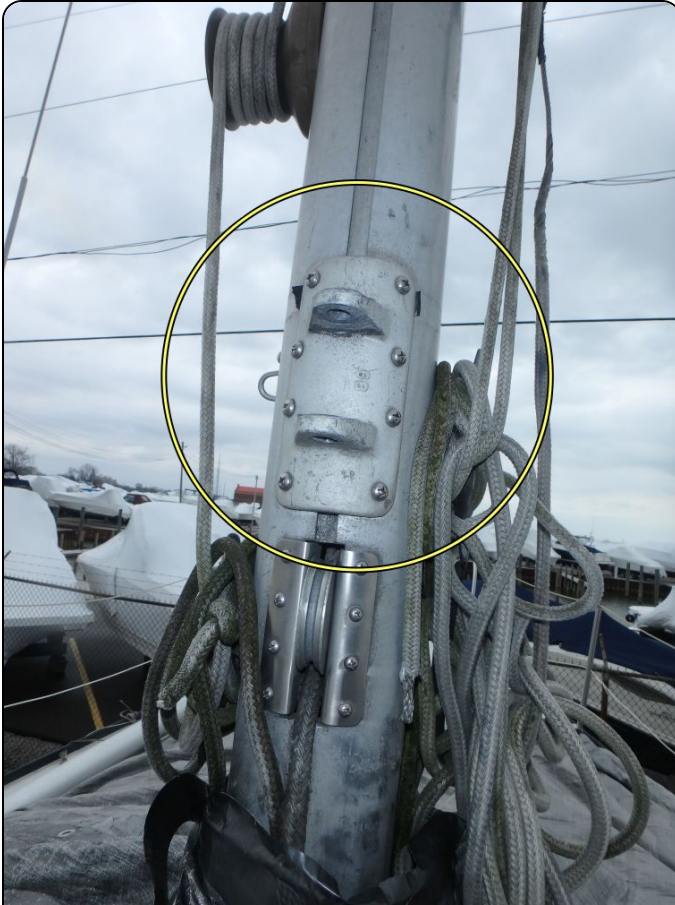
The gooseneck is utilized to secure the boom. The boom has not been installed or used in the past three years. The attachment point where the boom would connect to the mast is aluminum and appeared free from cracks or fatigue.

Photo 18: The aluminum gooseneck attachment point.

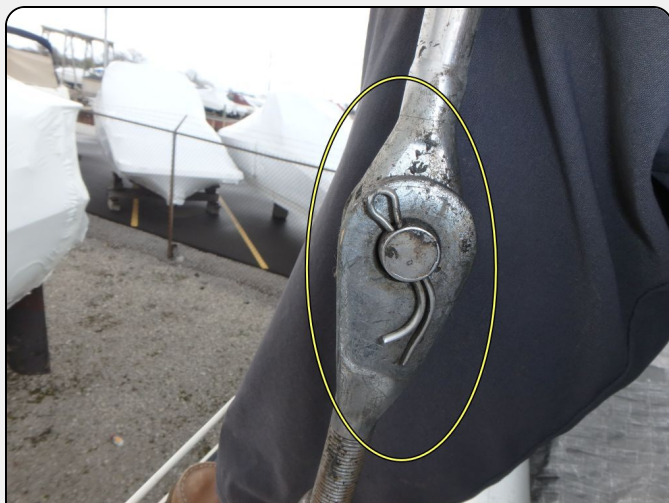
Photo 19: The Stay-Lok eye shows small distress markings on close inspection.

Monitor these Stay-Loc fittings in the future to be sure the distress is not getting worse. Due to the fact the vessel does not use the main sail which would add stress to these Stay-Loc fittings the concern is not serious enough to recommend these issues be addressed prior to sailing.

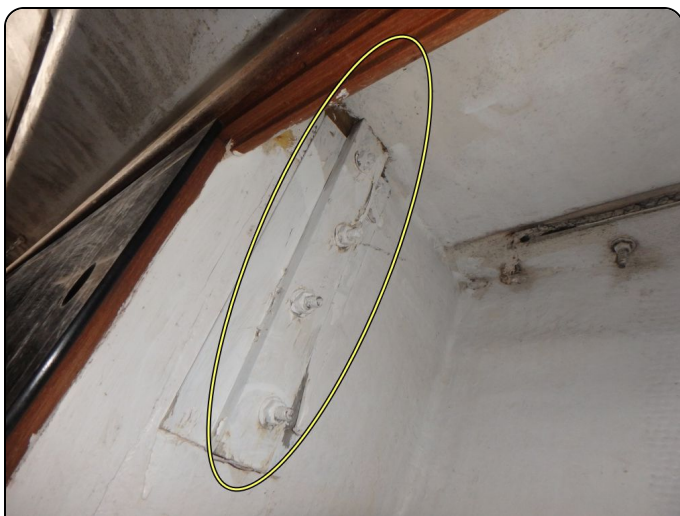
There was elevated moisture and delamination detected during the inspection around the chainplates where they are mounted to the outside deck. This may potentially lead to "crevice corrosion" which is a localized form of corrosion that occurs in confined spaces or crevices where oxygen access is limited, and moisture, salts, or contaminants can accumulate. The trapped environment creates a chemical imbalance, accelerating pitting and material degradation. Regular cleaning, proper material selection (e.g., 316 stainless steel), and sealing crevices help prevent it.

Photo 20 Amidship chainplate backer support

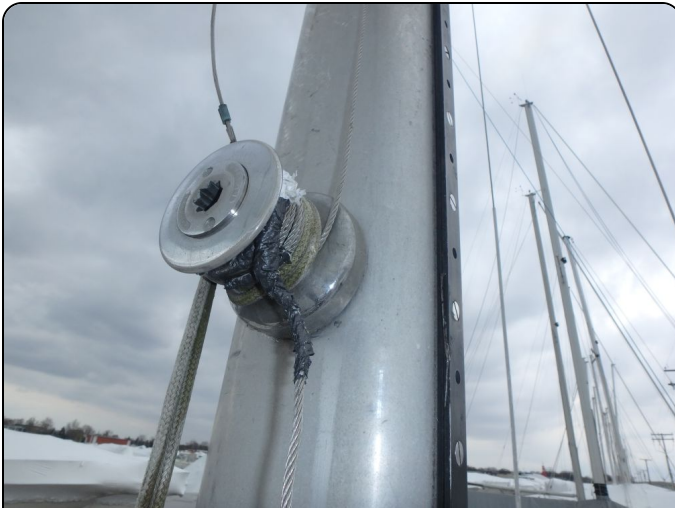
Braided 5/16" halyards with wire to line splices. The mainsheet halyard was in poor condition with the wire to rope splice covered in tape and showing signs of fraying.

Photo 21: Wire to rope splice for the main halyard.

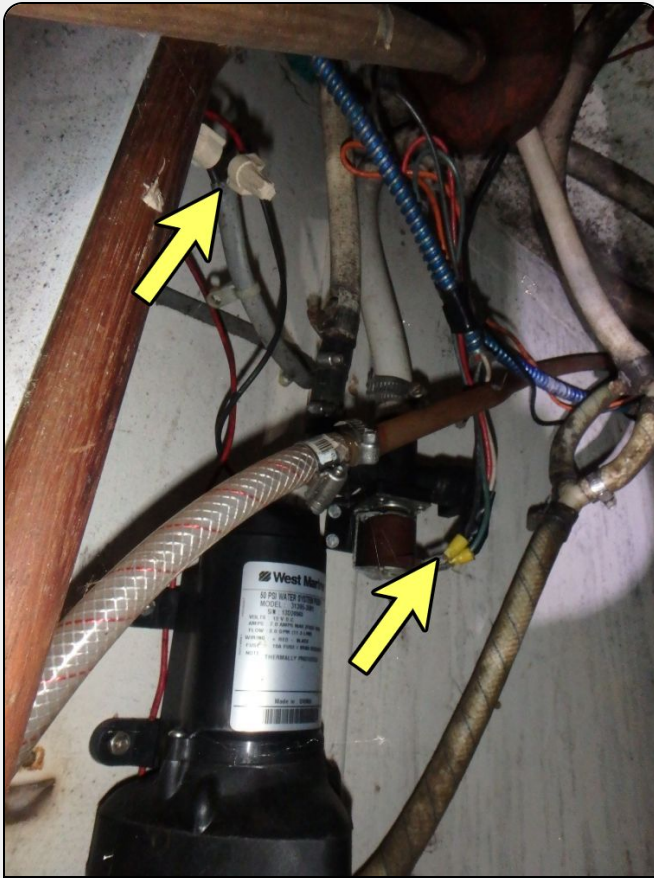
Photo 22: Wire nuts should not be used on boats.

Use heat shrink connectors from manufacturers such as Ancor or Blue Sea Systems for wire splices.

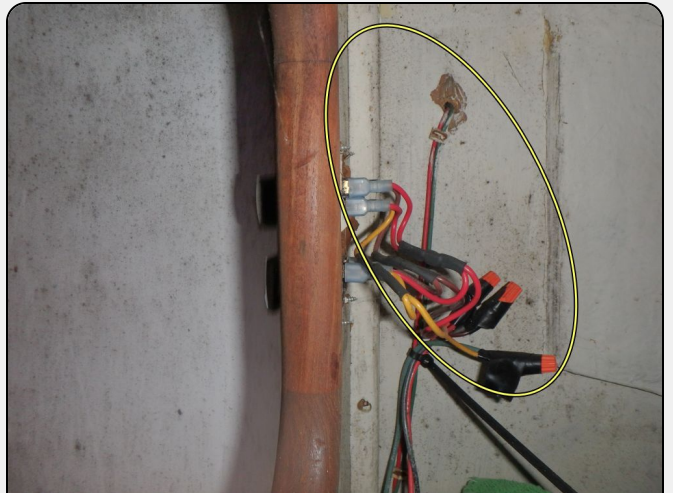
Photo 23: wire connectors on the back side of the switches in the head.

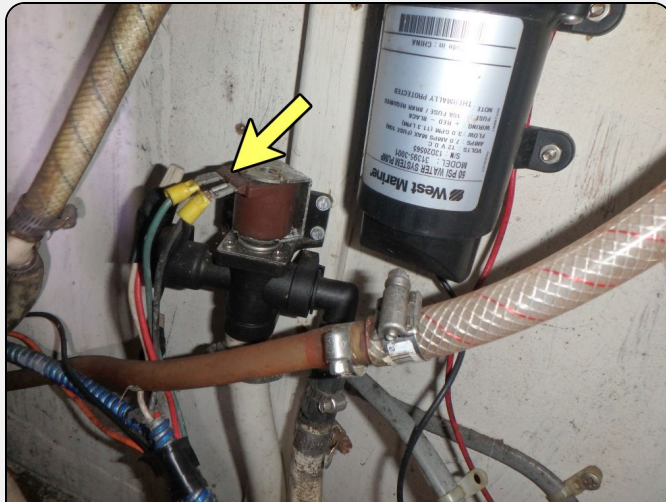
Photo 24: These exposed connectors need to be covered.

Apply heat shrink or new spade connectors on the solenoid to prevent metallic objects from accidentally touching these connects are creating sparks.

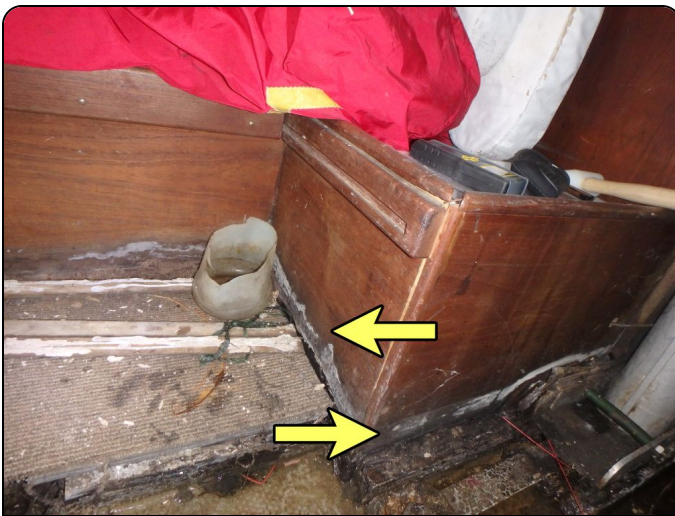
Mostly made from teak wood. The wood is in overall good condition for its age. Water staining was noticed on the very bottom 3"-6" of the wood; The owner stated there was standing water in the cabin while the boat was in winter storage several years ago which would explain the water marks on the wood.

Photo 25: Dark stains on the bottom of the cabinets indicate past water damage.

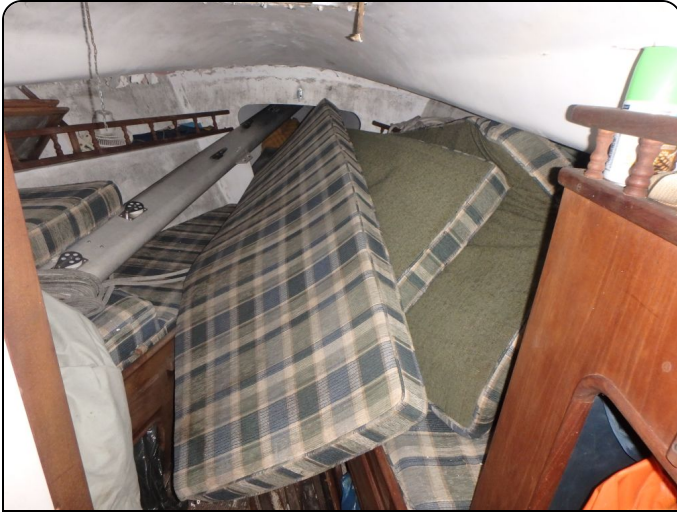
The interior cushions showed signs of water stain but were functional and were mostly dry during the survey.

Photo 26: *Interior cushions should some wear and water stains.*

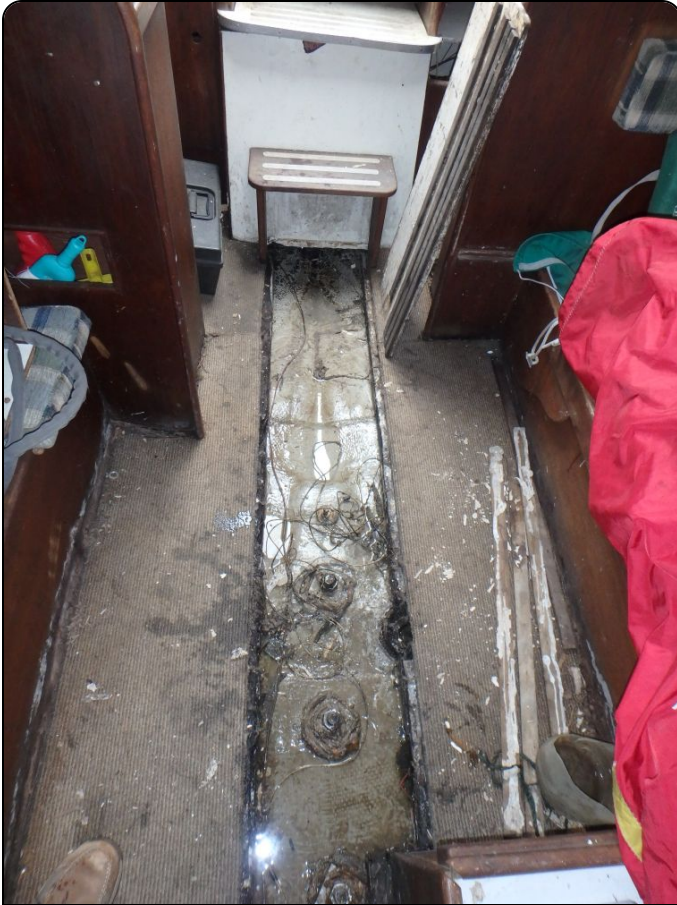
While the interior was in overall fair condition it served its' purposes. During the survey the floorboards were removed to provide access to the bilge. It's highly recommended to replace the floorboards to provide safe footing while sailing. The headliner in the cabin showed signs of a dark colored mold and peeling paint. Recommend to clean the headliner with soap, water and a 1% dilution of bleach to kill the mold.

Photo 27: Floorboards were removed for the survey.

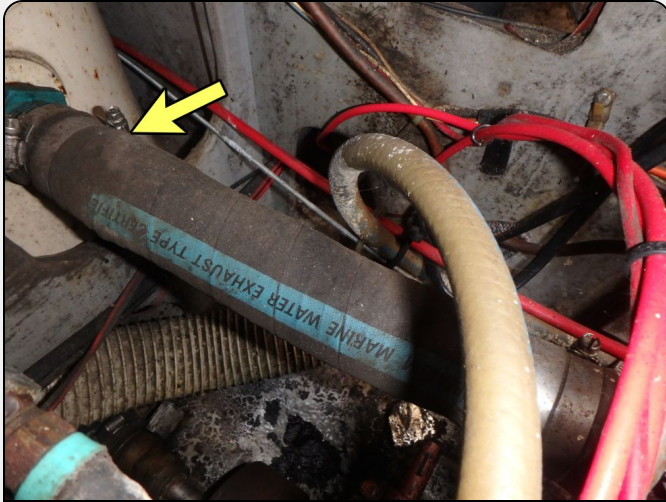
The engine used a raw water cooled exhaust with flex hose and a steel water lift muffler exiting the transom. The exhaust hose appeared to be "swollen" near the connection to the water lift muffler. Recommend to replace this section of hose.

Photo 29: Swelling noticed on exhaust hose indicating it's past it's useful life.

Replace the exhaust hose with double clamps on all connections per ABYC P-1.7. Hose must be suitable for exhaust systems and marked with "Marine Water Exhaust Type Hose" to be sure it meets the standards.

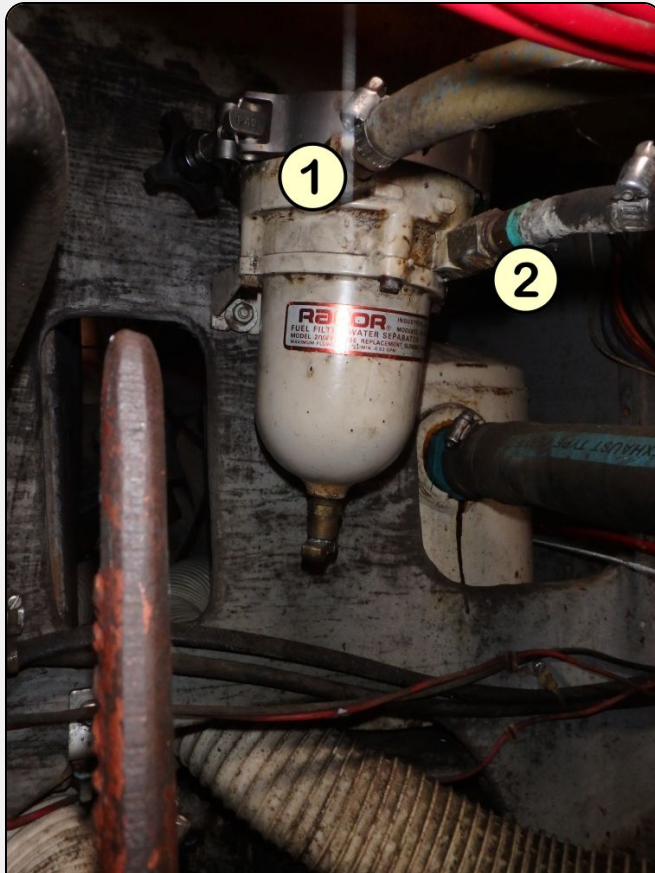
The fuel line from the Racor filter to the engine does appear weathered and likely beyond its service life. Typical fuel hose is good for a maximum of 15 years and since no markings were visible on the hose, I suggest sometime this season that the fuel lines are replaced with Type A1 USCG approved fuel line. The line should be double hose-clamped at all connections. The same refit would apply to the fuel line from the gas tank to the Racor fuel filter using an A1 type fuel line of appropriate size.

Photo 31 Hose 1 Leads from the Racor filter to the engine.
Hose 2: Comes from the fuel tank to the Racor.

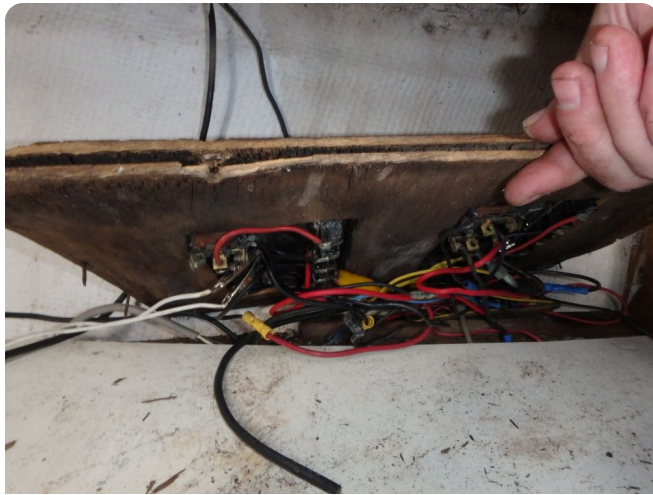
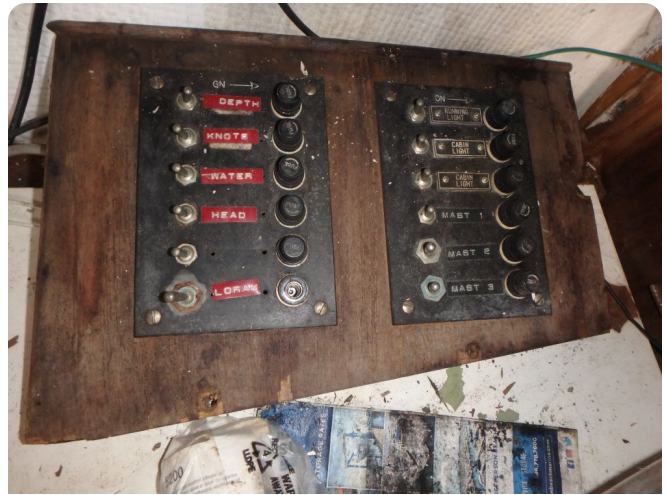
The DC panel needs to be permanently mounted into a secure area.

Mount the panel into an area or enclosure where nothing could accidentally make contact with the exposed terminal which would create a spark.

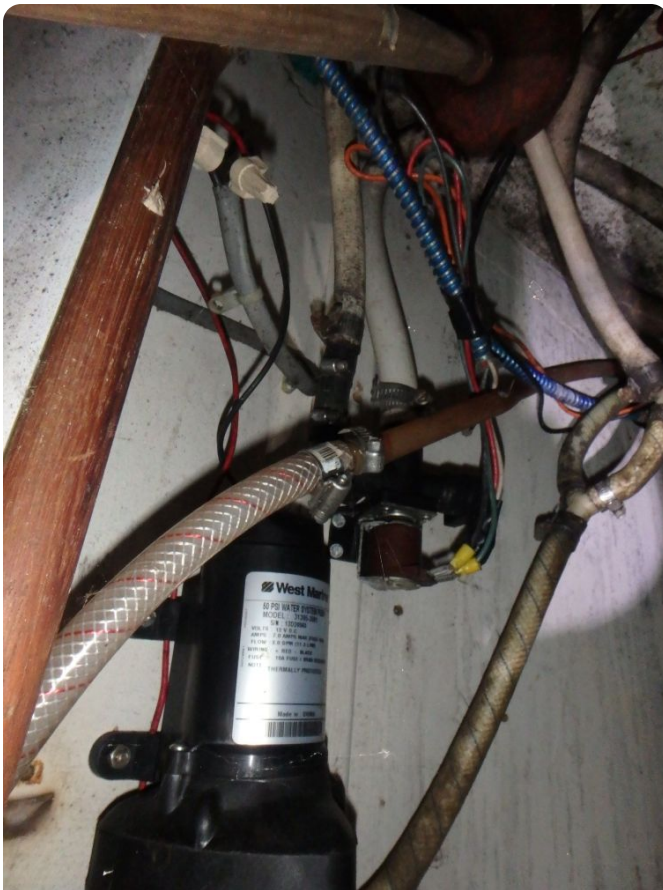
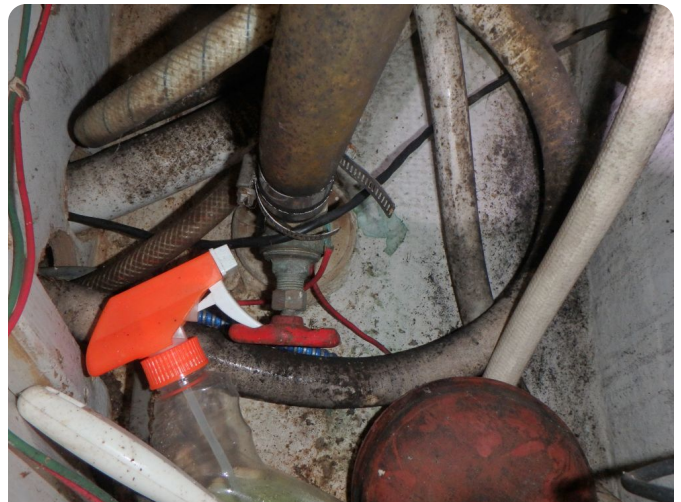
The boat had two water sources (head faucet and galley faucet) each with their own dedicated 12v pump. The fresh water hoses did not appear to have leaks but did show signs of age indicating they may be past their service life. There were no visible date markings on the hoses but best practices for fresh water hoses of reinforced PVC or vinyl (which this vessel uses) on boats suggest they are replaced every 5 10 year. The freshwater tank was not accessible and the black water holding tank was located under the v-berth.

Some of the fresh water hoses appeared past their service life.

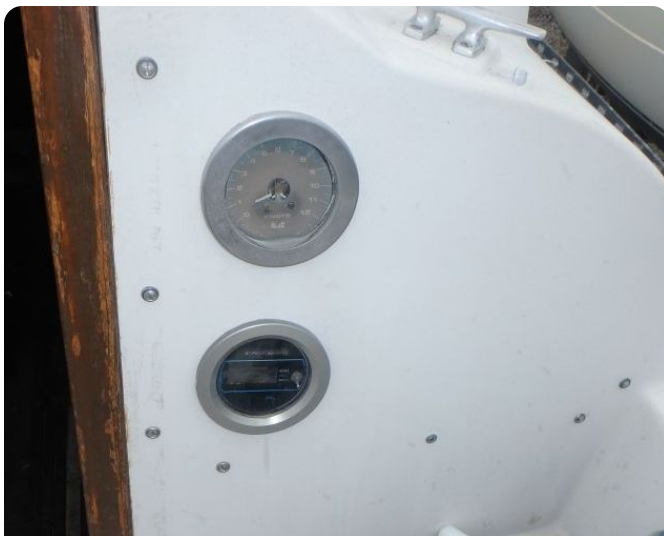
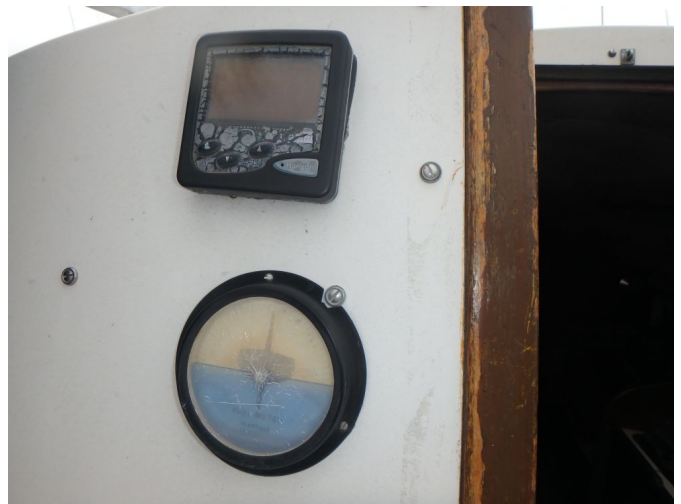
The vessel had an analog knot meter which had no wire connected to it (rendering it inoperable) and a DataMarine Model S100KL s/n: 055129 digital distance / speed meter on the starboard side of the cockpit. Both of these showed signs of weathering and use.

The port side of the cockpit had a Horizon digital display and a Heel Meter both of which were severely weathered and difficult to read.

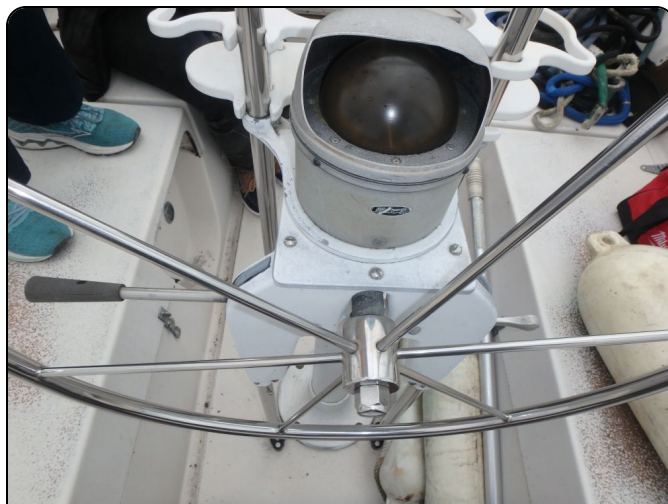
An AquaMeter compass was integrated into the steering pedestal in the cockpit. As observed, the compass had moderate to severe hazing on the glass/ plastic viewing bubble making it hard to read. An additional Ritchie brand compass was sighted in the cabin near the navigation station and appeared to move freely and function as intended.

Photo 46: *Compass at the helm.*
