REPORT OF MARINE SURVEY

**Appraisal Inspection
of the vessel
"Forever And a Day! and a Night"
1994 Bayliner 3055 Ciera Sunbridge**

10/20/2022

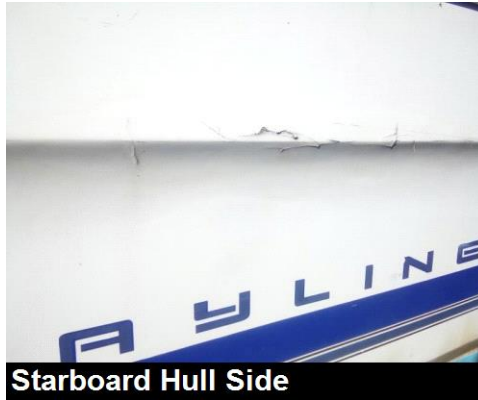
Starboard Hull Side

Also noted on the starboard hull side was an area approximately 10" in height by 24" in length where there is a crack as well as gel coat stress cracks from what appears be the result of an impact.

Deep scratches should be filled in and covered with matching gel coat.

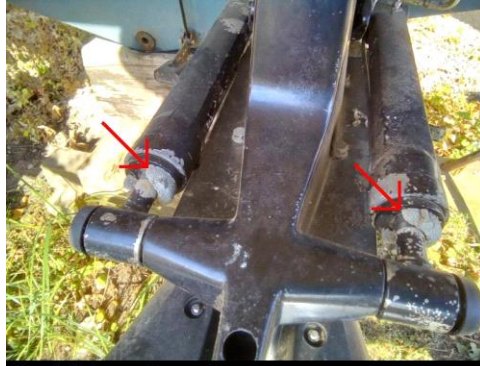
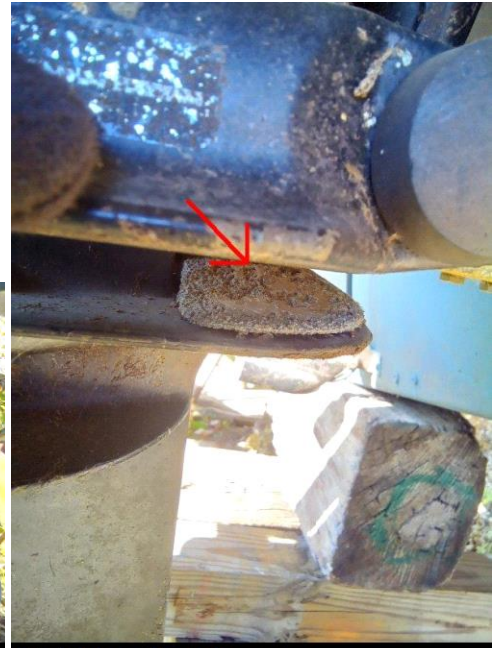
Outdrive Anodes

Trim tabs: No.
Out drive(s): Yes, need replacement.

All anodes are deteriorated. **RECOMMENDATION:** Replace all anodes.

Monitor all anodes frequently on hull and underwater equipment and replace when they are no more than 50% wasted. Anodes are normal replacement items designed to help protect the running gear from electrolytic corrosion.

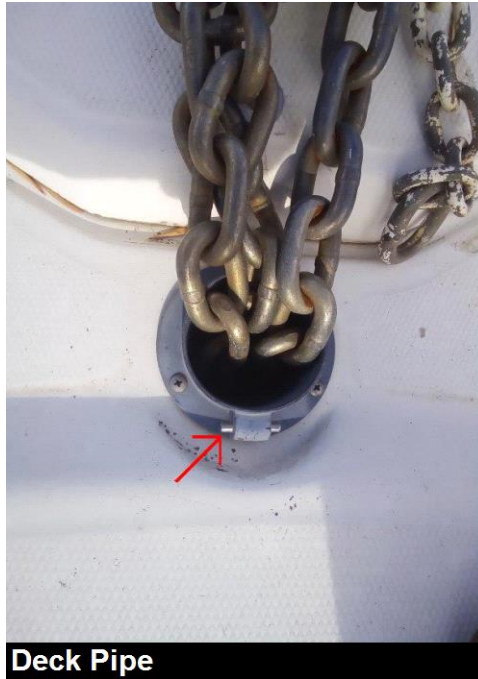
Deck Pipe

- Anchor/chain locker:** Below deck accessed from V-berth area. Lines/chain run thru deck pipe.
- Deck pipe:** Cover missing.

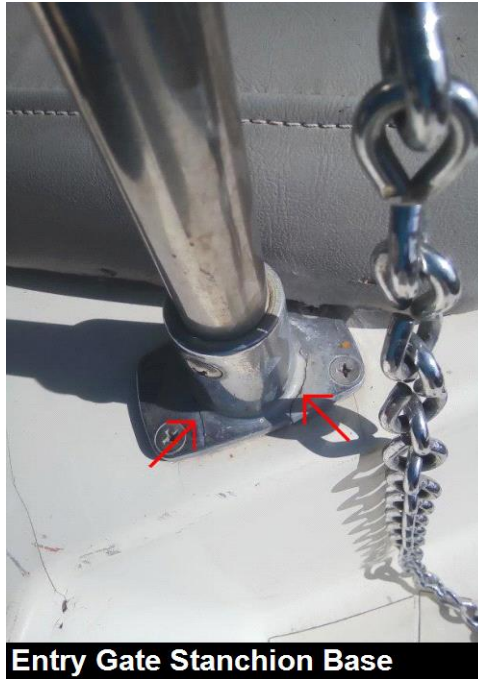
Entry Gate Stanchion Base

Radar arch:	Fiberglass and well secured.
Stern rail:	Stainless steel. Stanchion base near transom entry is broken and loose. Recommendation: Inspect further and repair or replace as needed to restore to original condition.

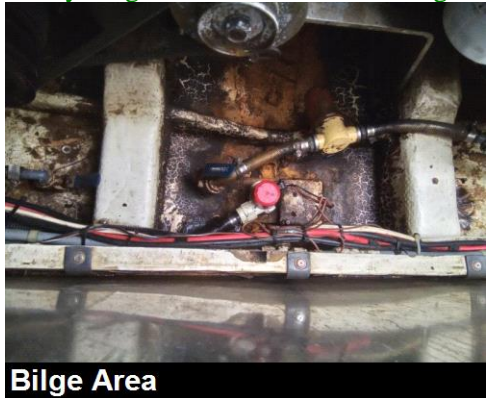
Bilge(s): Engine bilge spaces are oily and in need of cleaning ----- Keep bilge areas as clean as possible to more quickly identify leaks as soon as they occur. Clean as required. NOTE: Whenever you visit your boat, it's good practice to check the bilge area(s) for higher than normal levels of water and proper functionality of the bilge pump(s) or anything else that could be causing trouble.

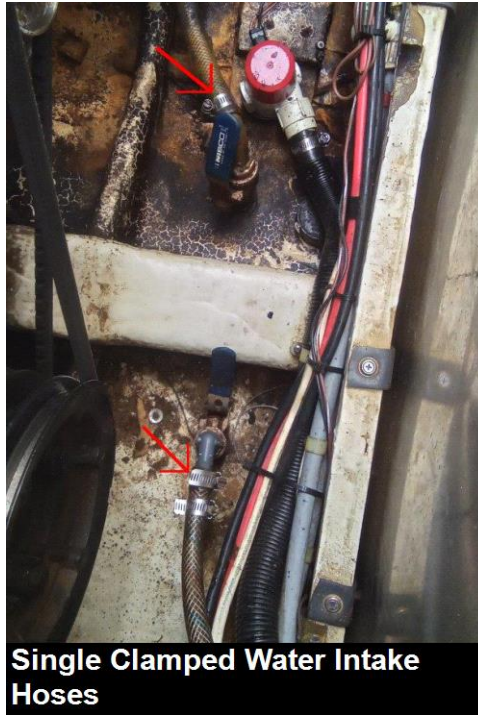
Single Clamped Water Intake Hoses

Sea valves piping: Marine rubber covered reinforced hose. Some Sea cock hoses are single clamped or clamp is not securely on fitting. ---- Recommend all sea cock hoses be double clamped if sufficient room for two clamps on sea cock barb fitting.

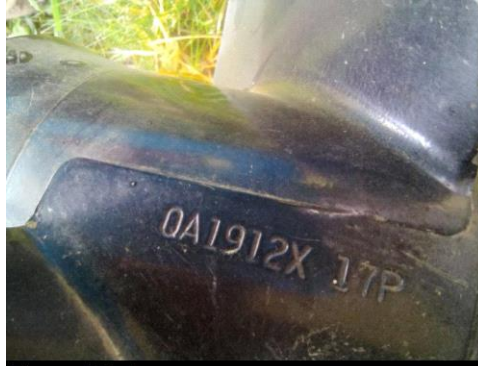
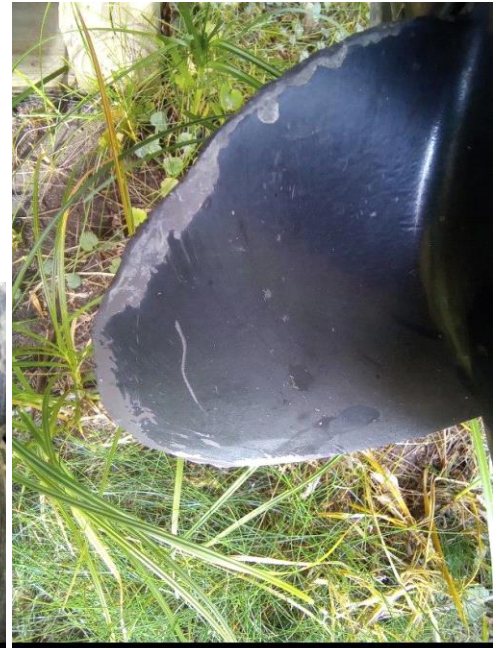
Prop Edge

Prop(s):	Prop hub stamped with a pitch of 17. Prop blades leading edges are nicked or bent and should be serviced. RECOMMENDATION: Have prop(s) repaired and re balanced to prevent excess vibrations. Prop Edge.
-----------------	---

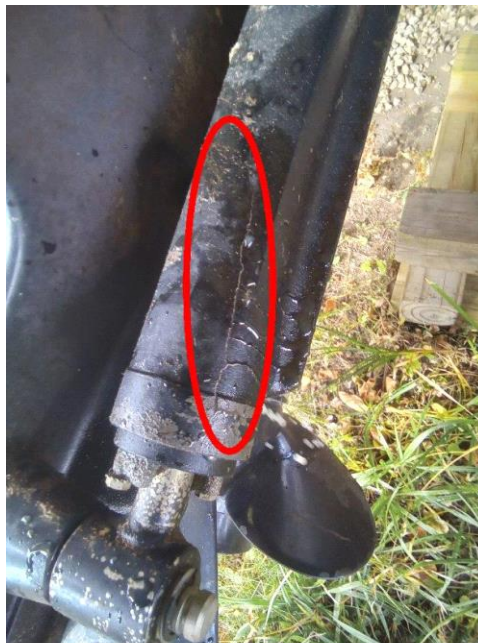
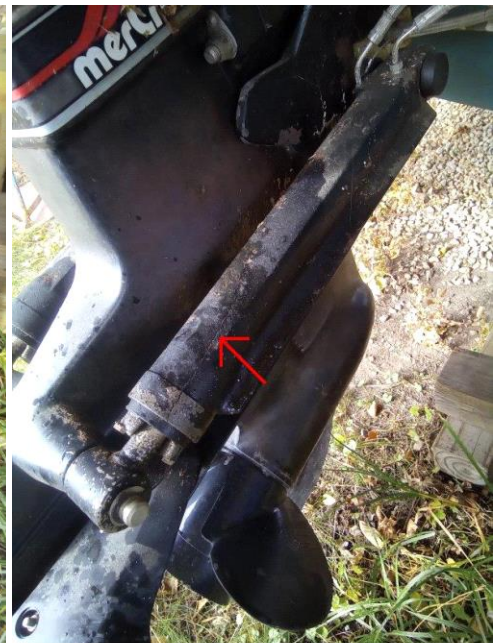
Port Inside Trim Ram Crack

When manually lifted the Portside inside trim ram squirted water from a crack that appears to be from freeze damage. Recommendation: Inspect further and repair as needed to restore full function.

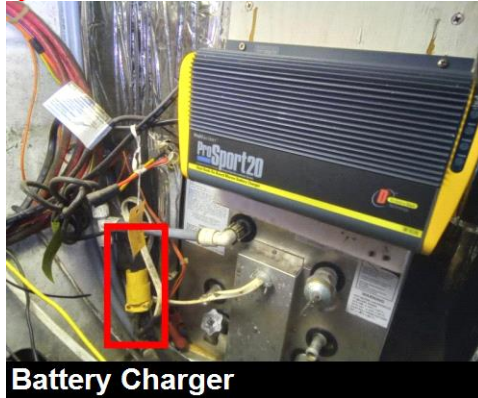
Battery charger is plugged into a 110V extension cord which is plugged into an inverter that is NOT labeled as ignition protected and is located in a gasoline powered vessel next to the gasoline fuel tank. Recommendation: Relocate Inverter to an area that is isolated from the fuel tank and engine space and relocated the electrical connection for the battery charger to an area isolated from the engine space.

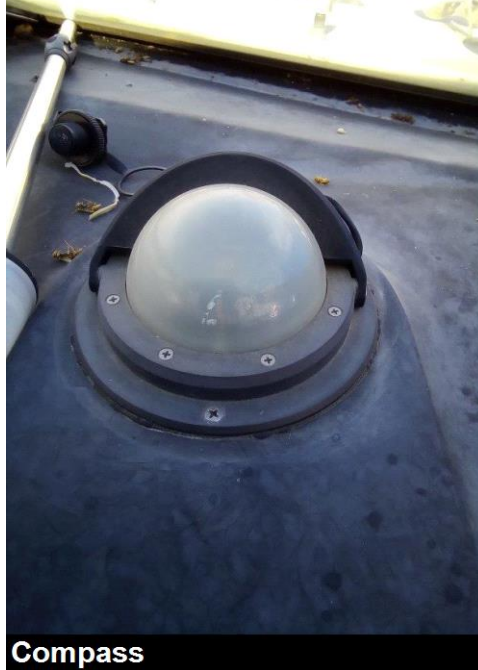
Mounted at main helm: 4" Ritchie Compass has very cloudy dome making compass card difficult to read. ----- Repair or replace as deemed necessary.

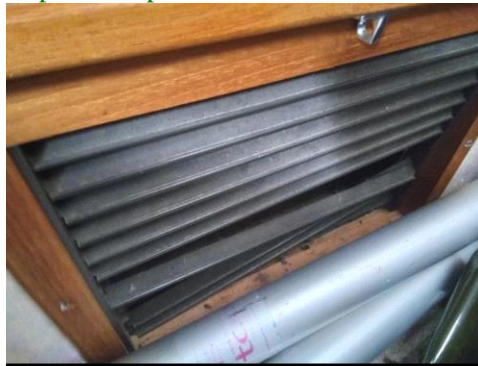
Air Conditioner Vent Cover

Hunter digital control. Not tested.
Air intake filters in need of cleaning. ----- Clean air intake filter to allow A/C unit to operate at maximum efficiency. Vent cover for filter is broken. Recommendation: Repair or replace as needed to restore full function.

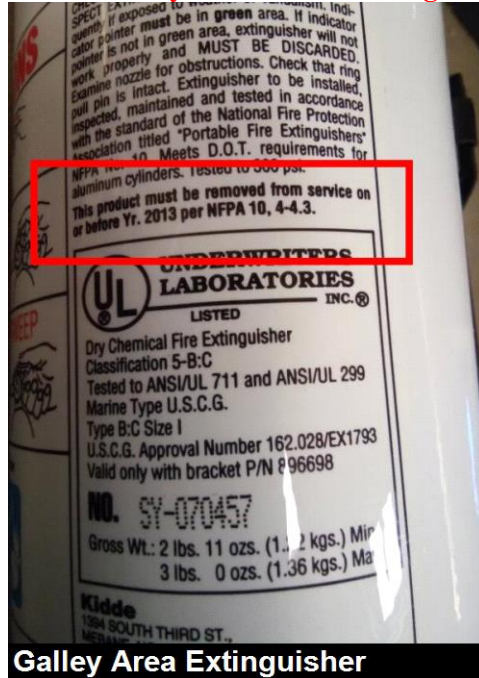
Galley Area Extinguisher

All gauge(s) read full. USCG approval on the extinguisher is only valid if the extinguisher is mounted in the required bracket per USCG 46 CFR 162.028-3(g). **Dry chemical Fire extinguishers should be installed with available brackets in a readily accessible and visible location- Not stored inside drawers or cupboards. RECOMMENDATION: Use the recommended bracket for each hand held dry chemical fire extinguisher to meet USCG requirements.**
