Associated Marine Consultants, Inc.

1981 Passport 40

Report of Marine Appraisal

June 24, 2023

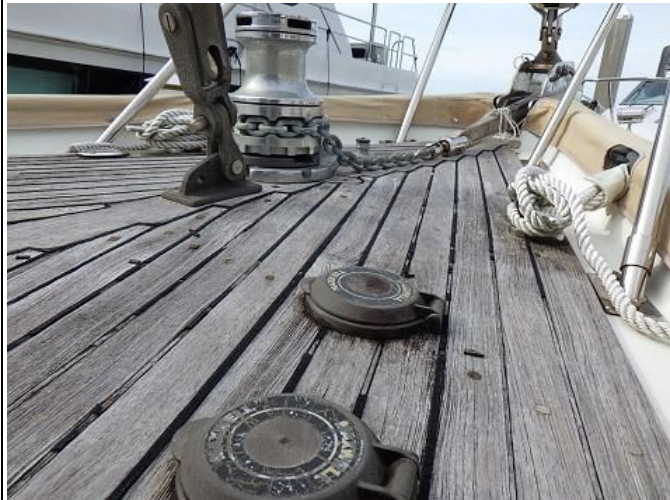
MATERIAL: Wood cored FRP: Fair condition with deteriorated sections of wood core.
Teak board planking on side decks and in the cockpit: Fair condition with open exposed screw holes, significant weathering, and sealant failure.

Deterioration of teak decking.

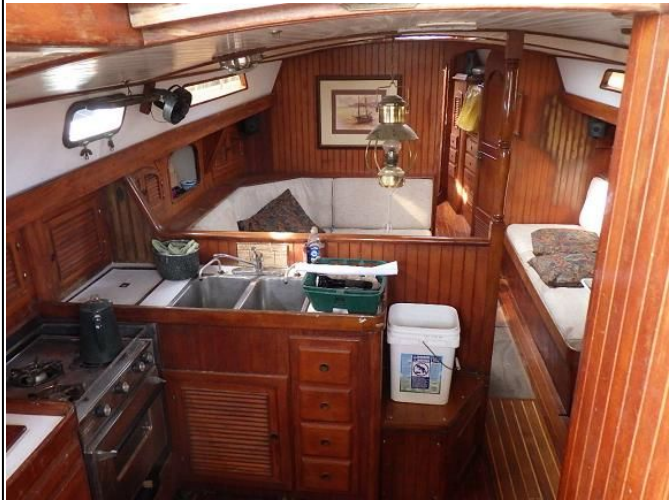
WATER INTRUSION SIGNS: Signs of past water intrusion were visible in the cabin.

Well designed cabin has notable water damage.

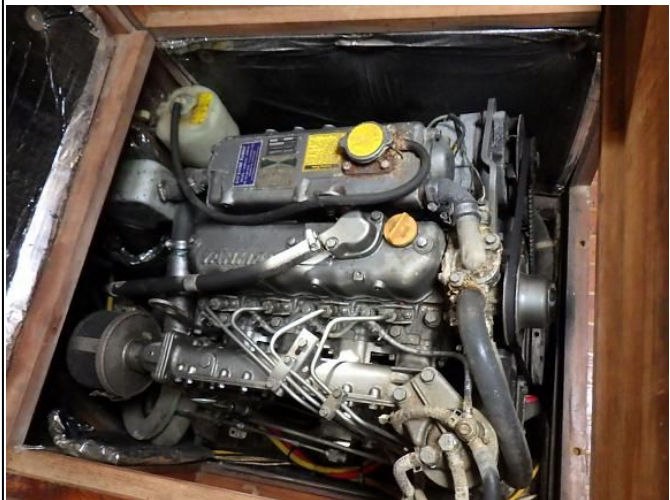
Surface rust and corrosion was present on the exterior surfaces of the engine.

Newer Yanmar diesel engine.

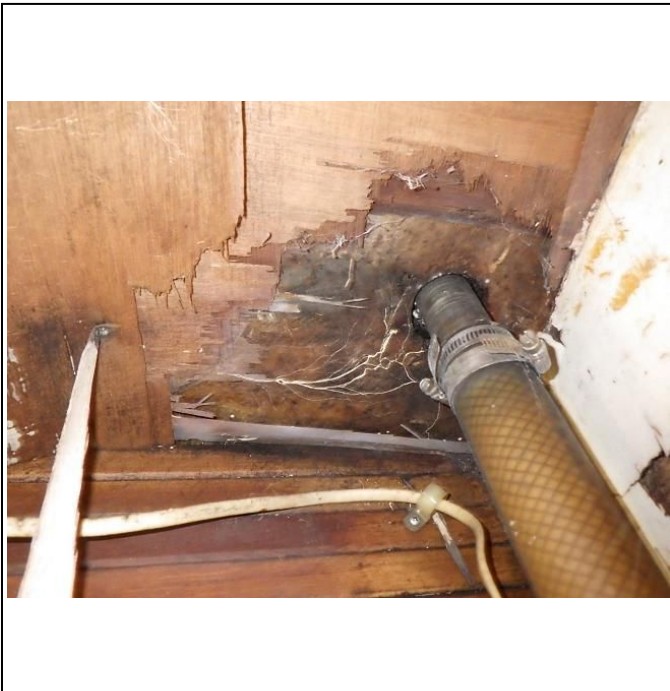
Deteriorated deck structure as sighted from the cabin.

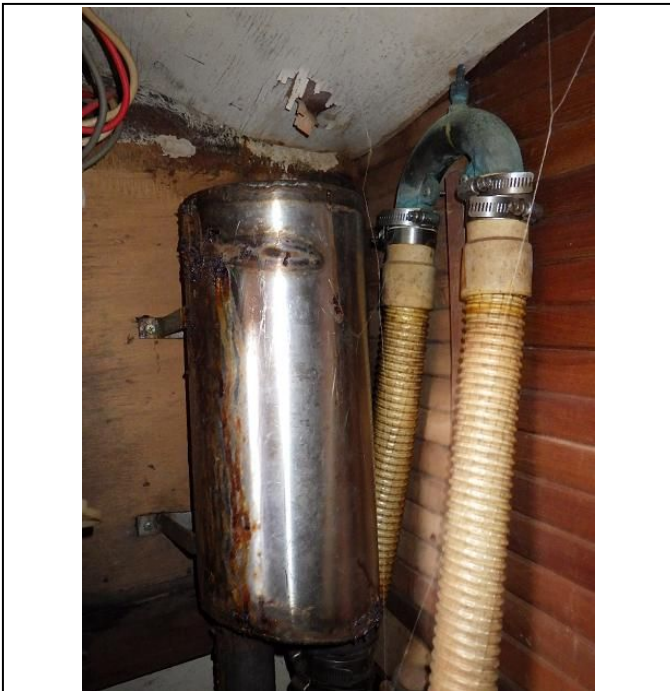
EXHAUST SYSTEM: Cast iron manifold to cast steel riser/mixer to split discharge and stainless steel muffler in Poor condition.

Stainless steel muffler for engine has crevice corrosion, and is leaking.

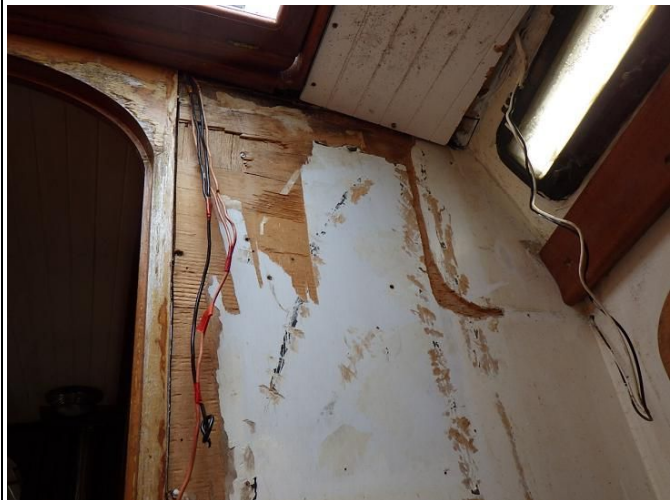
Cabin wall has had water damage.

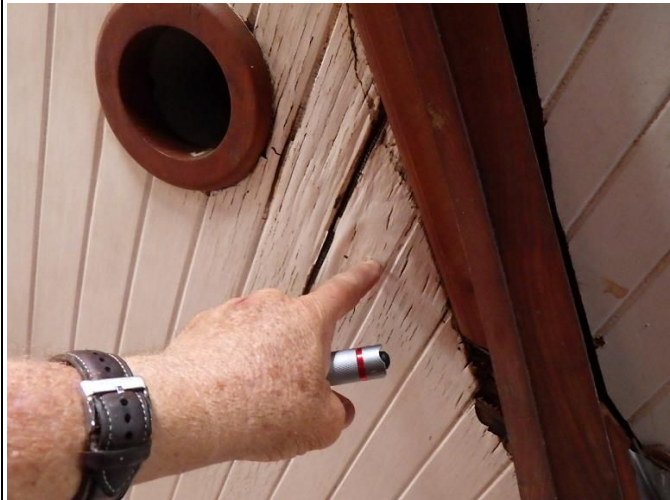
HEADLINERS: Hardwood paneling with teak trim: Fair condition with deteriorated wood.

Headliner panel has wood rot.
