1988 Cal 28 Sloop
Gin N Me Cricket

Report of Marine Survey

1988 Cal 28 Sloop

**Conducted by
Charles Ulrick**

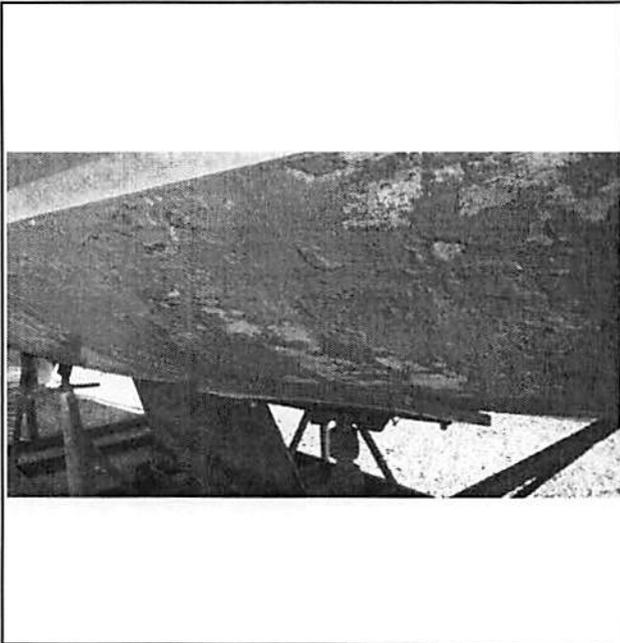
Blue ablative bottom paint is loose and excessive

Excessive/loose bottom paint

Blue ablative bottom paint is loose and excessive	
FINDINGS	RECOMMENDATIONS
Blue ablative bottom paint is loose and excessive	<i>sand and repaint bottom</i>

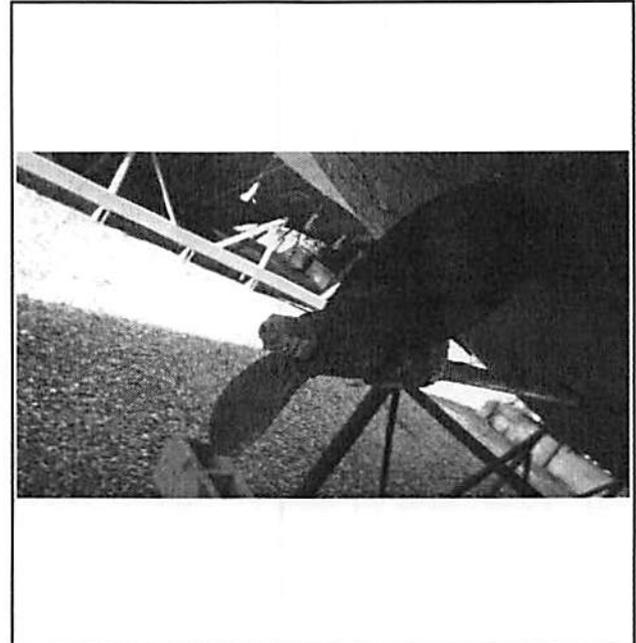
2 Blade bronze prop with some stray current corrosion

Prop with stray current corrosion

2 Blade bronze prop with some stray current corrosion	
FINDINGS	RECOMMENDATIONS
2 Blade bronze prop with some stray current corrosion	<i>Remove corrosion and inspect prop</i>

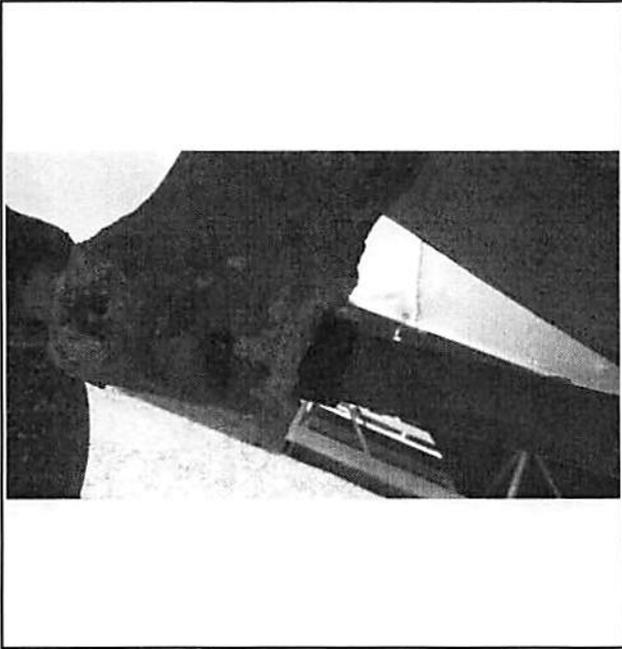
Single I-beam cast bronze strut with excessive stray current corrosion

Strut with stray current corrosion

Single I-beam cast bronze strut with excessive stray current corrosion	
FINDINGS	RECOMMENDATIONS
Single I-beam cast bronze strut with excessive stray current corrosion	<i>Remove corrosion inspect the strut and replace if necessary</i>

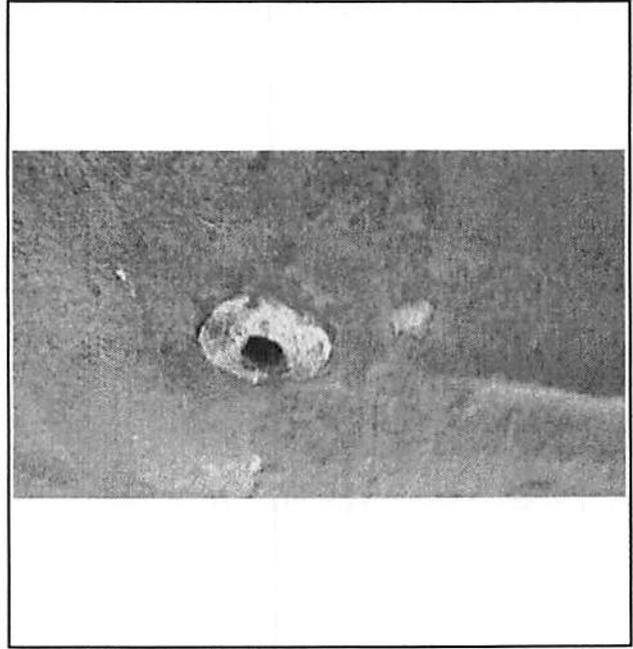
The head intake thru hull has excessive corrosion

Head thru hull with stray current corrosion

The head intake thru hull has excessive corrosion	
FINDINGS	RECOMMENDATIONS
The head intake thru hull has excessive corrosion	<i>Replace thru hull</i>

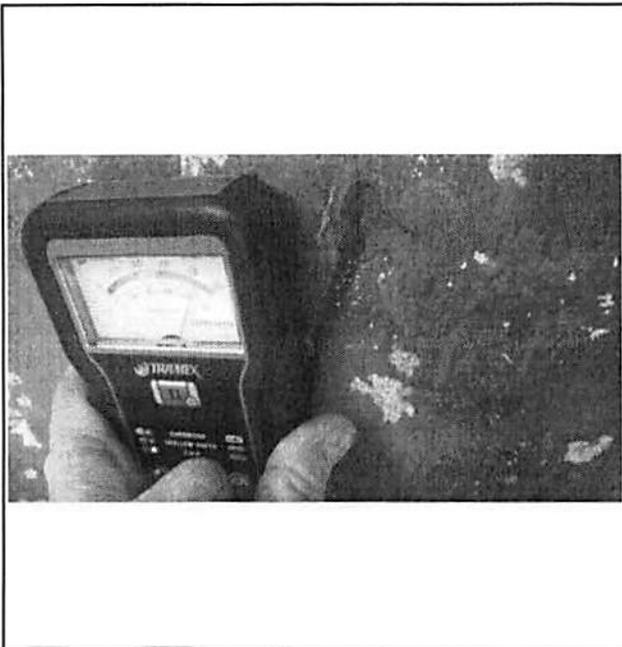
Foam cored fiberglass with high moisture was detected along with a small crack leaching resin

Rudder with high moisture, small crack, leaching resin

Foam cored fiberglass with high moisture was detected along with a small crack leaching resin	
FINDINGS	RECOMMENDATIONS
Foam cored fiberglass with high moisture was detected along with a small crack leaching resin	<i>Consult a fiberglass expert for repairs.</i>

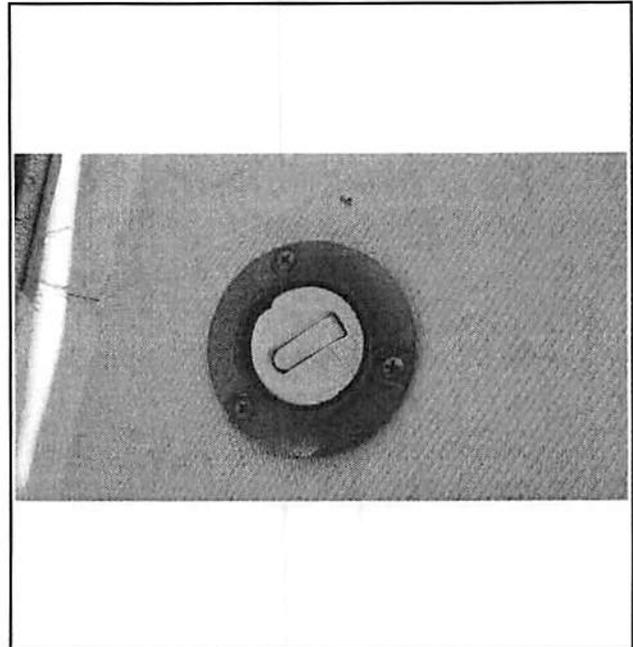
Water fills not labeled

Port and starboard side decks (not labeled)	
FINDINGS	RECOMMENDATIONS
Port and starboard side decks (not labeled)	<i>Label the fittings water</i>

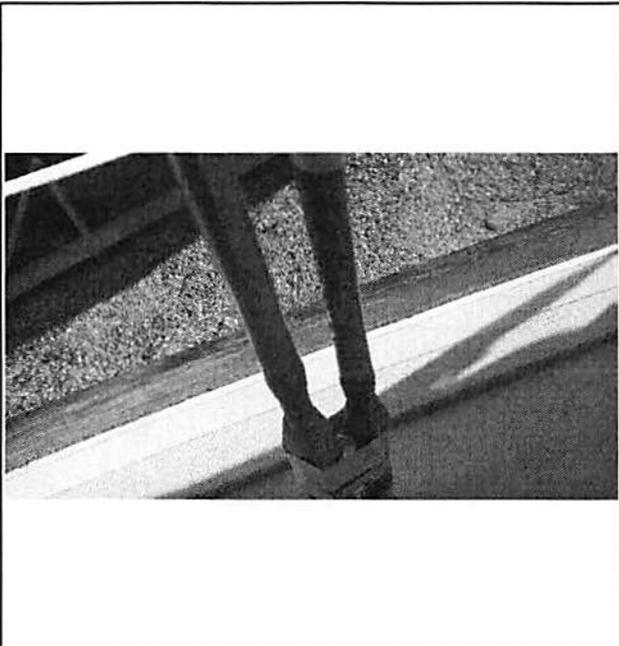
1 x 19 Stainless steel wire with swag fittings continuous rigged with single adjustable back stay. The rigging is original and corrosion was sighted at the swaged fittings

Swaged fittings with corrosion

1 x 19 Stainless steel wire with swag fittings continuous rigged with single adjustable back stay. The rigging is original and corrosion was sighted at the swaged fittings	
FINDINGS	RECOMMENDATIONS
The rigging is original and corrosion was sighted at the swaged fittings	<i>Consult a rigging expert to further investigate , repair, replace as necessary</i>

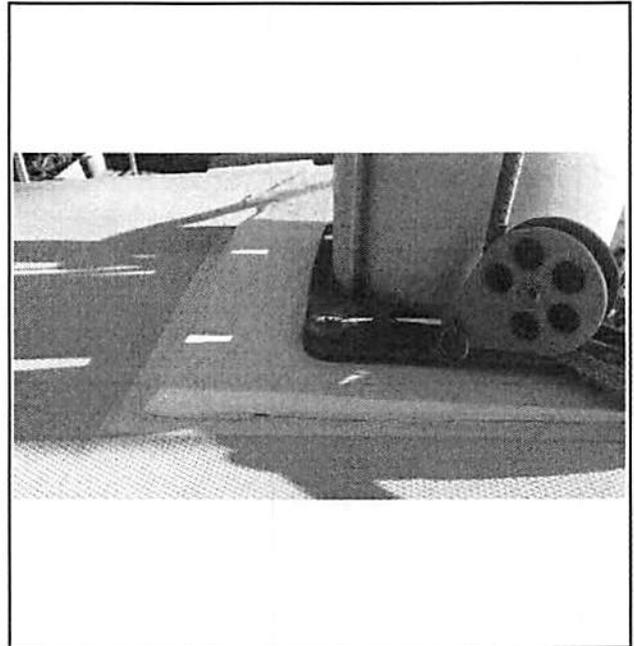
Deck step with compression post. Gelcoat cracks and depression was observed at the mast step.

Mast step with gelcoat cracks and depression

Deck step with compression post. Gelcoat cracks and depression was observed at the mast step.	
FINDINGS	RECOMMENDATIONS
Gelcoat cracks and depression was observed at the mast step.	<i>Consult a fiberglass expert for an estimate and repairs.</i>

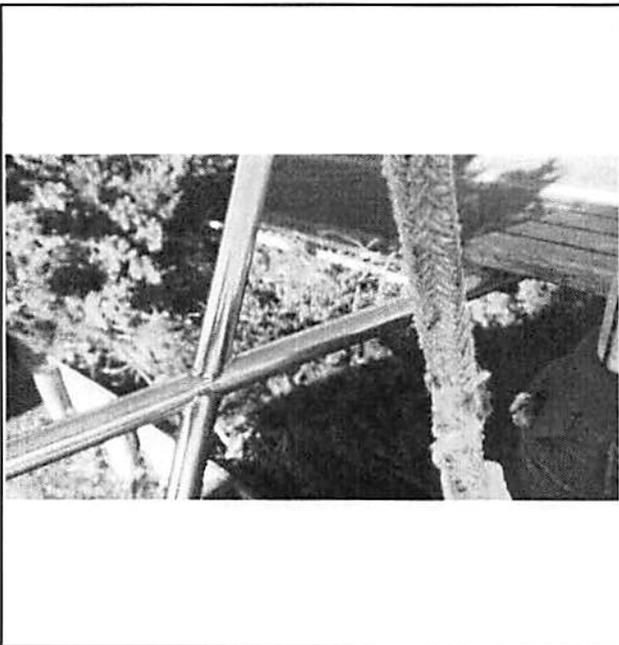
Frayed jib halyard

In mast halyards were braided and color coded. The halyards are weathered. The jib halyard is frayed	
FINDINGS	RECOMMENDATIONS
The jib halyard is frayed	<i>Replace halyard</i>

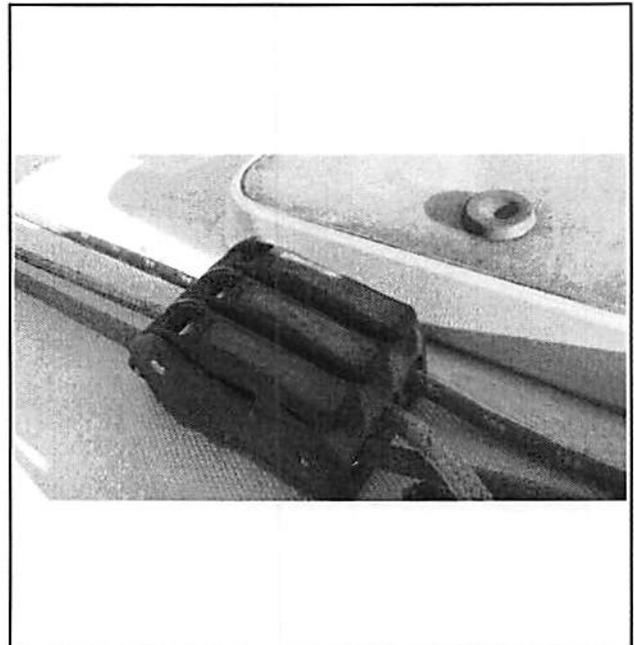
Spinlock clutches in serviceable condition. **Not properly labeled**

Clutches not labeled

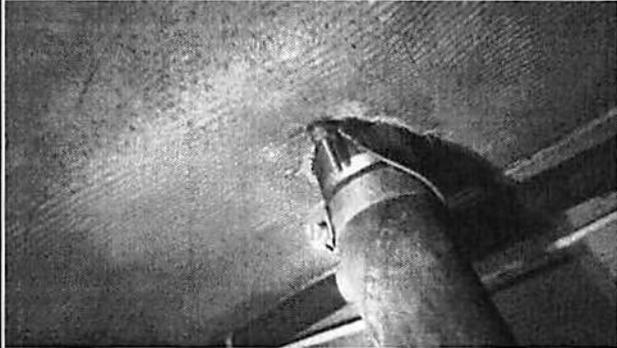
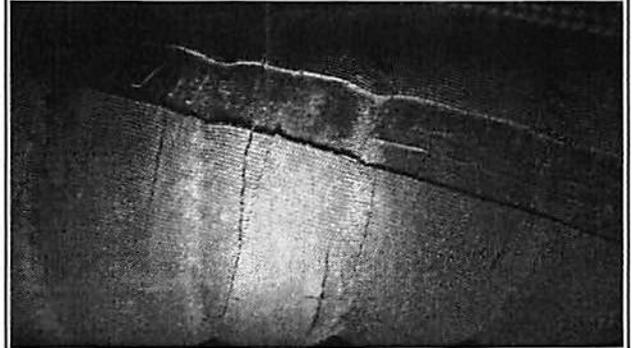
FILL PIPE MATERIAL:
USCG A2 hose is cracked and not doubled clamped
***A.2**
USCG A2 hose is cracked and not doubled clamped

Single clamped fuel fill hose

Cracked fuel fill hose

USCG A2 hose is cracked and not doubled clamped	
FINDINGS	RECOMMENDATIONS
USCG A2 hose is cracked and not doubled clamped	<i>Comply with ABYC H-23 fuel hoses doubled clamped and replace hose.</i>

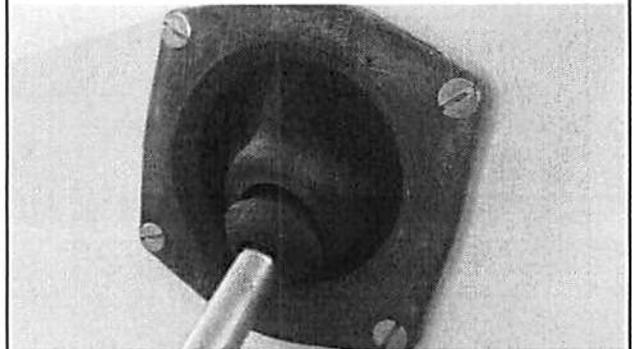
Damage Whale pump

Whale manual cockpit and rule 800 (no float switch) The whale pump has a bad diaphragm.	
FINDINGS	RECOMMENDATIONS
The whale pump has a bad diaphragm.	<i>Repair as necessary</i>

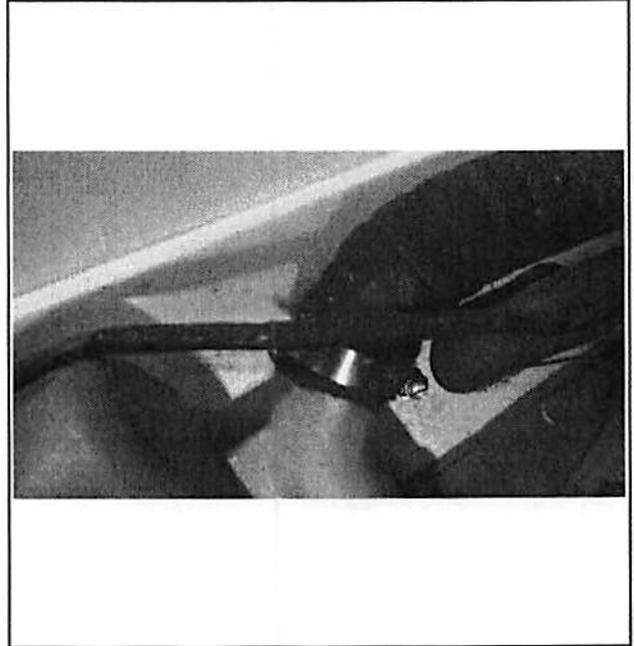
Raw water cooled with mixing elbow , marine grade hoses with water lift muffler. The exhaust is not doubled clamped and the hoses are cracked.

Cracked exhaust hose

Single clamped exhaust connections.

Raw water cooled with mixing elbow , marine grade hoses with water lift muffler. The exhaust is not doubled clamped and the hoses are cracked.	
FINDINGS	RECOMMENDATIONS
The exhaust is not doubled clamped and the hoses are cracked.	<i>Comply with USCG Safety Regulations. and ABYC P- 1.7.1.10.1 Double clamp all exhaust connections and replace hoses</i>
