Report of Marine Survey

Vessel: 1995 Carver 440 Aft Cabin Motor Yacht

Purpose: Condition & Valuation

Date of Survey: September 20th, 2022

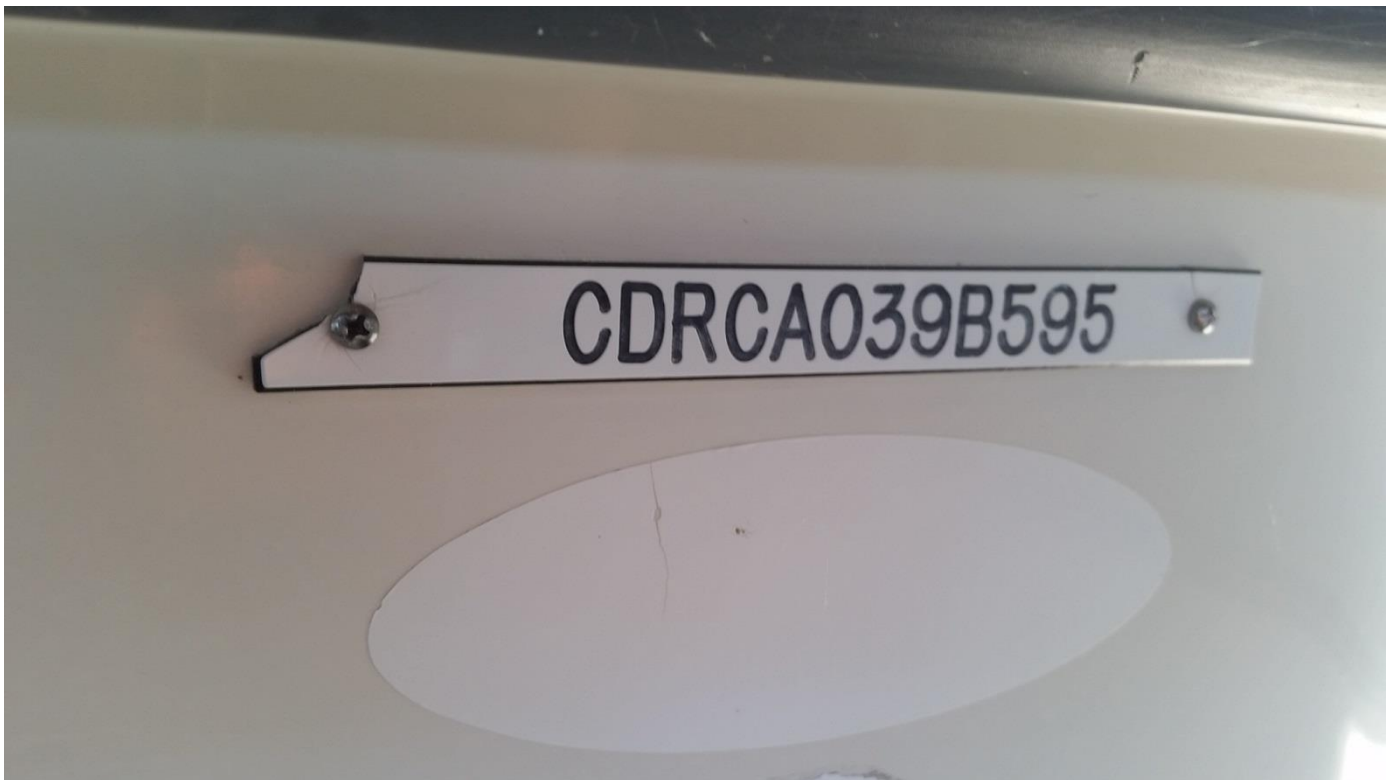
Transom (Starboard Aft Corner)

USCG Documentation#:	1181572
State Validation sticker:	2018 TX NOTE: State validation sticker expired. Renew sticker.
Registration valid and sighted on vessel hull as per regulations:	No. See above finding.
Vessel Type:	Fiberglass Motor Yacht w/Flybridge & Semi-Vee Hull Configuration
Manufacturer:	Carver Boat Corporation, Hopkins MN (Div of Marquis Yachts)
Year of Vessel:	1995
Length of Vessel:	<i>Length overall:</i> 44' 7"
Vessel Draft:	4' 3"
Vessel Beam:	15'
Vessel Weight:	28,500 pounds

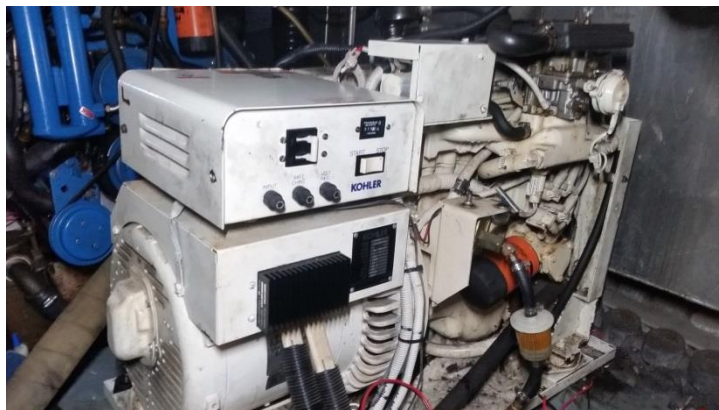
Hoses/Clamps:	Serviceable condition. No cracks sighted. Hoses are properly clamped with stainless hose clamps where applicable.
Belts/Pulleys:	Belt condition is serviceable. No cracks or splits sighted. Pulley/belts appear to be in line.
Cooling System:	Raw water and closed cooled with heat exchanger and thru-hull seacock. Raw-water travels through heat exchanger and then out exhaust. Coolant level full.
Fuel Supply Lines:	USCG A1 fuel hose, no cracks or leaks where accessible for inspection. Stainless hose clamps sighted at all connections.
Oil level/Condition:	Mostly clean and full. No indication of water.
Mounts/Beds:	Generator mounted in tray located midships centerline in engine space. Well secured to support mounting.
Exhaust Piping:	Wet exhaust hose and fiberglass muffler. Hoses are properly routed and securely double clamped. No cracking, leaks or splits sighted.
Generator Tested:	Yes, generator was started and ran for approximately ten minutes. No issues observed.

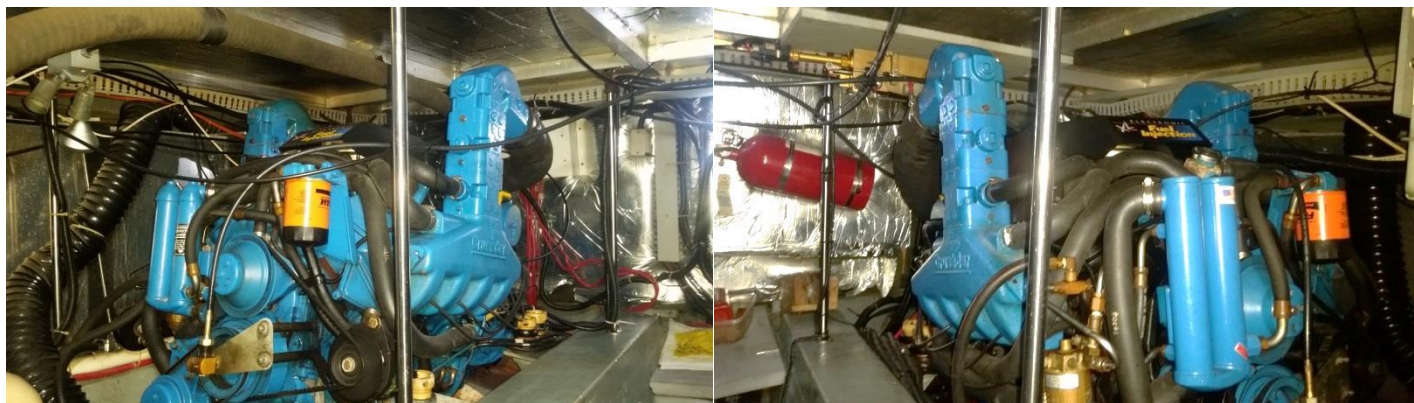
Yes, the engines were started and ran for approximately five minutes. No issues observed.
