ADMIRALTY MARINE SERVICES

Ref: Appraisal of the 1954 Chris Craft Sportsman "Monkey Shine" (HIN) SS20179

This appraisal for the 1954 Chris Craft 17' Sportsman "*Monkey Shine*" Hull Identification Number: SS20179 was conducted on May 23, 2025, at the [REDACTED] [REDACTED] Red Bluff, CA [REDACTED]. The vessel was surveyed without removal of any fixed partitions or other fixed or semi-fixed items. Locked compartments or otherwise inaccessible areas would also preclude inspection. This vessel, engine, and her systems were inspected in a static condition. This was a condition & value appraisal for donation to a non-profit.

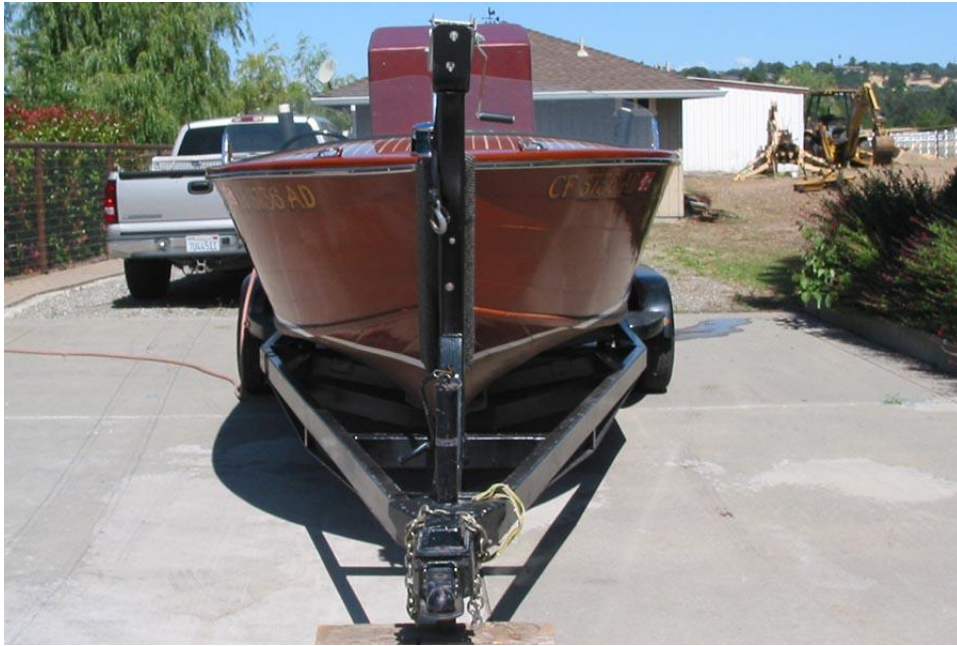
Carvel planked hull; freeboard planking requires service.

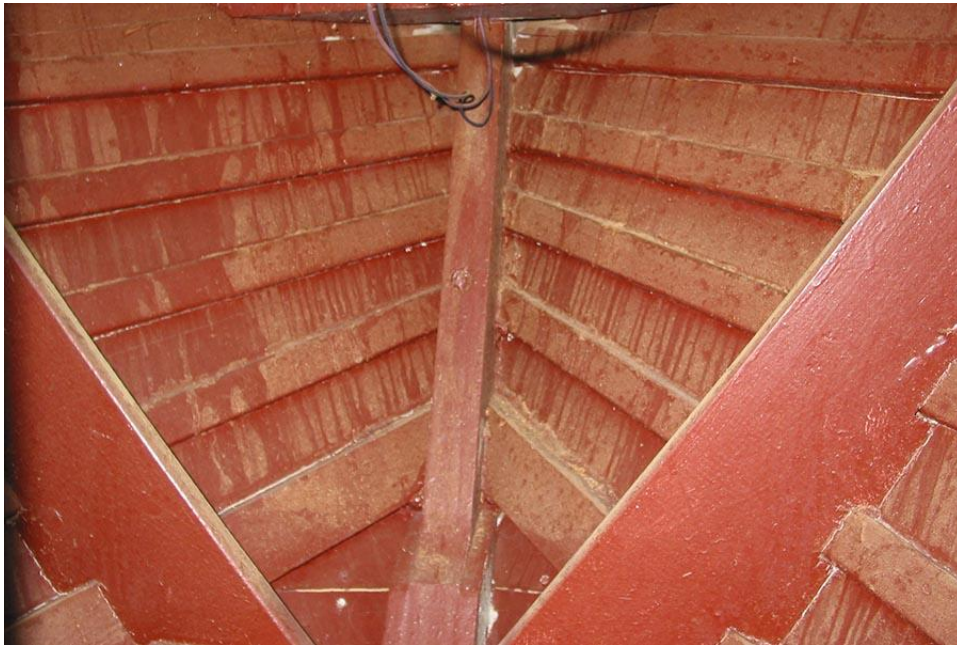
Bow batten & seam construction.

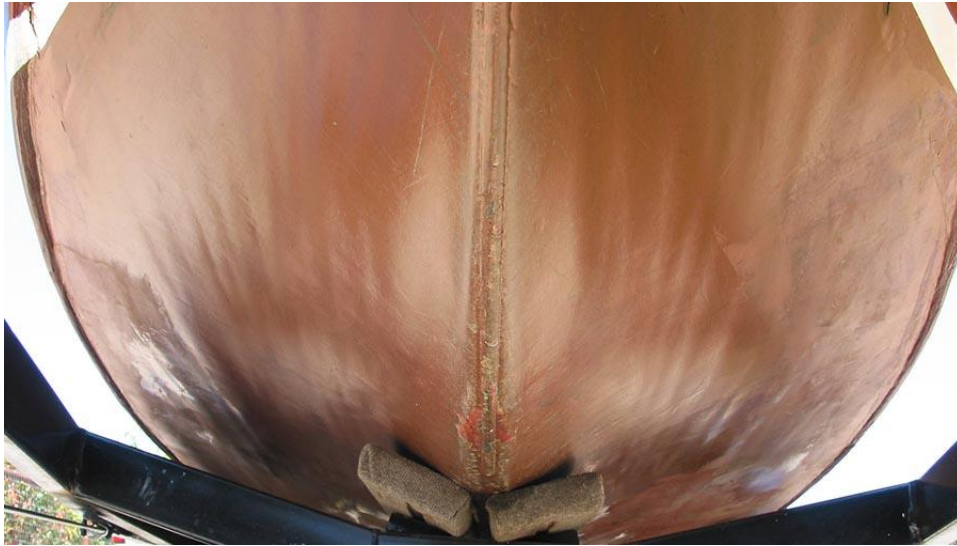
The wet surface has a fiberglass overlay which is parting from the hull planking.

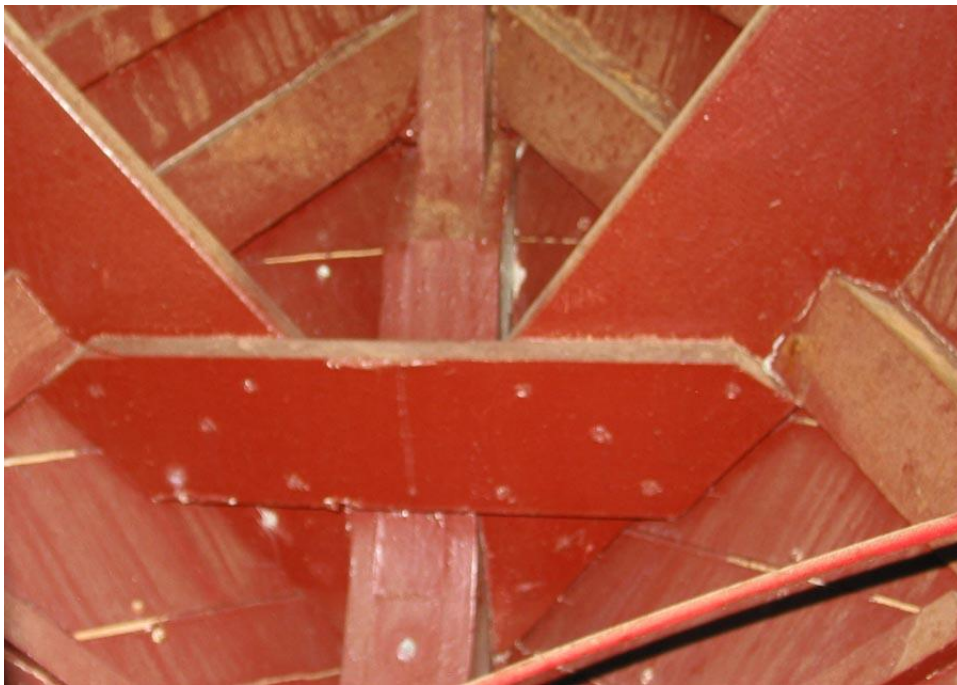
The sawn frames, floors and the bow forefoot scarf joint will require attention

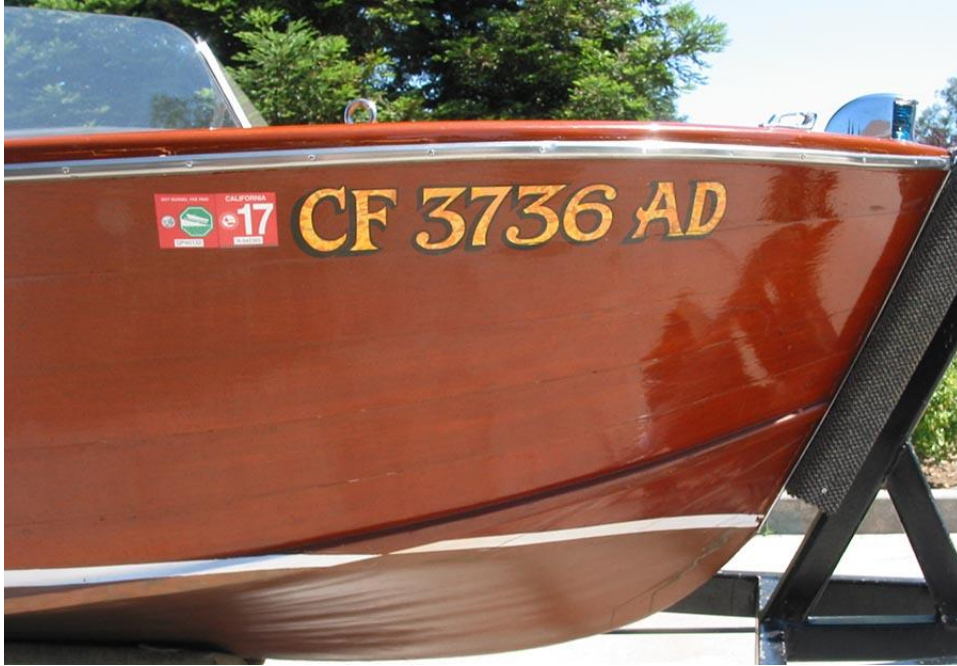
Starboard (stbd) bow freeboard carvel planking, clamp /shelf hull deck joint is intact

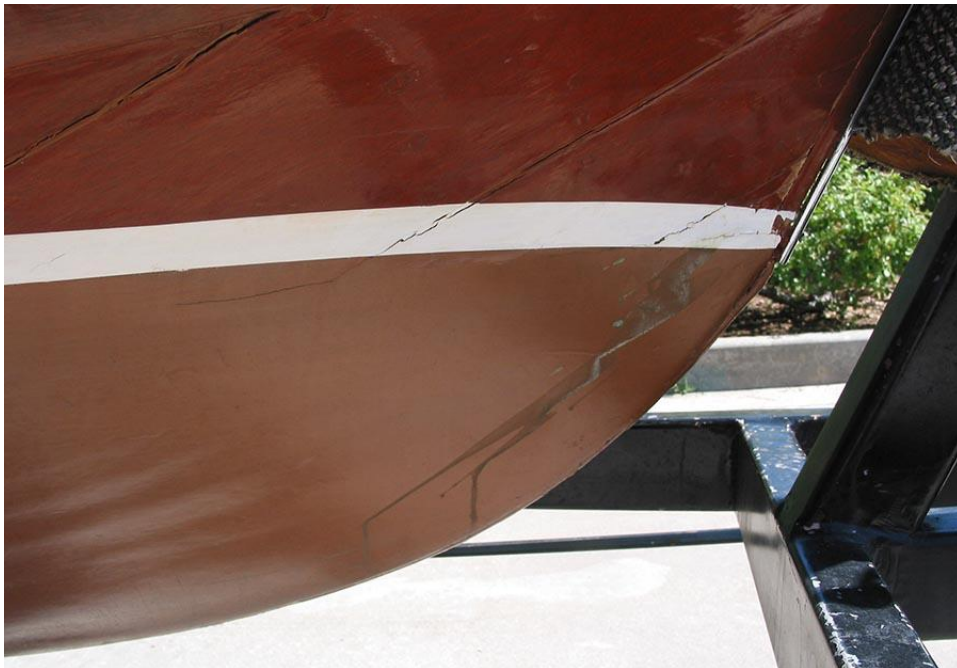
Stbd forefoot scarf joint & plank seams are exposed; the fiberglass overlay is parting from the hull planking.

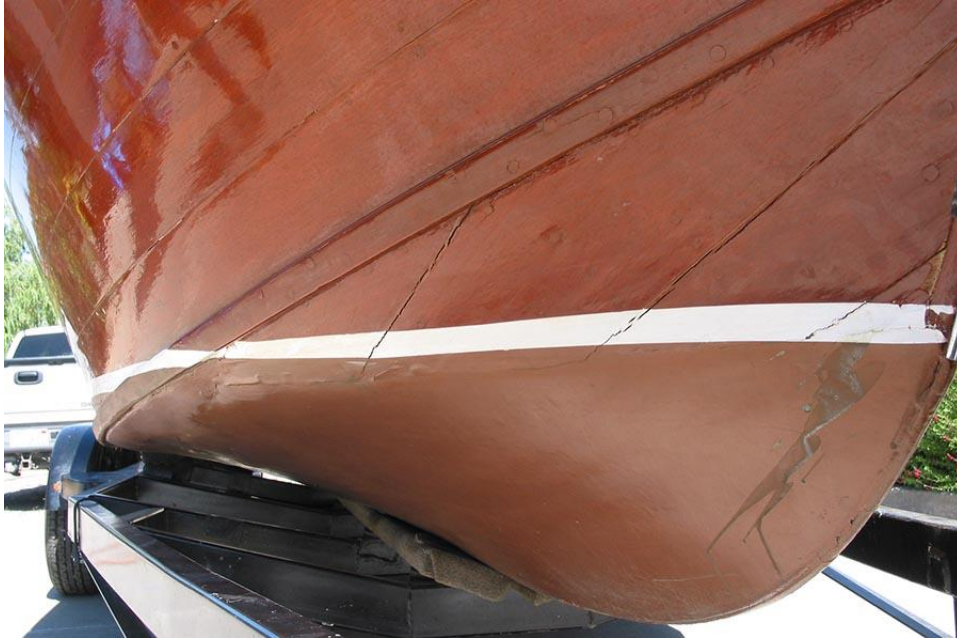
Stbd forefoot scarf joint & plank seams are exposed; the fiberglass overlay is parting from the hull planking.

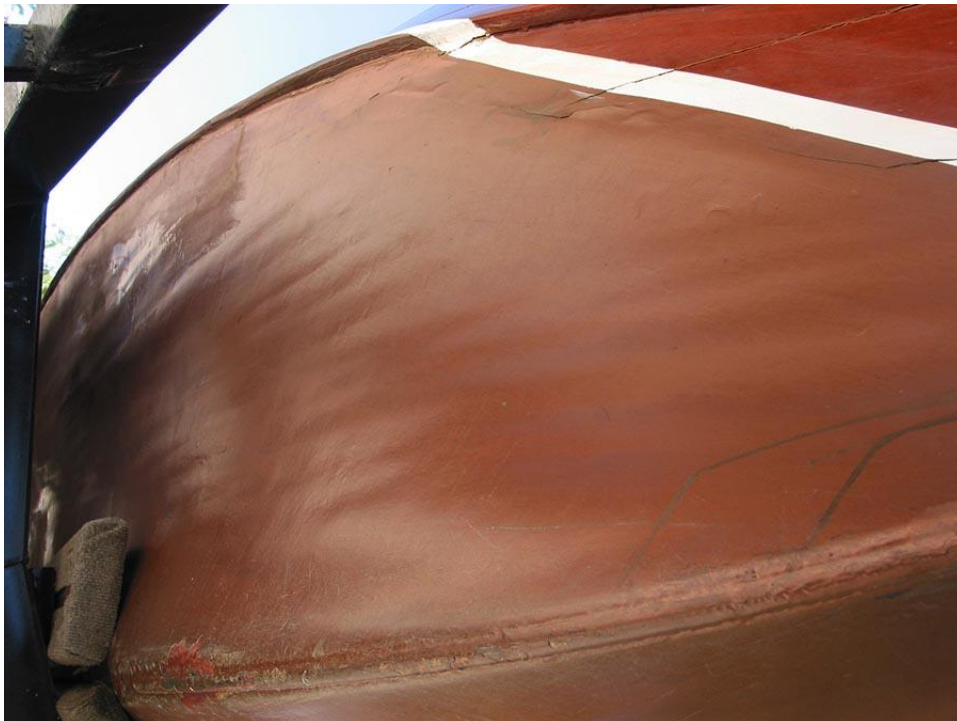
The fiberglass overlay is parting from the hull planking.

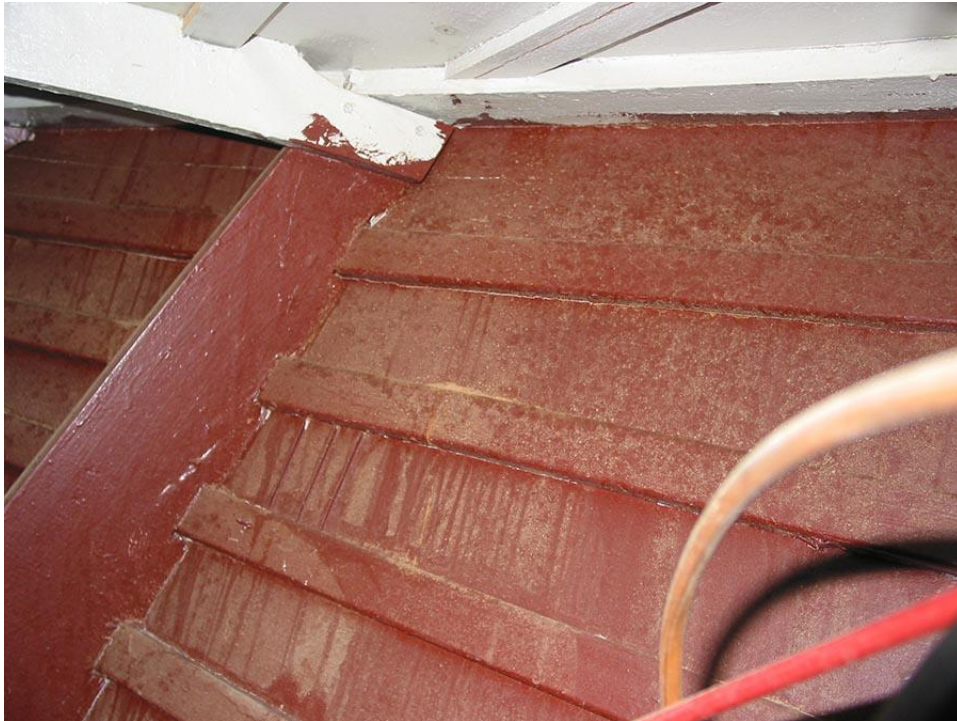
Stbd foredeck clamp shelf hull deck joint secure

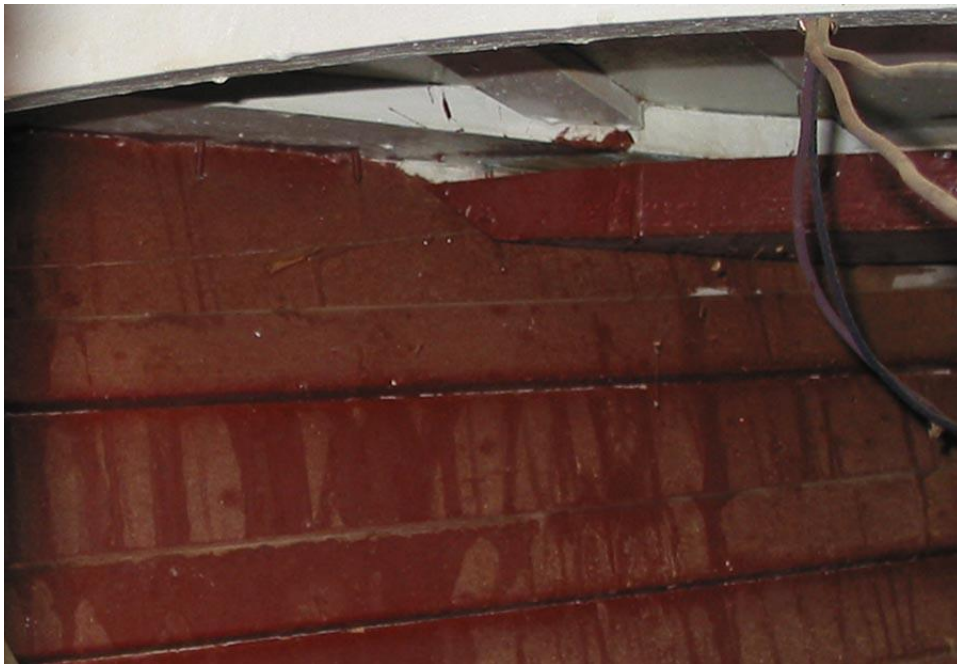
Port foredeck clamp shelf hull deck joint secure

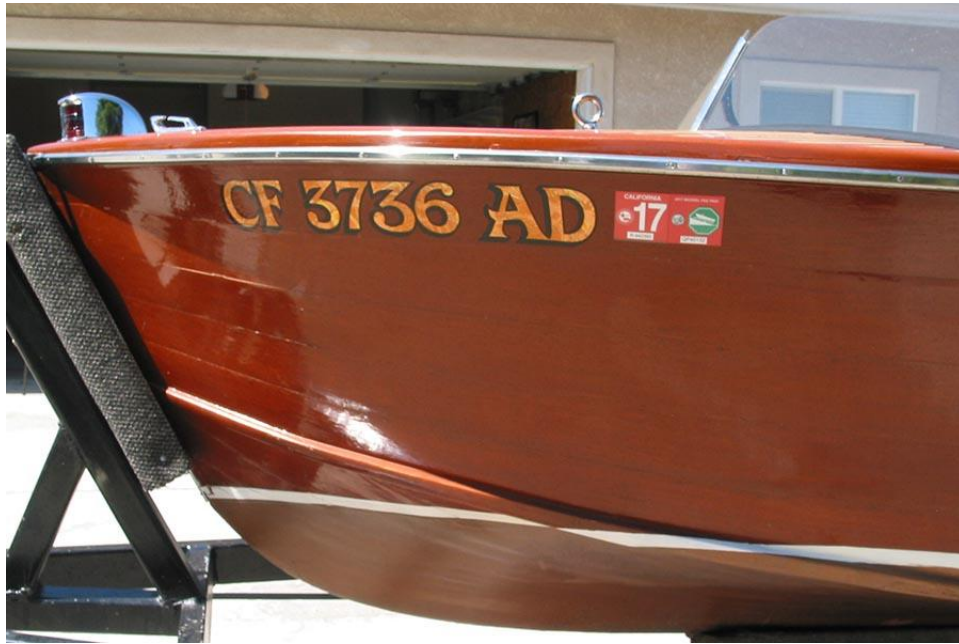
Port bow freeboard carvel planking, clamp/shelf hull deck joint is intact

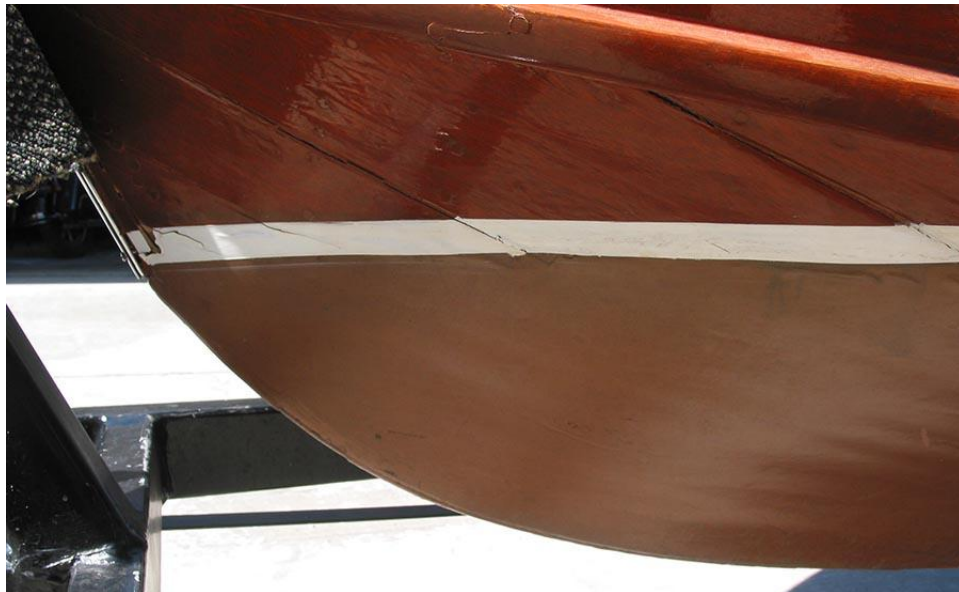
Port forefoot scarf joint & plank seams are exposed; the fiberglass overlay is parting from the hull planking.

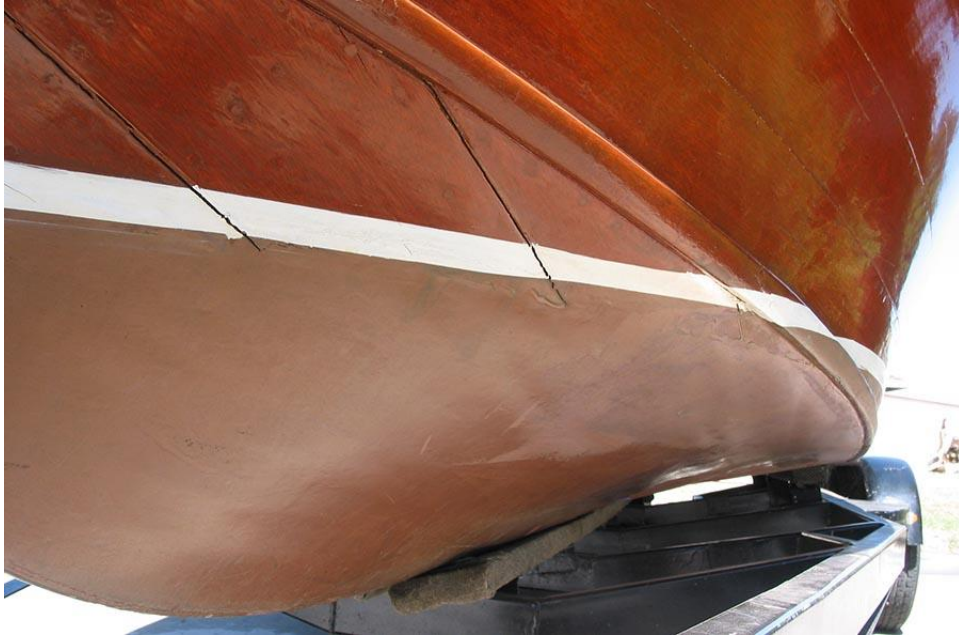
Stbd bow plank seams are exposed; the fiberglass overlay is parting from the hull planking.

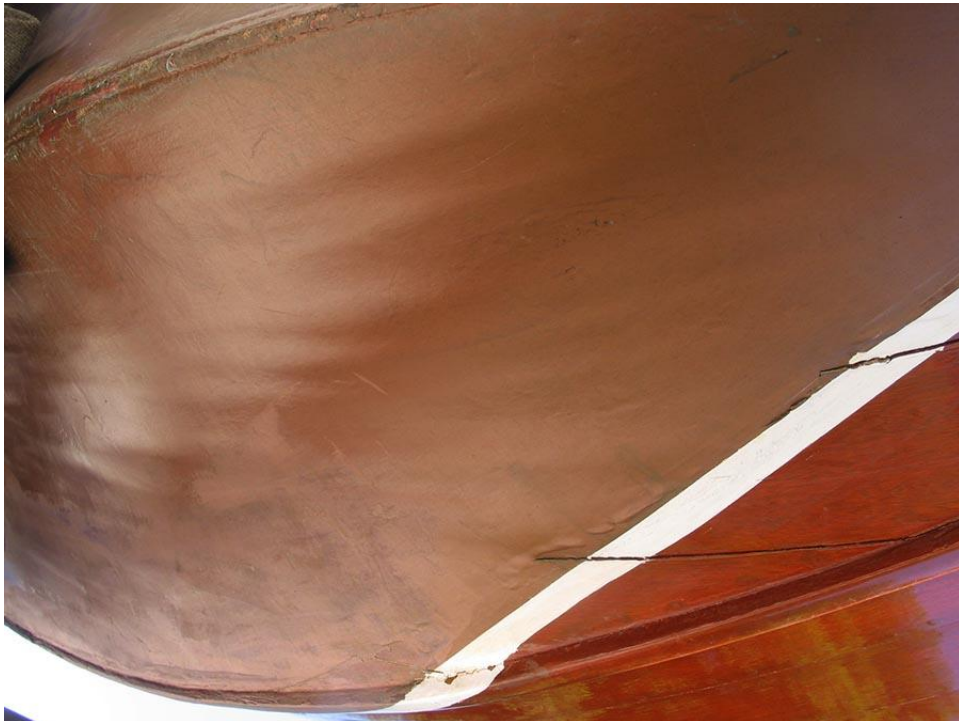
The fiberglass overlay is parting from the hull planking.

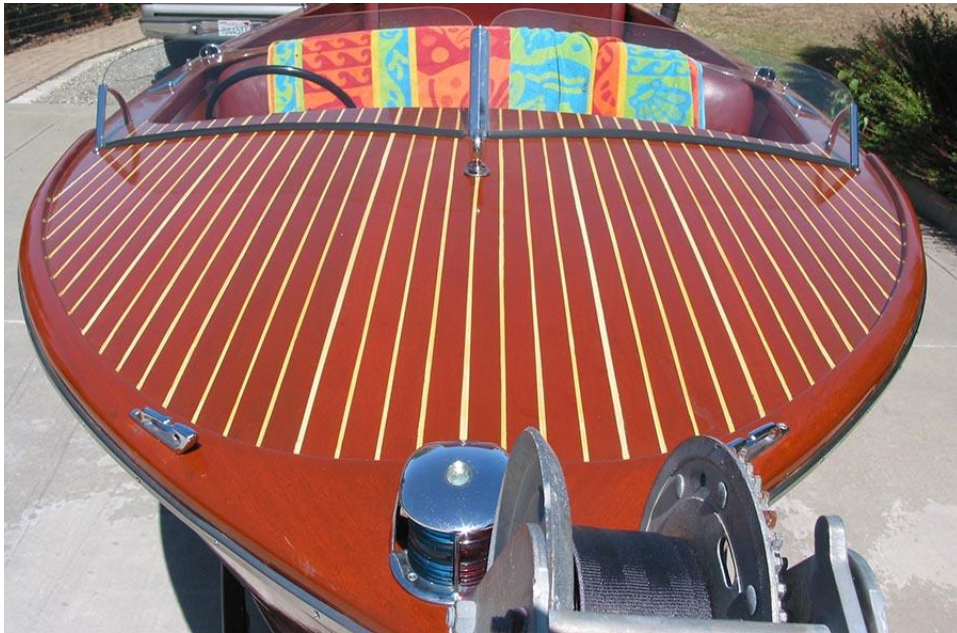
Foredeck payed seam planking & hull carvel planking intact.

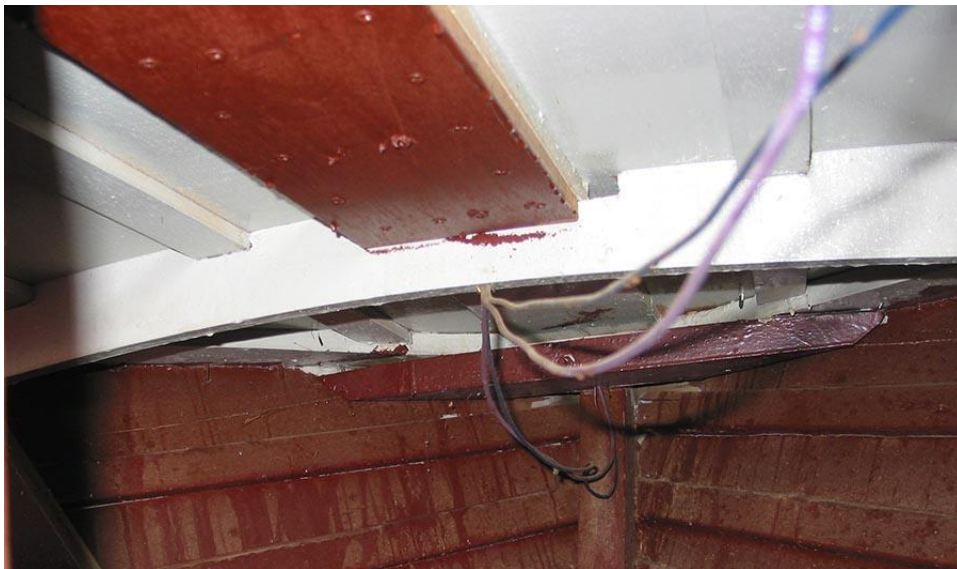
Foredeck transverse deck beams, support battens & plywood sub-deck appear intact.

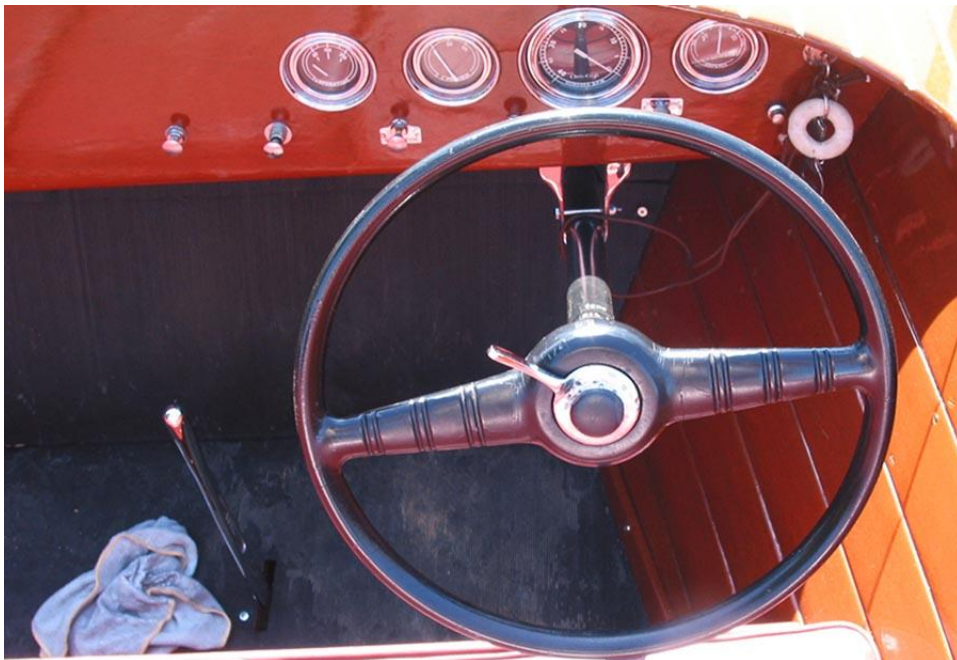
Period gauges & mechanical steering assembly appears serviceable.

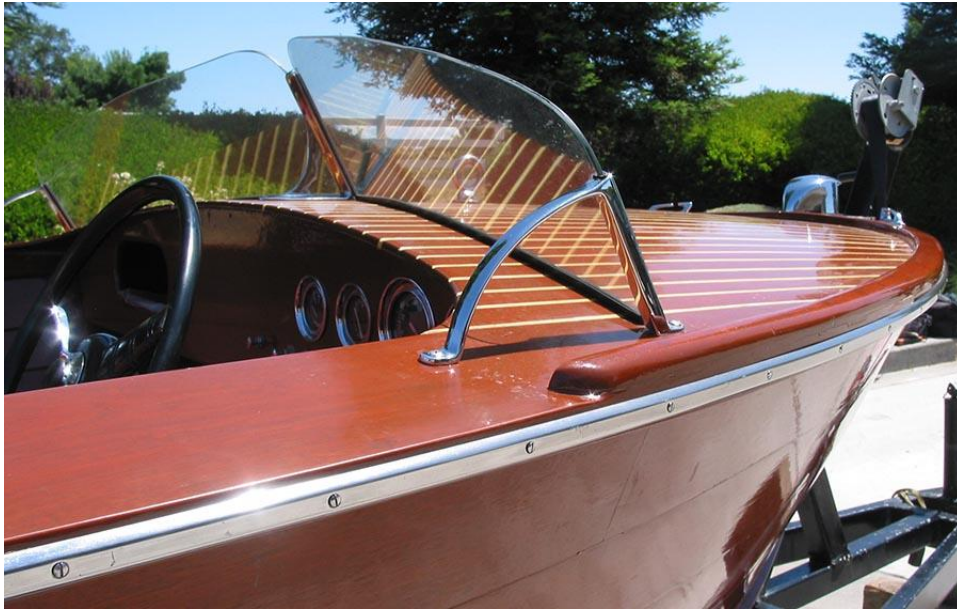
Starboard foredeck joinery intact & serviceable

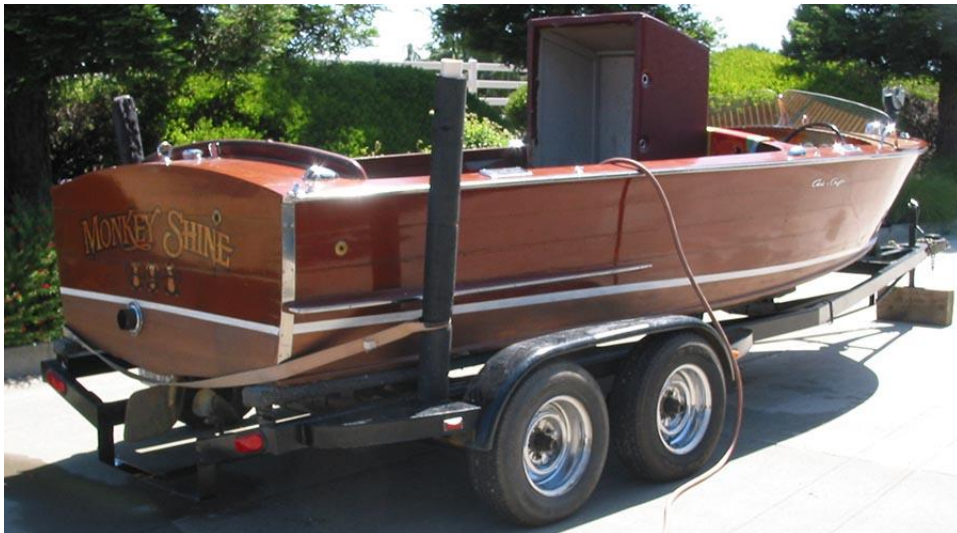
Starboard quarter carvel freeboard planking overall serviceable.

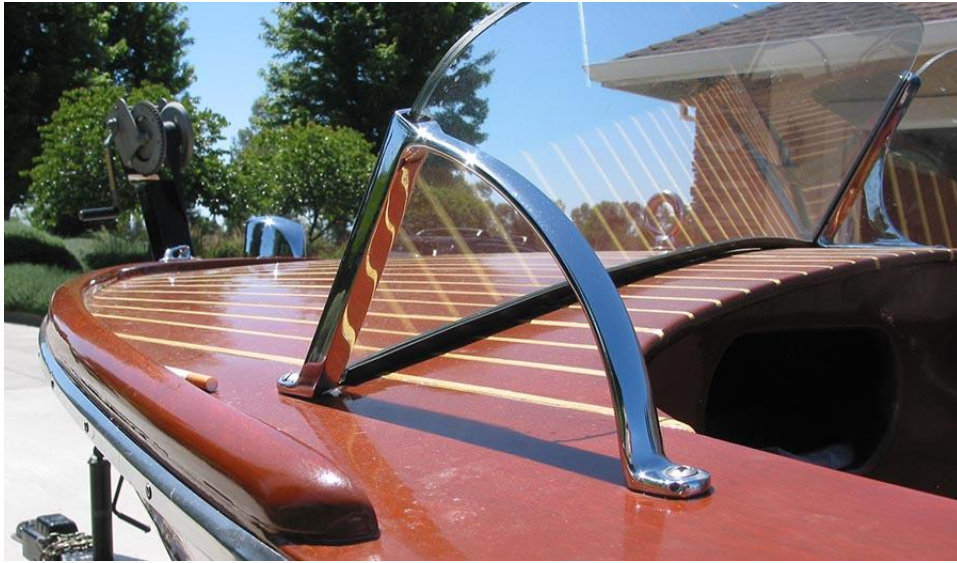
Port foredeck joinery intact & serviceable

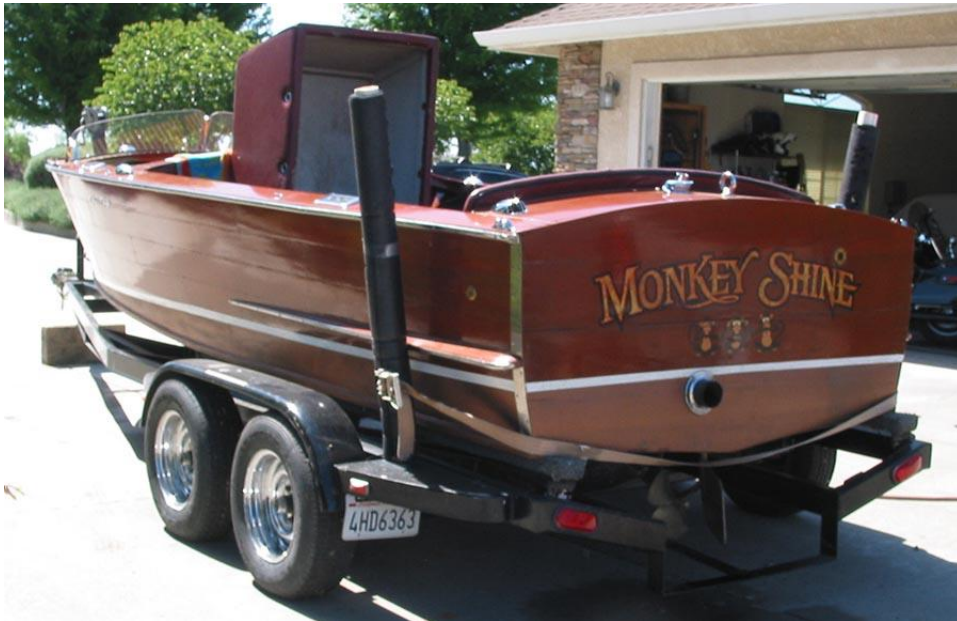
Port quarter carvel freeboard planking overall serviceable.

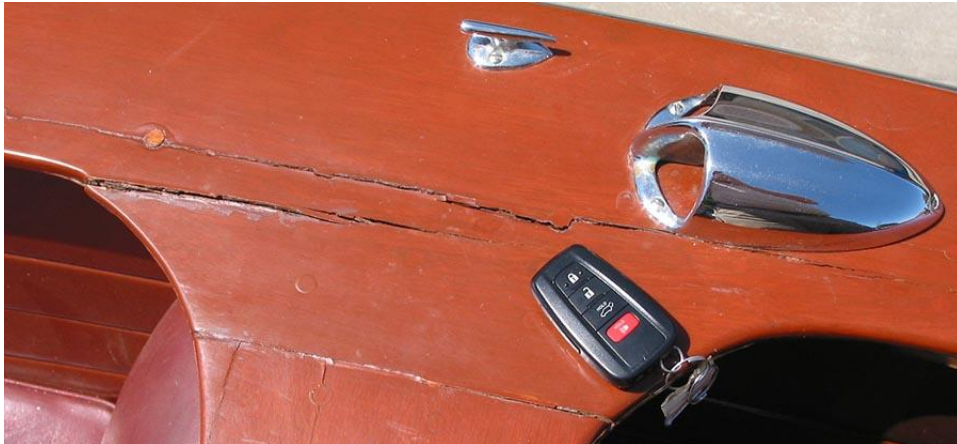
Starboard coverboards are dried, cupping, and cracking.

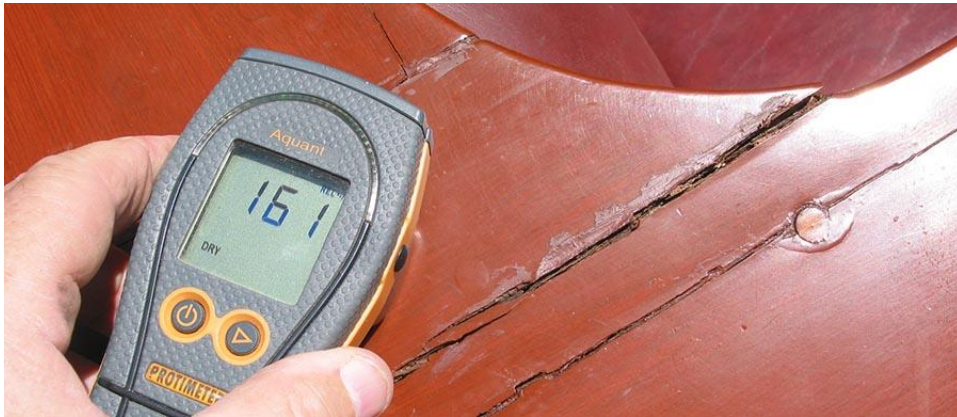
The hull was monitored with a non-invasive Protimeter Aquant meter which records moisture readings in relative terms of the moisture condition up to 19 mm / $\frac{3}{4}$ " beneath the surface of the hull. It pinpoints areas of concern that may justify a more extensive investigation. The meter moisture readings varied.

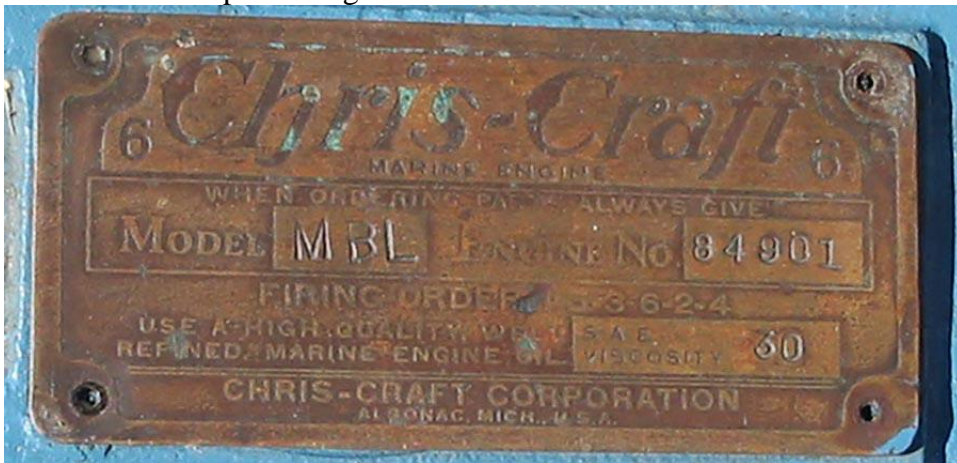
Chris Craft MBL engine, serial# 84901

The MBL engine was not an option in 1954.

Engines offered B, K, KL, KBL, KLC, KFL, & 283

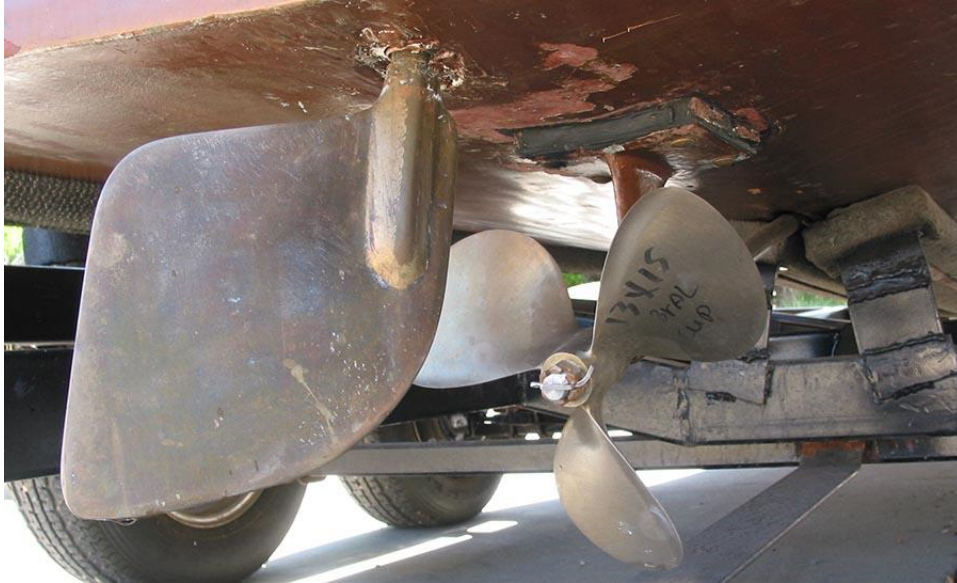
Wet surface planking requires upgrading.

Note: Propeller blade pitch must be researched for operating area; a incorrect pitched prop may cause engine damage

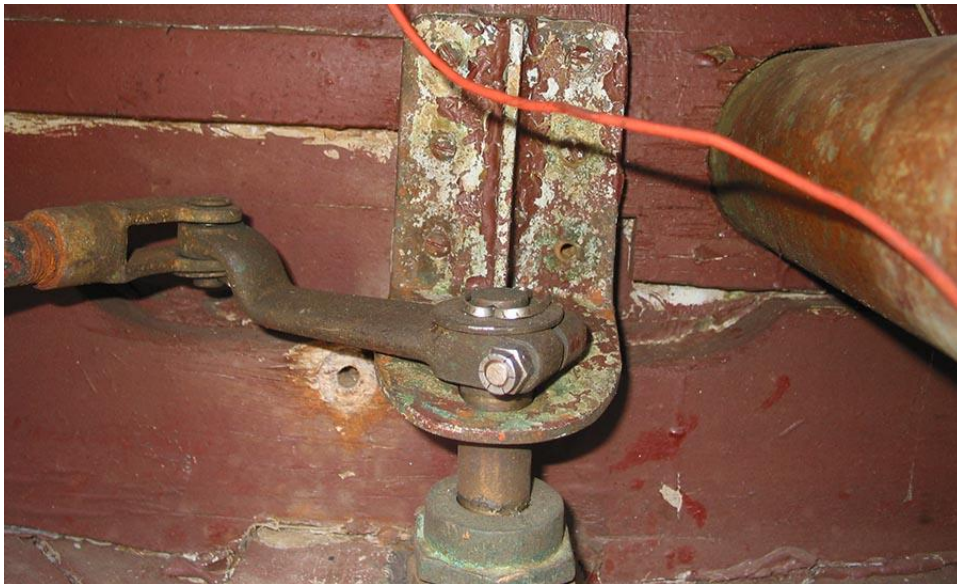
Aft rudder post mechanical steering assembly intact
