MARINE SURVEY INSPECTION ABOARD THE VESSEL

2002 Sea Ray 240 Sundancer Xanadu

MARINE SURVEY INSPECTION & REPORT CONDUCTED BY

FILE NUMBER & STATUS	No. 1115   Complete As Of 02/25/2023
MARINE SURVEY INSPECTION TYPE	Condition & Valuation Survey
MARINE SURVEY INSPECTION REPORT PREPARED FOR	[REDACTED]
DATE(S) OF MARINE SURVEY INSPECTION	02/21/2023
YEAR, MAKE & MODEL OF INSPECTED VESSEL	2002 Sea Ray 240 Sundancer
VESSEL HULL IDENTIFICATION NUMBER	SERV3375A202
VESSEL NAME & HAILING PORT	Xanadu   N/A
US COAST GUARD VESSEL DOCUMENTATION & REGISTRATION NUMBERS	N/A   SC 7011 DB
<b>OVERALL VESSEL RATING</b>	<b>AVERAGE CONDITION</b>
<b>FAIR MARKET VALUE OF VESSEL</b>	<b>\$25,000.00 USD</b>
<b>ESTIMATED REPLACEMENT COST OF VESSEL</b>	<b>\$150,000.00 USD</b>
MARINE SURVEY INSPECTION LOCATION(S)	[REDACTED], North Charleston, South Carolina 29405, USA
WEATHER & SEA STATE CONDITIONS ON SURVEY DAY	66° F, mostly sunny, dry, wind SW @ 11 MPH, calm sea state, flood tide, 58° F seawater and excellent visibility
SEA TRIAL LOCATION	N/A
VESSEL DESIGNER, BUILDER & HULL NUMBER	<a href="#">Sea Ray Boats</a>   <a href="#">Brunswick Corporation</a>   <a href="#">Knoxville, Tennessee, USA</a>

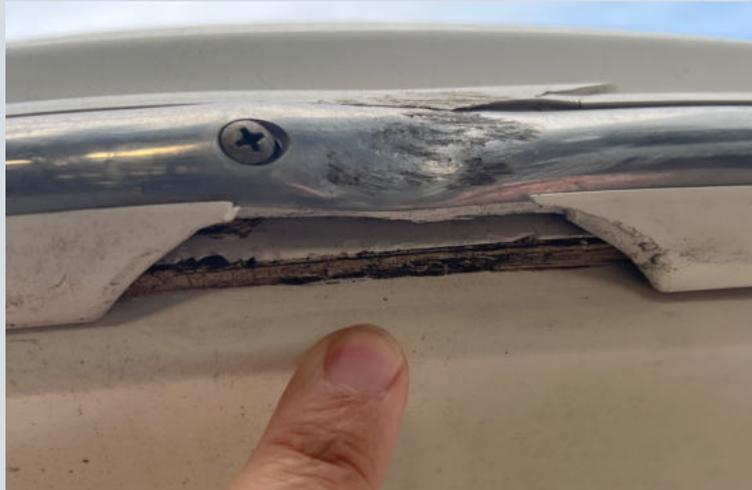
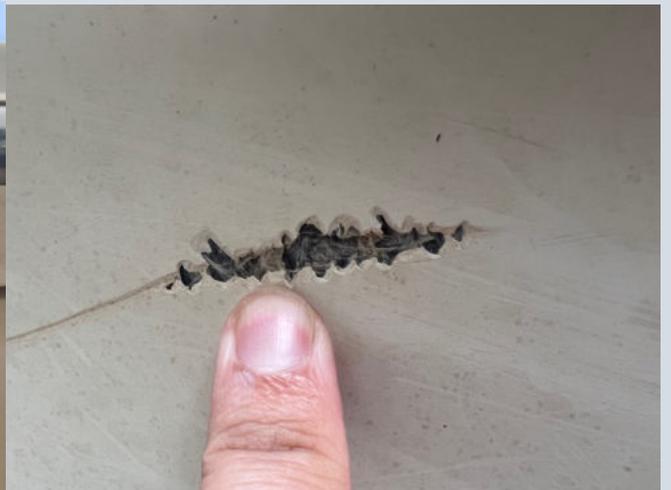
FRP hull exterior, topsides and hull bottom appear in serviceable structural shape without grounding damage, delamination, soft-spots or water intrusion and removable scuffmarks shown on the bow

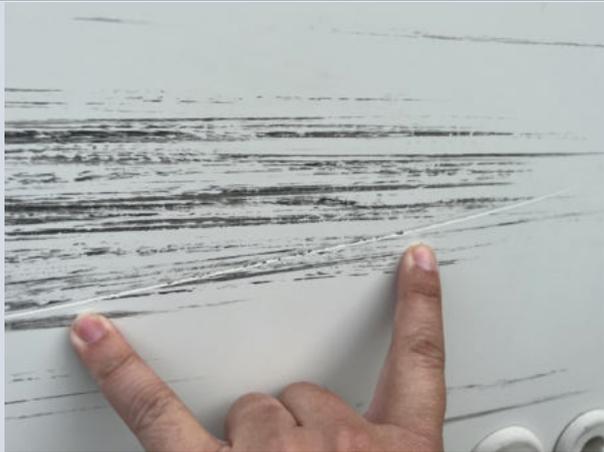
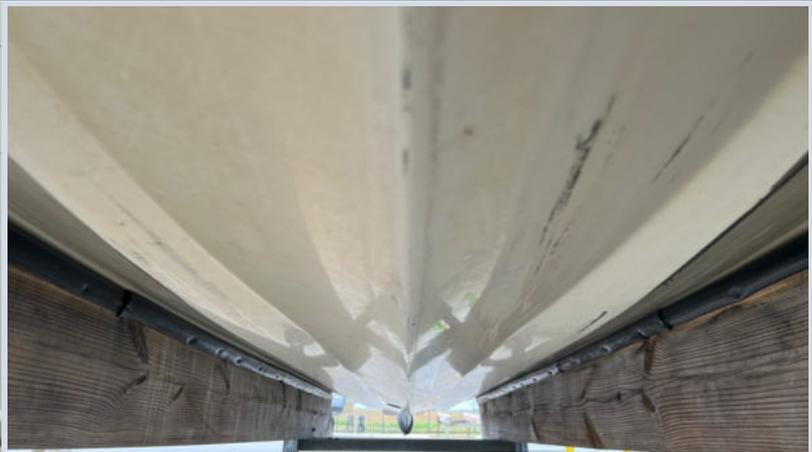
Wear shown on the hull-to-deck joint on the port bow and minor gelcoat wear shown the starboard side of the bow below the waterline

<p><b>HULL EXTERIOR, TOPSIDES, HULL-TO-DECK JOINT, SPRAY RAILS &amp; BOOTSTRIPE</b> Aboard the 2002 Sea Ray 240 Sundancer <i>Xanadu</i> (240), the port and starboard FRP white gelcoat finished vessel hull exterior, topsides, hull-to-deck joint, spray rails and black painted bootstripe appear in practical esthetic and physical repair, well-supported and structurally sound without significant defects for a vessel of this age, size and use. Zero indication of delamination, soft-spots, active water intrusion, saturation, voids, acute physical impacts, stress-cracking, fractures, decay, rot, pitting, fractures, haloing, saltwater corrosion, surface rust, oxidation, excessive wear and tear, osmotic or paint blistering was detected during the visual inspection, thermal, moisture and percussion tests. Using a phenolic hammer every 2-4" percussive soundings, TRAMEX moisture and FLIR thermal readings were manually performed from stem to stern above the waterline on both sides of the hull. Dry and acceptable percussion, moisture and thermal readings were verified, the hull-to-deck joint and hardware appears in useful shape, well-supported and bonded without separation or water intrusion around the vessel. The black painted bootstripe finish appears in serviceable esthetic condition around the waterline. <i>Routine and customary cosmetic wear and tear for a vessel of this age, size and use was discovered on the port and starboard FRP white gelcoat finished vessel hull exterior and topsides including intermittent evidence of mostly insignificant cosmetic gelcoat scratches, removeable scuffmarks, dock rash and fender rub. 1x isolated 2" FRP gouge was reported on the portside hull-to-deck joint near the bow.*</i></p>

4. **The hulls wetted surface area is noticeably stained/discolored from bow to stern. 1x isolated 1" long gelcoat scratch was reported on the starboard bow below the waterline exposing the FRP layup.** Detail and repair the cosmetic finish as needed.

3. **Routine and customary cosmetic wear and tear for a vessel of this age, size and use was discovered on the port and starboard FRP white gelcoat finished vessel hull exterior and topsides including intermittent evidence of mostly insignificant cosmetic gelcoat scratches, removeable scuffmarks, dock rash and fender rub. 1x isolated 2" FRP gouge was reported on the portside hull-to-deck joint near the bow.** Detail and repair the cosmetic finish as needed aboard the 240.

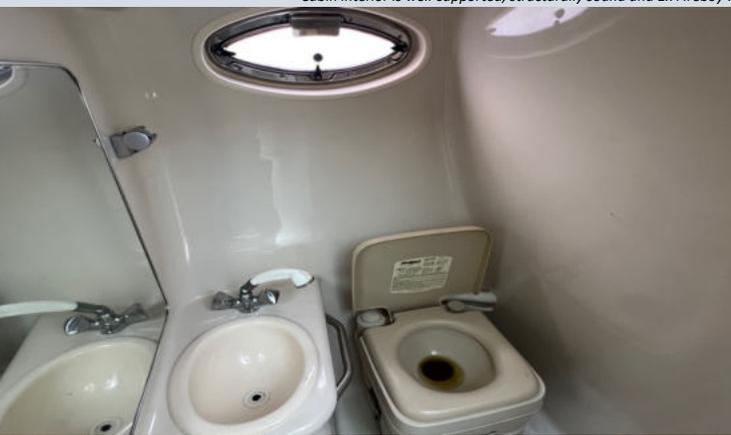
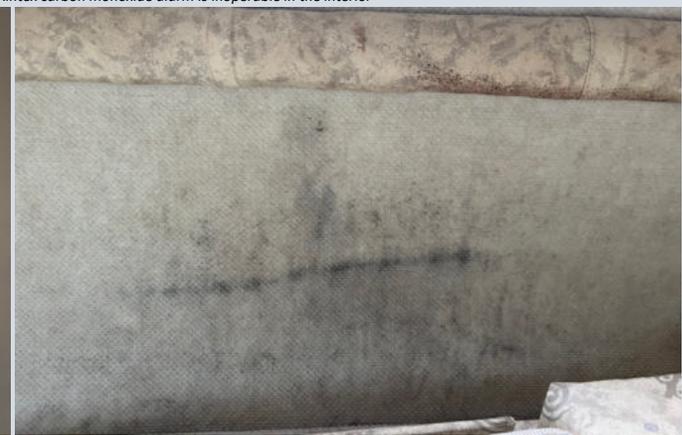
Cabin interior is well-supported, structurally sound and 1x Firebox-Xintex carbon monoxide alarm is inoperable in the interior

<b>FIRE, SMOKE, CARBON MONOXIDE &amp; GAS FUME DETECTION</b> <b>1x Fireboy-Xintex carbon monoxide alarm in the interior is inoperable. Zero fire, smoke and gas fume audible alarm systems are installed in the interior.*</b>
<b>VISUAL DISTRESS &amp; SOUND SIGNALING EQUIPMENT</b> The 1x fixed mount horn powers up. <b>Zero ships bells, whistles, flare guns, flare gun shells, LED electronic beacons, launchers for aerial meteor/parachute flares, reflective mirrors, SOS flags, glowsticks or sea-marker dyes were found. Zero handheld or aerial visual distress signals (flares) were found onboard.*</b>
<b>NAVIGATION, MASTHEAD, STERN &amp; ANCHOR LIGHTS</b> The 2x red/green navigation and white anchor lights appear in serviceable condition and power up.
<b>MAGNETIC COMPASS, TIDE &amp; NAVIGATION CHARTS</b> The 1x Ritchie Powerdamp magnetic compass at the helm operated normally. Zero tide and navigation charts were discovered.

1. **1x Firebox-Xintex carbon monoxide alarm in the interior is inoperable. Zero fire, smoke and gas fume audible alarm systems are installed in the interior.** Install alarms in the interior as needed aboard the 240.
2. **Zero handheld or aerial visual distress signals (flares) were found onboard.** Install new flares in a dry and easily accessible space aboard the vessel.

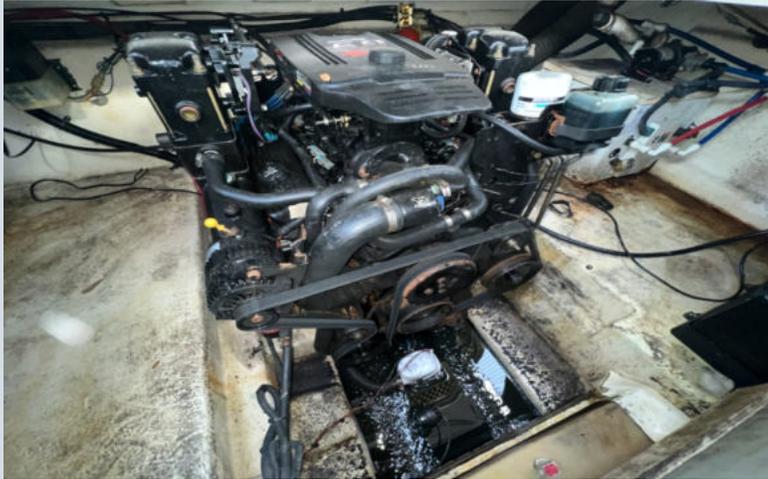
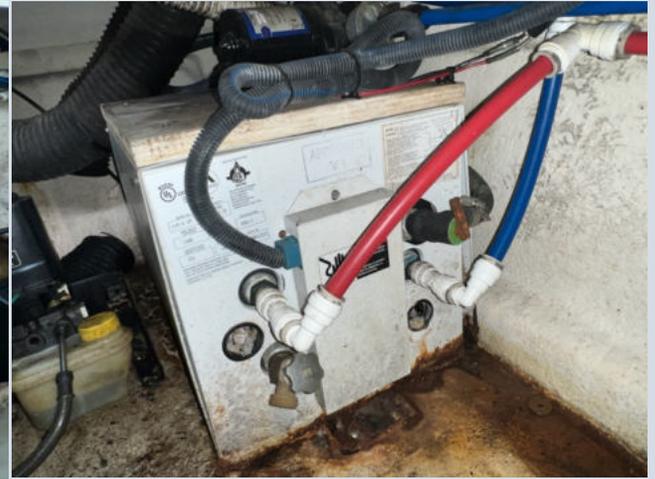
AC & DC power distribution panel, Clarion stereo head unit, freshwater pressure and Isotherm refrigerator and grey-water shower sump pump power up and the alcohol stove was unable to be tested

13. **The 1x Kenyon alcohol stovetop in the galley was unable to be tested.** Test galley stove.
14. **The 1x Atwood 6-gallon hot-water heater in the engine room exhibits surface rust and corrosion to the base.** Clean up corrosion, monitor and service hot-water heater as needed.

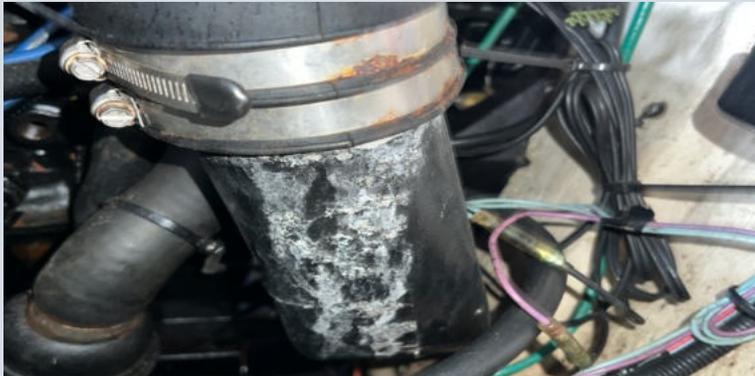
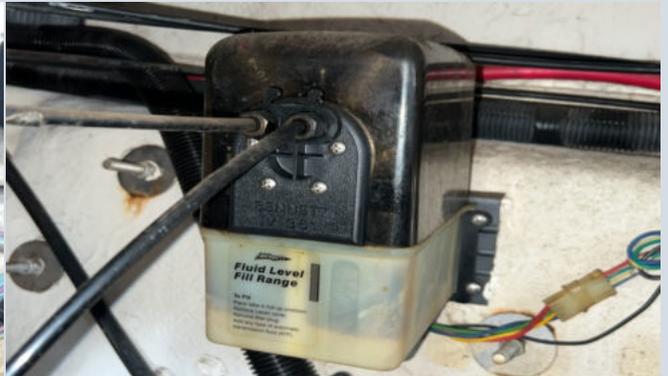
Corrosion shown on the portside exhaust manifold and an oily mixture shown in the engine room bilge and Sahara bilge pump powers up

<p><b>BILGE COMPARTMENTS &amp; LIMBER HOLES</b> The bilge compartments and limber holes from stem to stern appear in functional superficial and physical shape, clean, mostly dry, well-supported and physically sound without significant defects. Zero noticeable critical evidence of delamination, soft-spots, active water intrusion, saturation, voids, acute physical impacts, stress-cracking, fractures, decay, rot, pitting, fractures, haloing, saltwater corrosion, surface rust, oxidation, excessive wear and tear, osmotic or paint blistering was detected during the visual inspection, thermal, moisture and percussion tests. All limber holes are suitably sized, well-supported and unobstructed. Bilge compartments and limber holes were scrutinized for structural loss, deterioration, saturation, detached bonding and water damage without discovery. <i>An oily residue was discovered in the centerline bilge of the engine room.*</i></p>

5. **An oily residue was discovered in the centerline bilge of the engine room.** Detail the engine room as needed.
6. **The white fabric headliner is stained throughout the interior.** Detail the headliner as needed.

11. **The 1x Mercury MerCruiser Bravo III sterndrive skeg has a nearly 1" chunk missing.** Monitor and service the skeg as needed.
12. **Moderate surface rust and corrosion was discovered on the portside Mercury MerCruiser exhaust manifold and saltwater residue was seen on the exhaust hose near the transom.** Complete further discovery and service the exhaust systems as needed.
