**BOAT CHECK
MARINE SURVEYORS LLC**

2004 25' Cobalt 250

Condition & Value Report of Marine Survey

Date Of Survey: February 2 2024

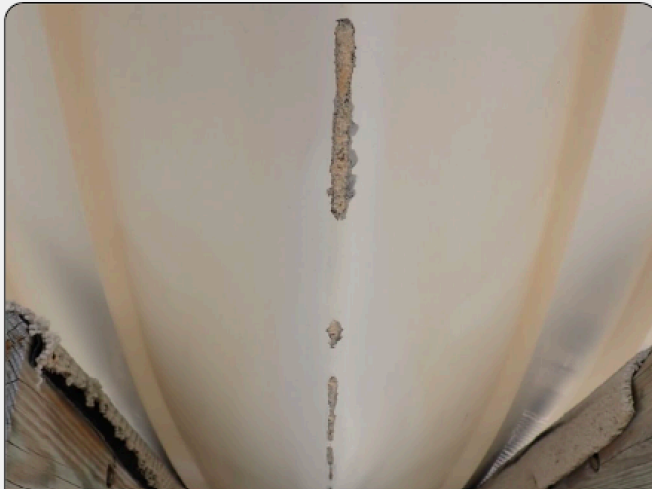
Lower Bow.

FINDING B-1 GENERAL EXTERIOR CONDITION

General wear & tear, spider cracking and oxidation was observed on some of the exterior surfaces.

Polish/detail the oxidized surfaces with buffing and waxing, as necessary.

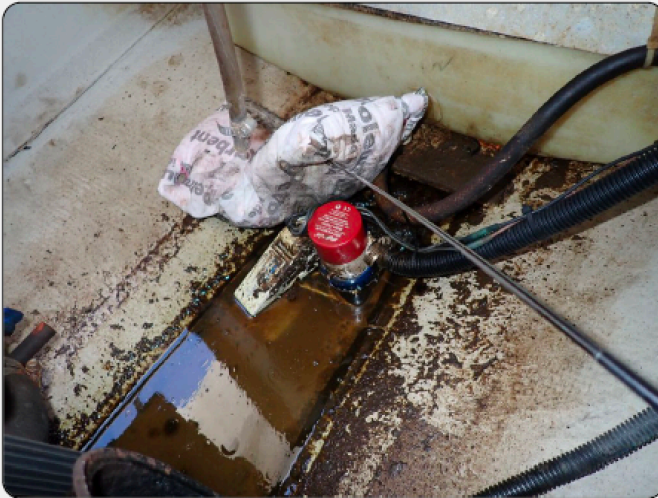
FINDING B-2 GENERAL BILGE CONDITION

Clean bilges, as necessary.

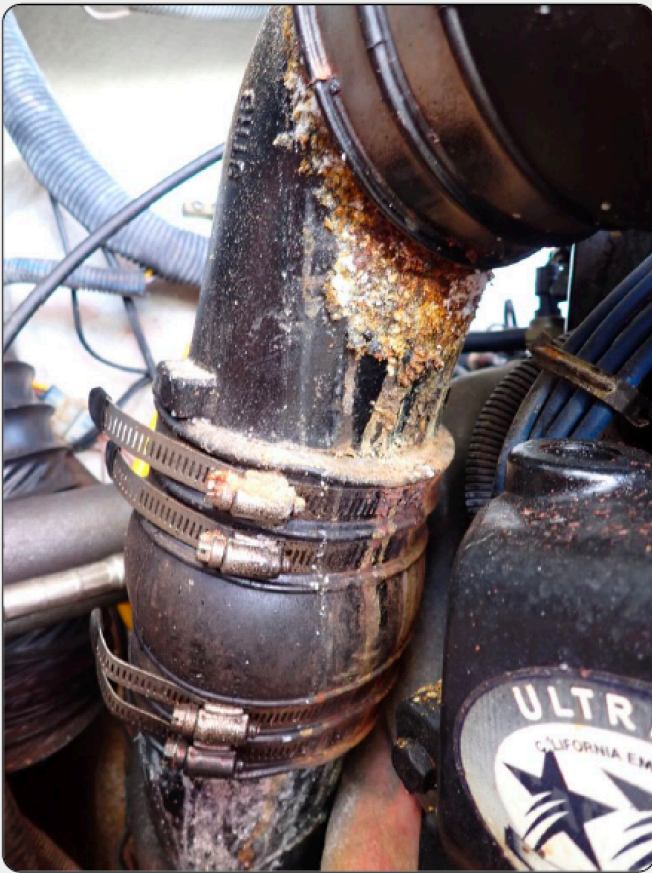
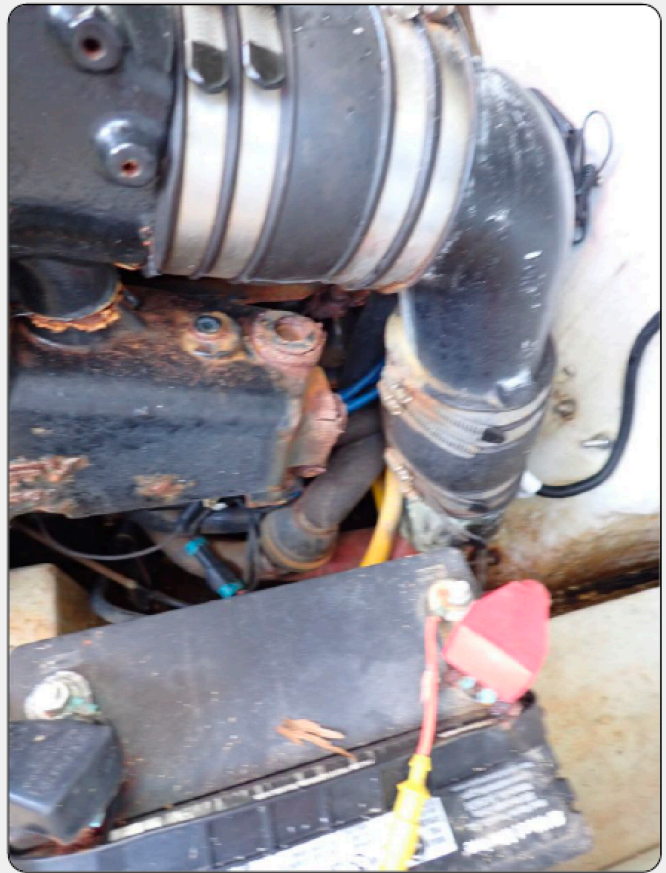
FINDING B-3 ENGINE EXHAUST SYSTEM

Dry raw water leakage rust staining was observed at the port & starboard engine exhaust hoses.

Investigate and remove the source of the corrosion.

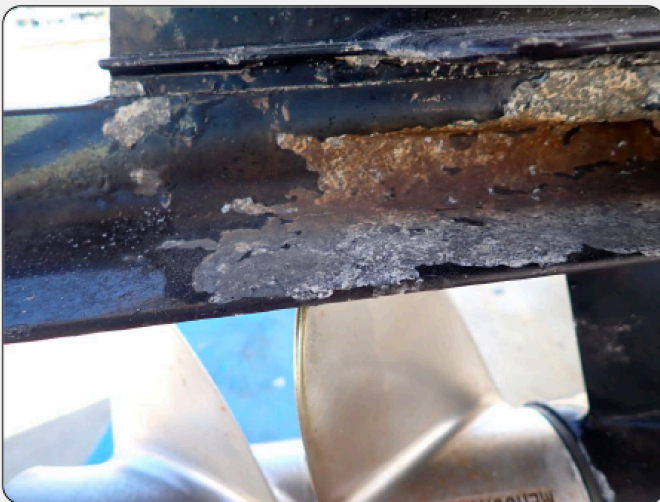
FINDING B-4 OUTDRIVES

Some corrosion was observed on the outdrive.

Remove corrosion and re-paint, as necessary.

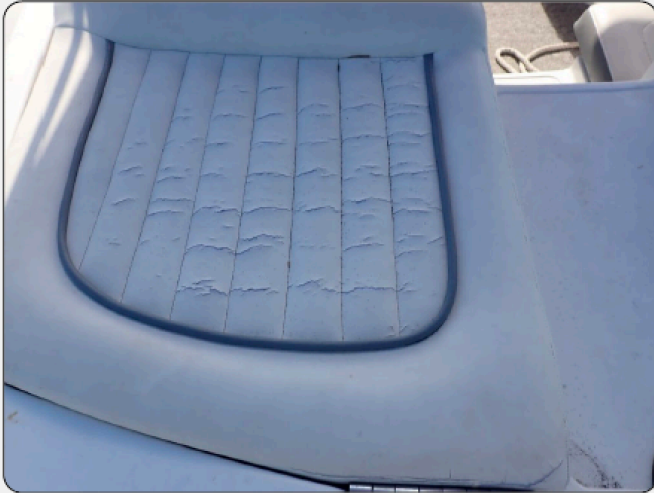
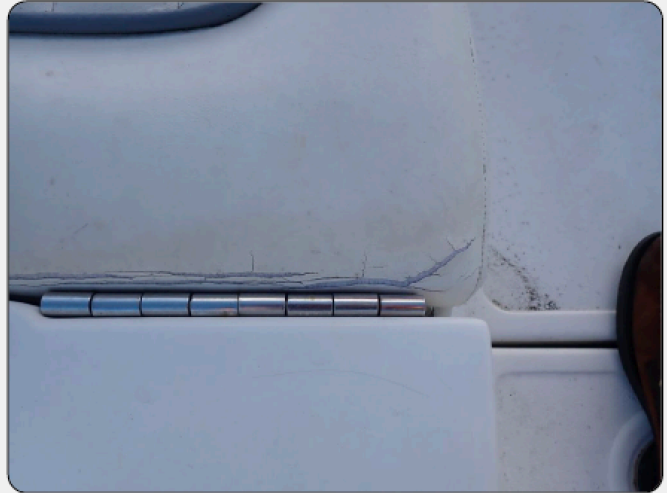
FINDING C-1 GENERAL EXTERIOR SOFT-GOODS CONDITION

Some of the vessel's exterior vinyl cushions had general weathering, cracks and wear.

Replace the cushion vinyl, as necessary.
