### **Findings**

This surveyor was onsite at [REDACTED] in Milwaukee, WI on 7/21/2022 to inspect the referenced vessel for damages alleged to have occurred as a result of impact from handling or layup of the boat.

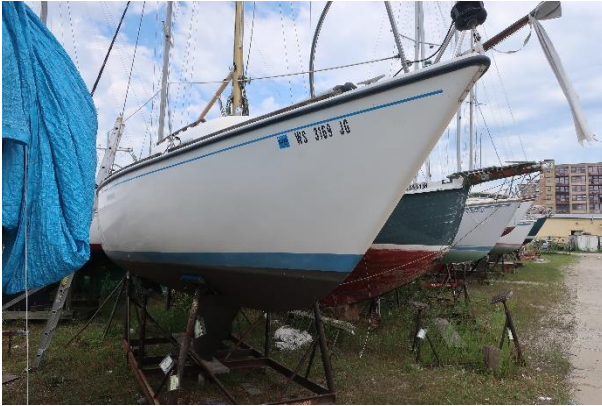
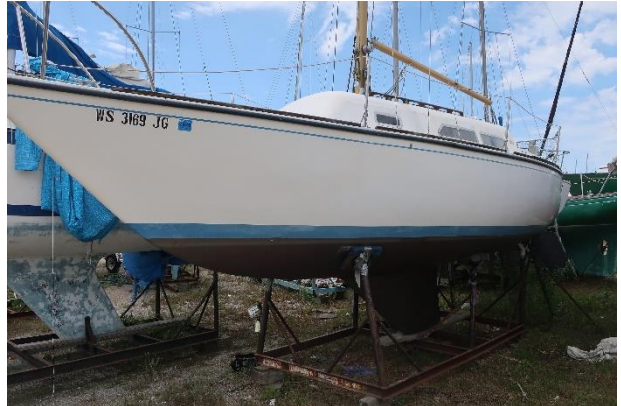
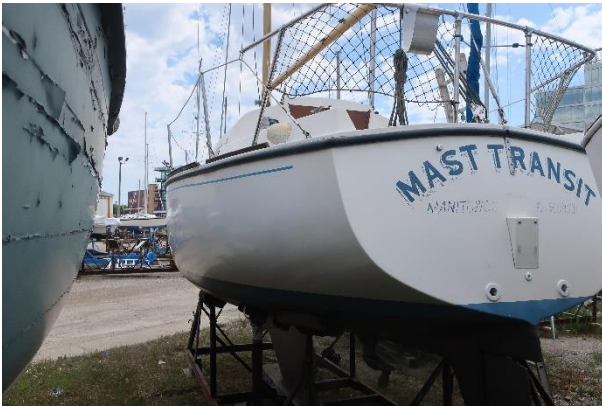
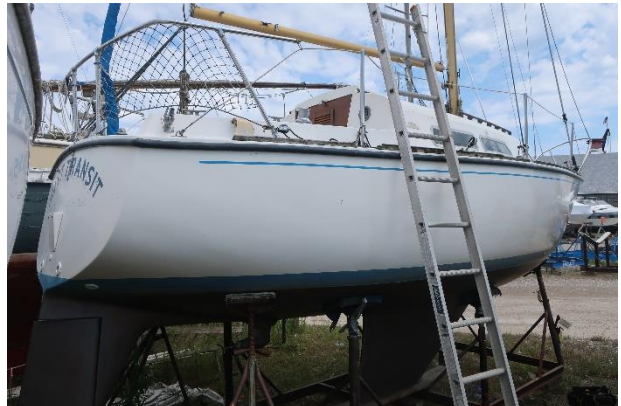
2. Four corners

The boat was observed to be in fair to poor condition. It is not equipped, nor appears serviceable for use.

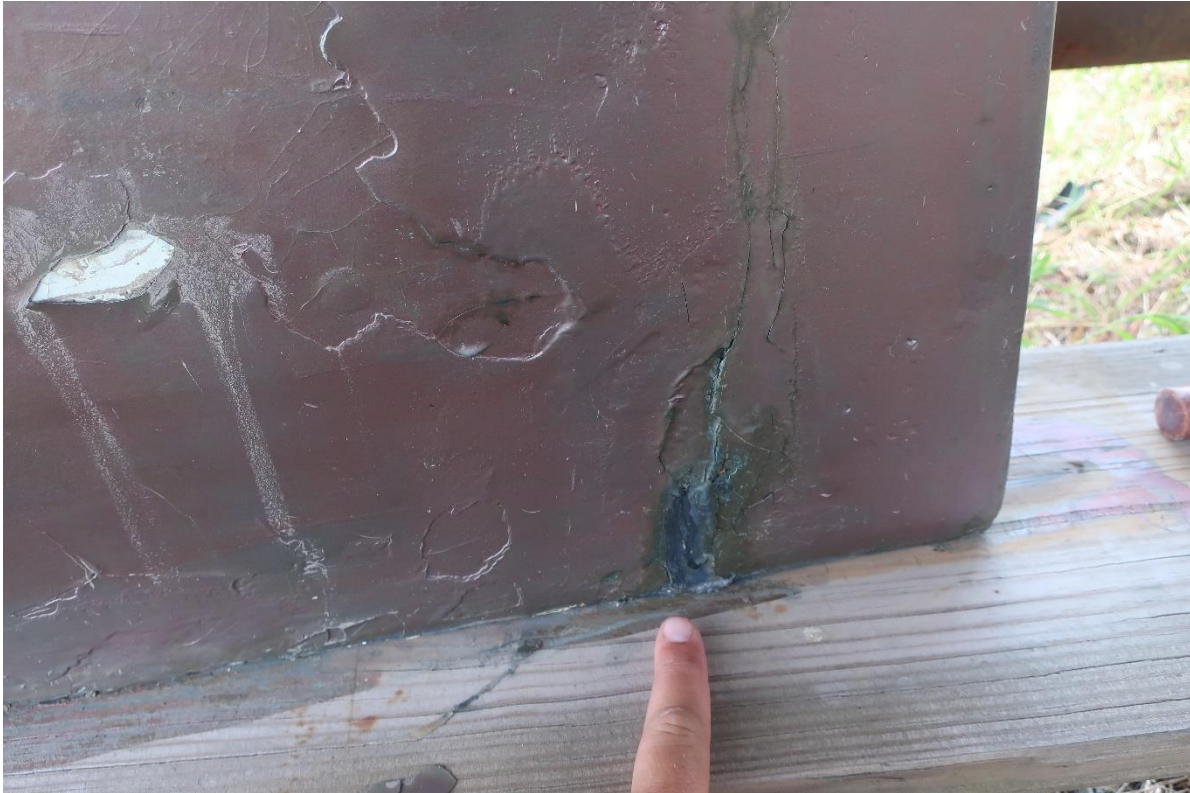
The leading and aft edges of the keel at the bottom appears to have a failing repairs, as discolored, and weeping. The keel is relatively moist to wet throughout based on moisture meter readings. Small blisters were apparent both port and starboard side. Percussive returns indicate delamination on the starboard side of the keel. Hollow sounds were apparent on the port side in the same areas, but the starboard seems to be more likely delaminated.

All observations indicate the vessel lacks proper maintenance. The keel appears to have water freeze / expansion damage. There is no conspicuous indication of recent impact. The bottom of the keel was not accessible for inspection, but visible areas do not show signs of the boat being dropped or improperly supported, but of failing repairs. The boat was on both a cradle and stands at the time of inspection.

3. Keel cracks (aft) - weeping

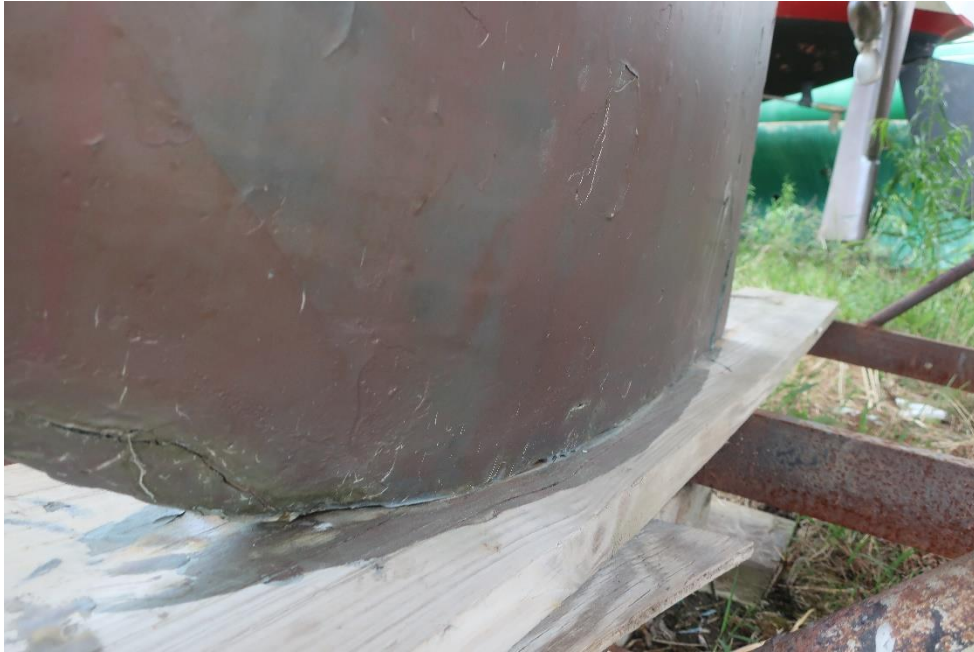
4. Keel cracks (fore) - weeping

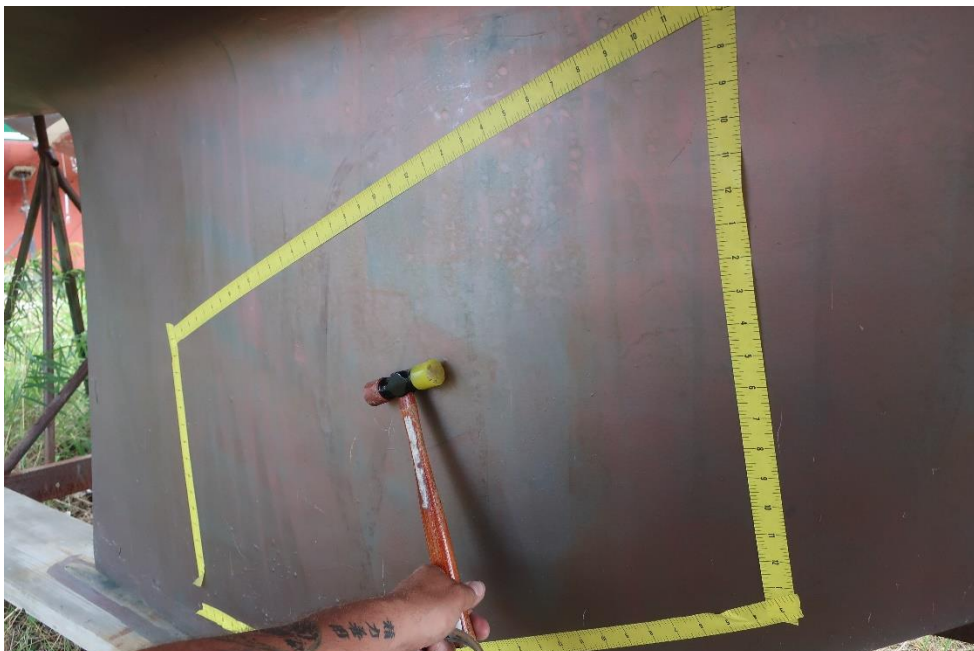
5. Starboard side of keel (percussively dull and delam likely)

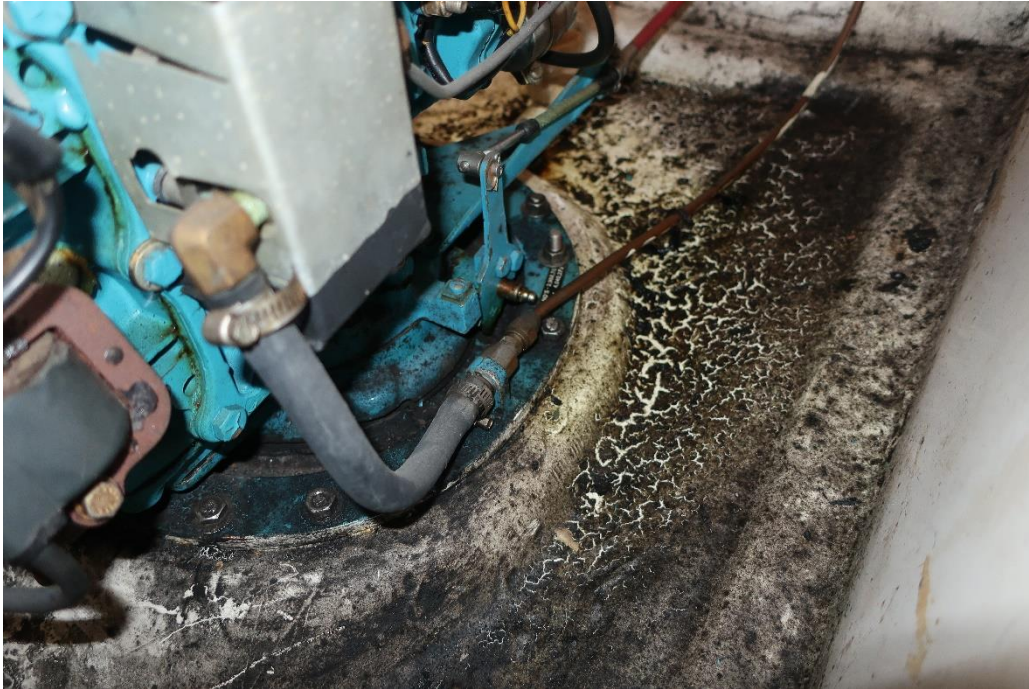
8. Engine room bilge

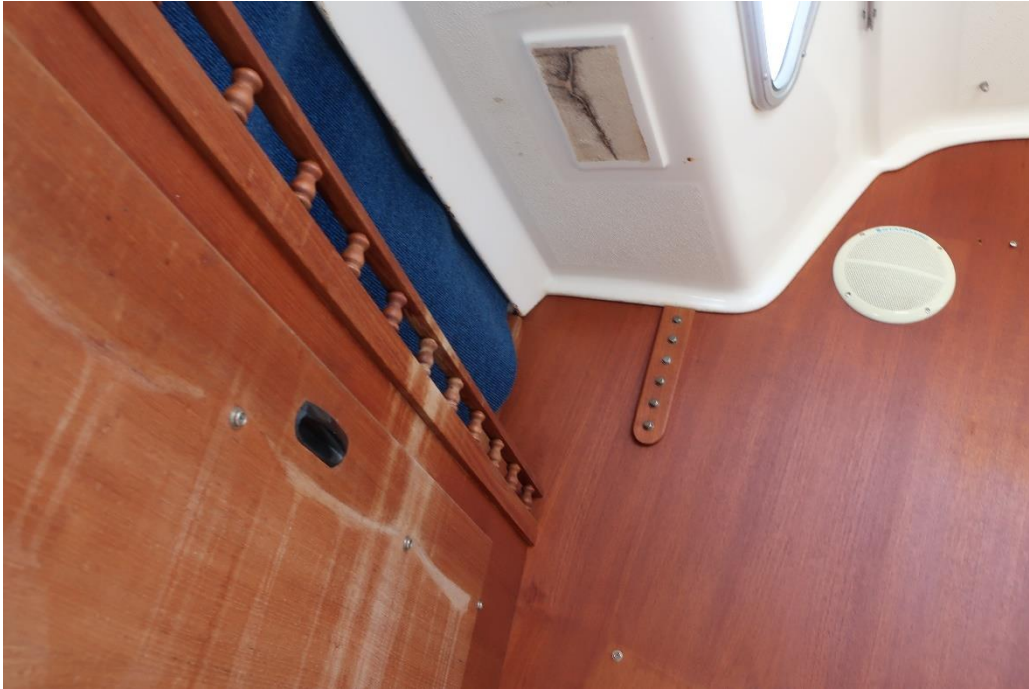
The interior of the boat is basically stripped down to the shell. Some electrical remains, but no features typical of accommodations for this vessel are present. Leak tracks were present on both port and starboard sides at the superstructure side windows.

9. Internal leakage (port side)

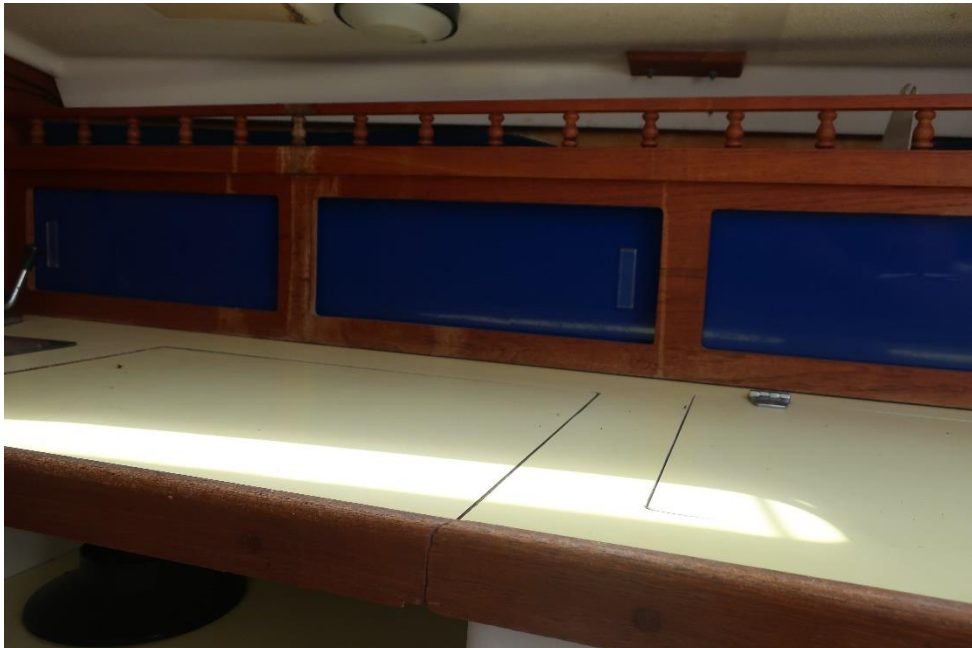
10. Internal leakage (starboard side)
