# Pre-Purchase Report of Marine Survey

## "Proly Do"

**1990 Chris Craft 320 Express**

**Date Of Survey:** 8/3/2026

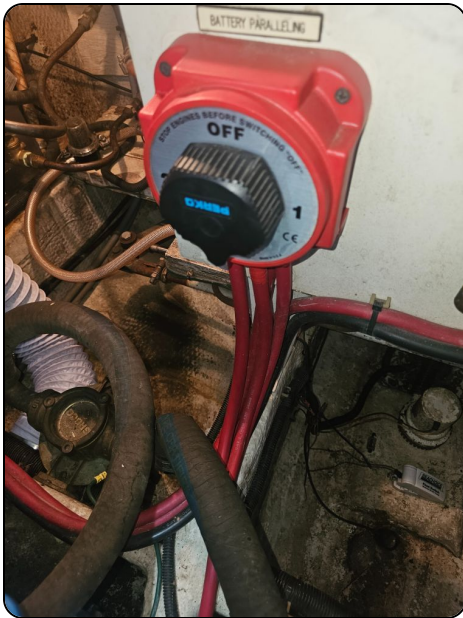
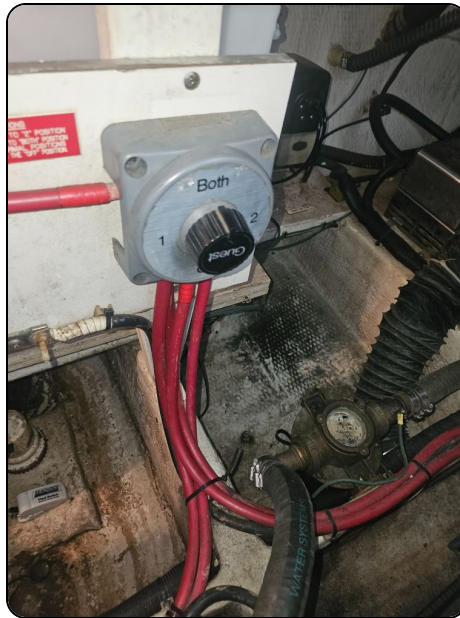
### BATTERY SWITCHES

Two Guest and Perko rotary battery switches were present. They were demonstrated during the inspection.

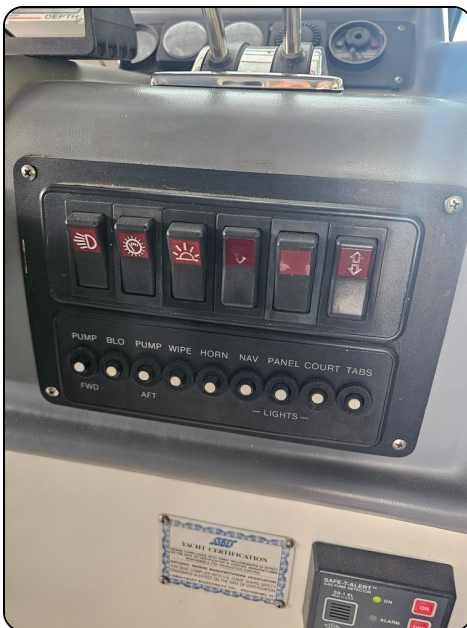
DC Sub panel breakers at the helm. All breakers where properly sized and labeled.

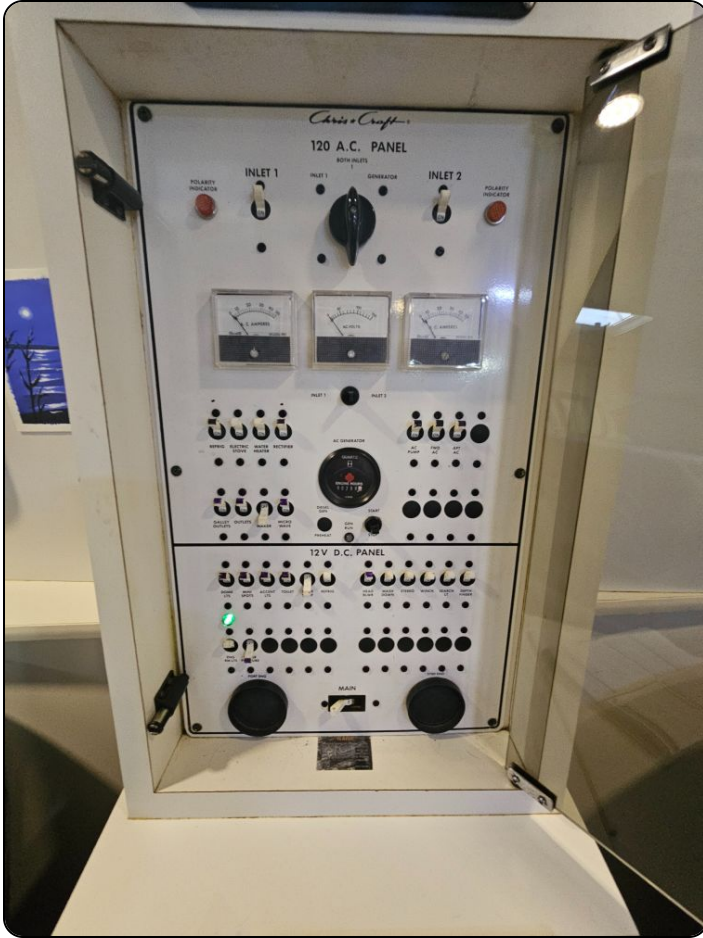
The main AC breaker was installed in the main salon electrical panel.
