Report of Marine Survey

Of the Vessel "Dark Day"

1986 26 Carver Santa-Cruz 2667

Inspection performed on: 10/27/23 with Report submitted on: 10/31/23

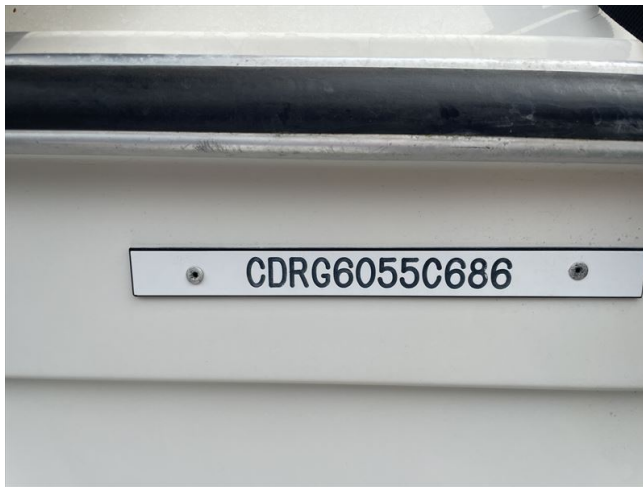
The vessel's HIN (Hull Identification Number) was verified during the Survey inspection.

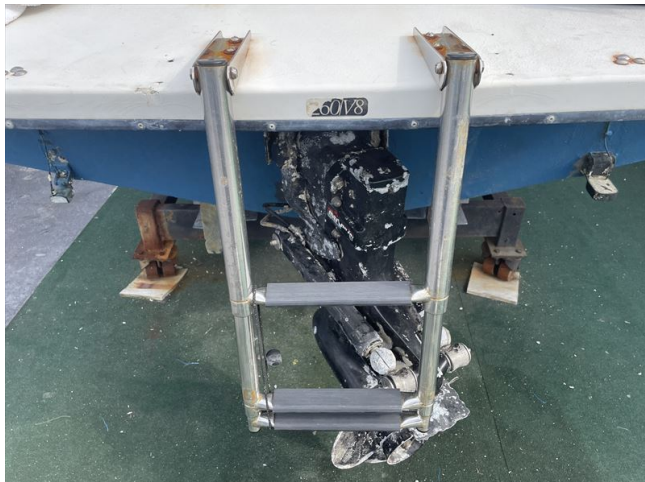
TRANSOM

Transom was visually inspected and tapped examined with a phenolic hammer showing no signs of structural damage.

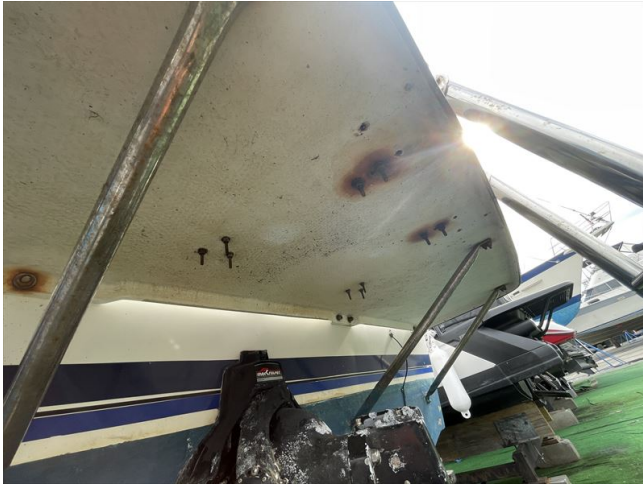
The cored fiberglass swim platform had normal percussion soundings and conductivity readings.

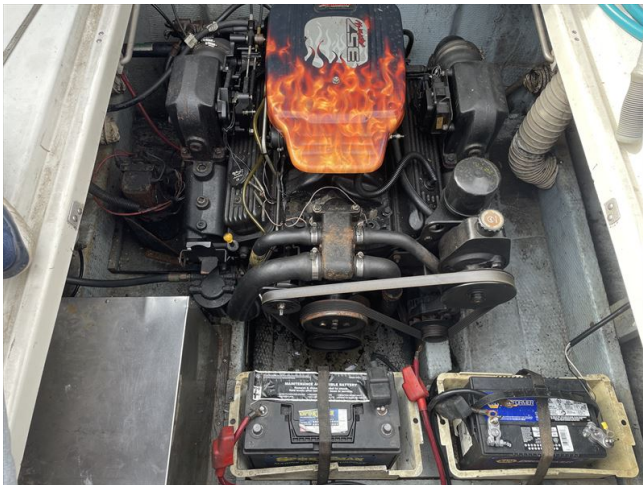
GENERAL BILGE CONDITION

The engines' bilge was found serviceable condition.

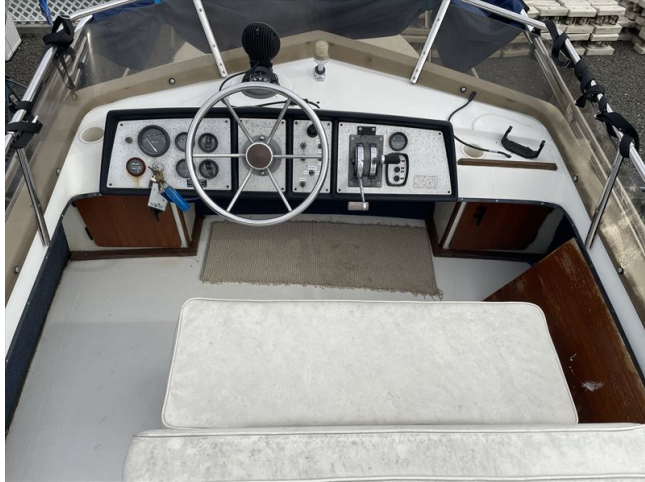
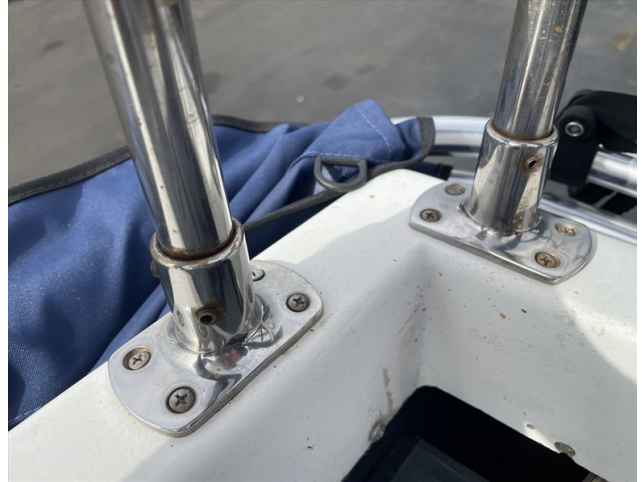
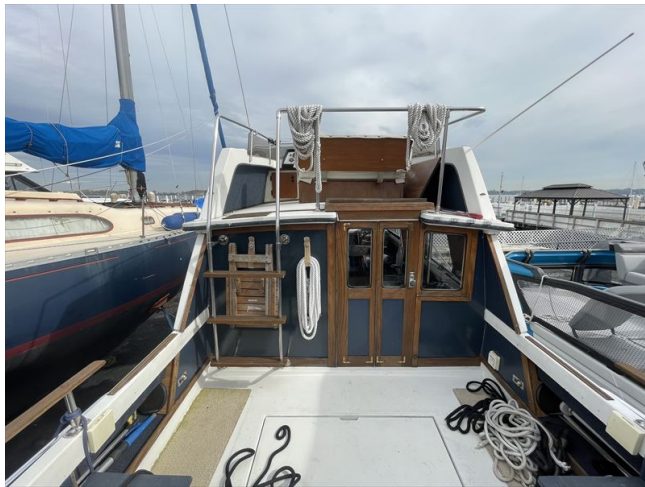
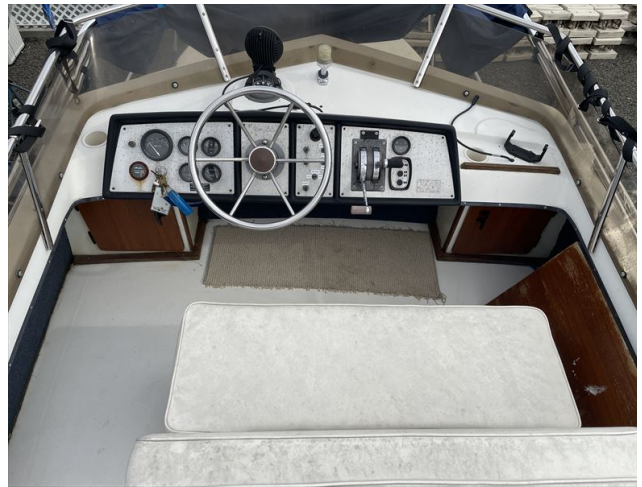
The deck was found in average condition.

Reportedly as per manufacturer, the vessel's deck is constructed with cored FRP (fiber reinforced plastic) with white gelcoat and textured non-skid and was found in good condition.

Exterior lights were found in serviceable condition. The opening cabin in the deck, according to manufacturer, is made of acrylic plastic glass and was found in serviceable condition.

The bow rail was found in serviceable condition. Stainless steel cleats were visually inspected and found in serviceable.

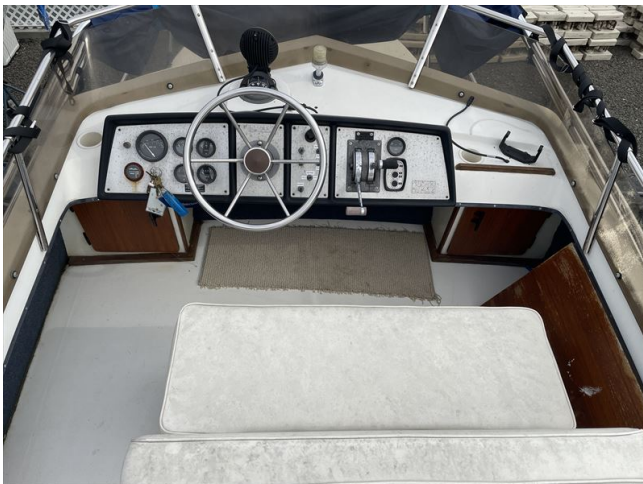
The flybridge provided the helm station and seating area - all found in serviceable condition.

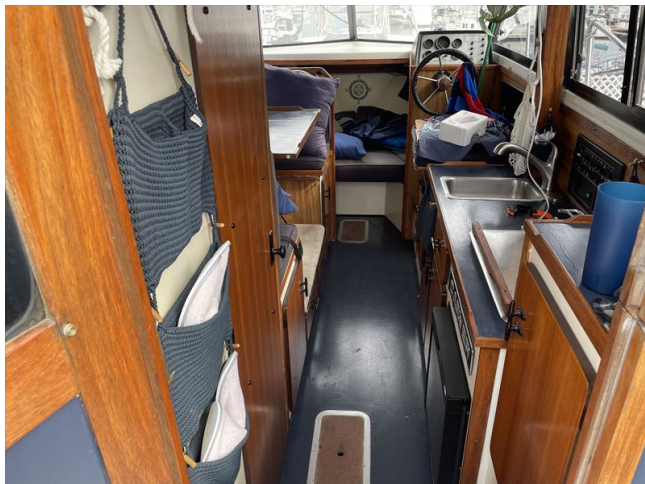
The main salon shows clean and in above average condition.

On the Port side you have toilet, followed by the seating area.

On Stbr side you find the galley with electronics and sink - all found working and in serviceable condition. (electronics were not powered up).

Towards the bow, sleeping accommodation was found in serviceable condition.

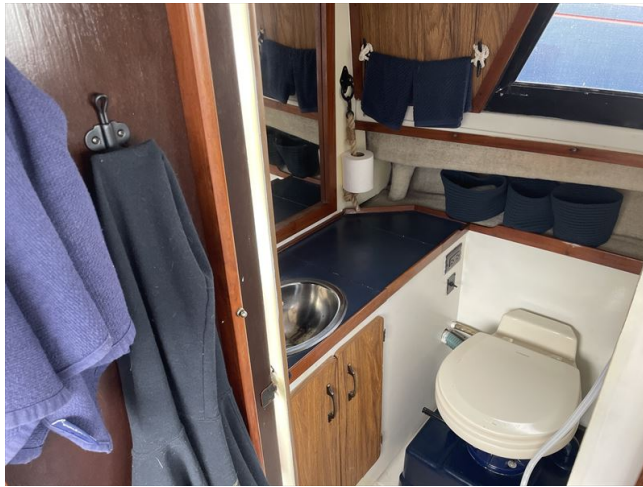
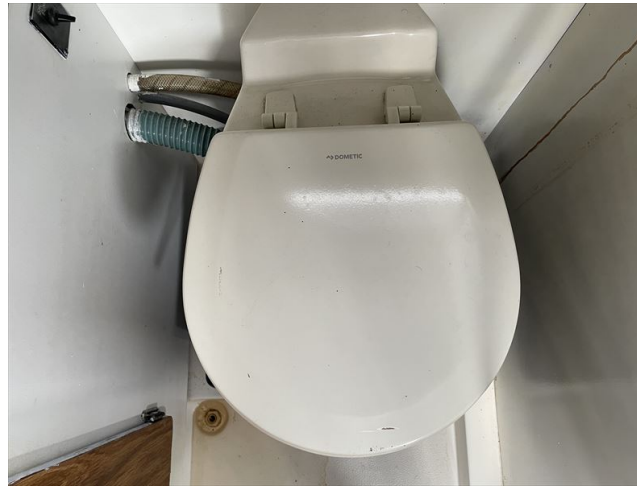
In the galley, port side, there is a sink, microwave, stereo, fridge all found functioning and serviceable condition. (Electronics were not tested)

The main general aspect of the head was in above average condition.

Toilet found in serviceable condition.

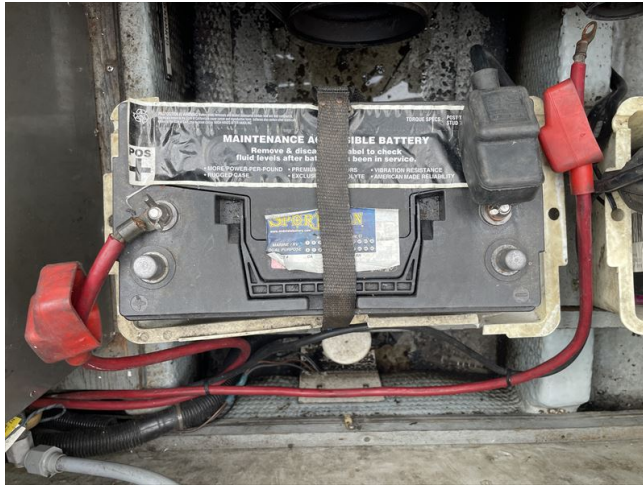
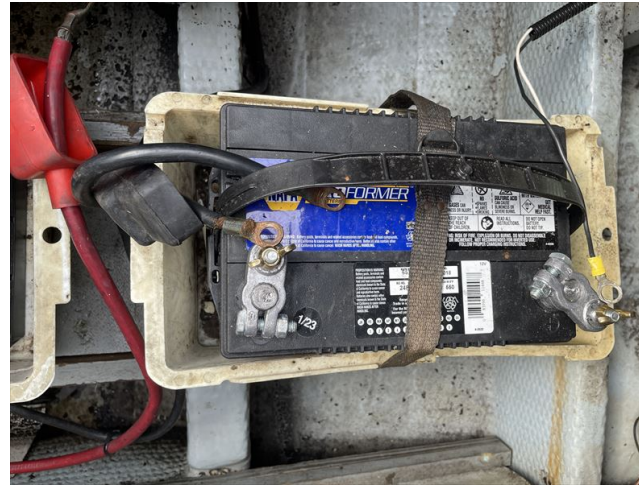
BATTERIES

Serviceable condition.

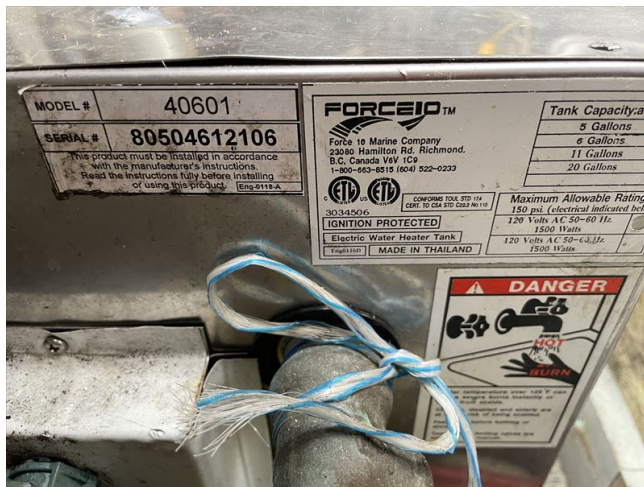
WATER HEATER

Visually inspected and in serviceable condition.
