Report of Marine Survey

Lily Mar

Hunter 28

May 30, 2023

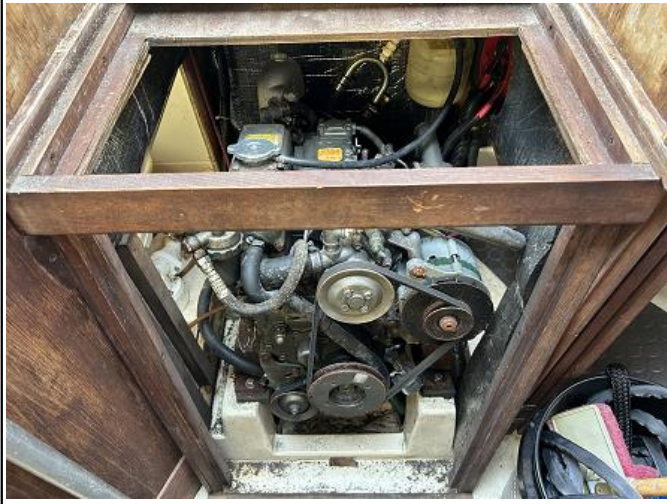
Engine

TYPE: One (1) four cycle I-2 diesel naturally aspirated engine.

MANUFACTURER: Yanmar, model 2GM20, serial #13621.

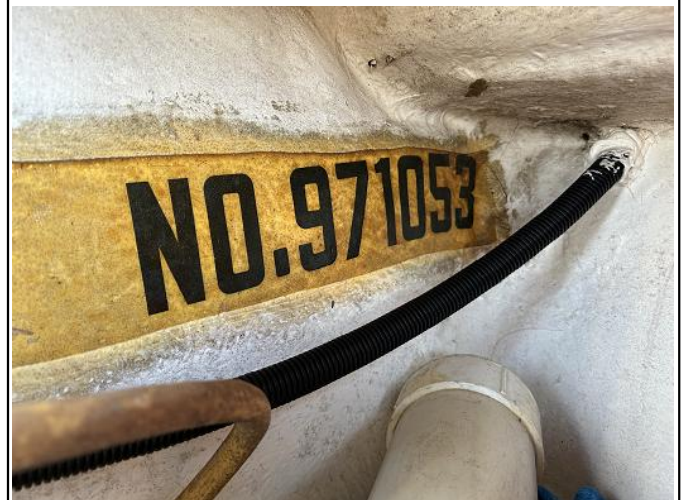
DOC Number

NOTE: Title 46, United States Code of Federal Regulations, Chapter 121, states any vessel for which a certificate of documentation has been issued are required to have the documentation numbers permanently fixed to the hull. Sighted and noted starboard side cockpit compartment, (see photo).
