Lowell Boats Marine Surveys  
Gary Lowell, AMS,  
Society of Accredited Marine Surveyors®

## VALUE APPRAISAL

Prepared for: [REDACTED]  
[REDACTED]  
[REDACTED]

This is to certify that on November 19, 2022, at your request, the undersigned marine surveyor attended the vessel mentioned in its slip at [REDACTED] on Smith Mountain Lake, VA. The purpose for inspecting the vessel was to determine the fair market value prior to donation to a charitable organization.

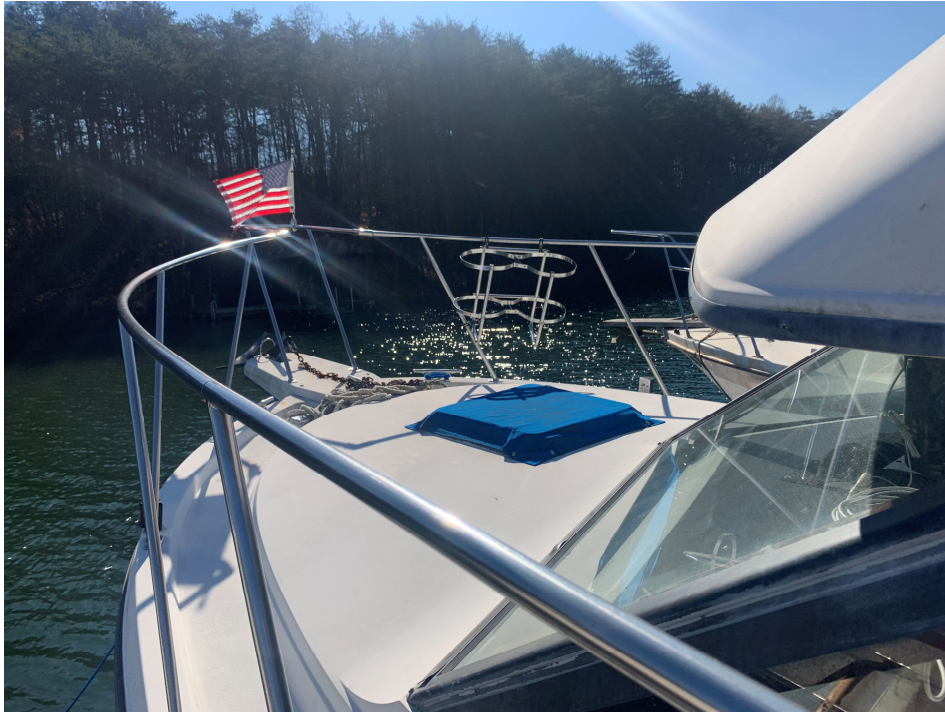
The foredeck was coated with a non-skid surface. The decks throughout gave slightly when walked on. Moisture meter reading in these areas were consistently high. The fore hatch was located in the center of the deck. A bow sprit with an anchor roller was mounted at the stem. The anchor roller contained a Danforth style anchor with chain and nylon anchor rode.

View of Foredeck

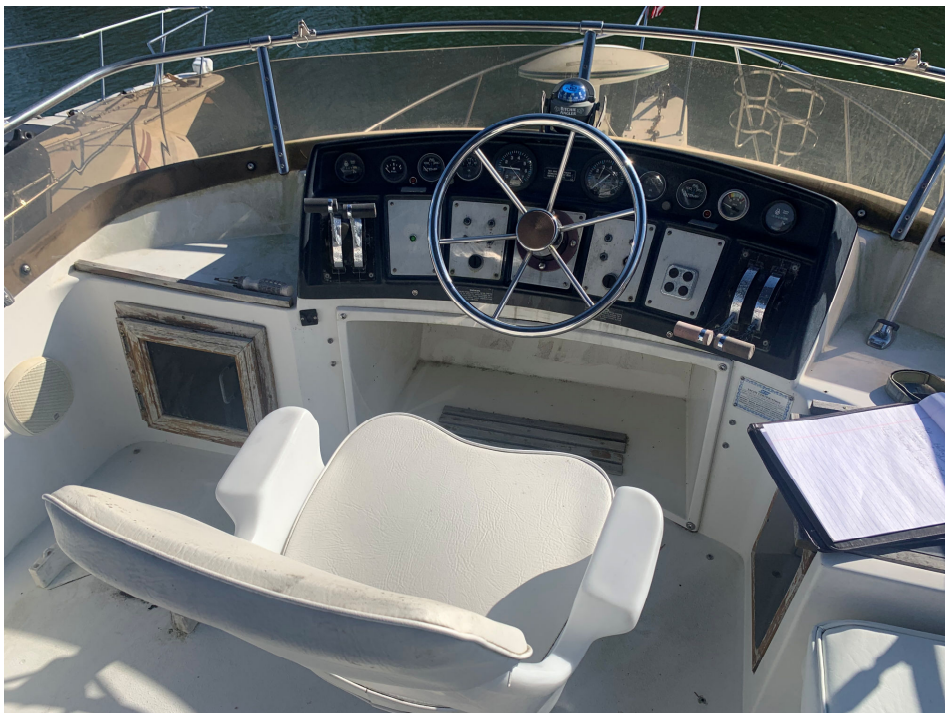
The single helm station was located on the flybridge. The ladder to the flybridge flexed when climbed, hand holds were minimal. The non-skid surface was minimal and may be slippery when wet. The deck of the helm area was soft and spongy throughout. The swivel helm seat flexed. Bench seats were located on the side and aft of the helm area. A low grab rail and spray shield surrounded the helm area. The area was covered by a folding bimini top, the canvas was worn and soiled.

The helm station was equipped with hydraulic steering. Throttle and shift levers were mounted on the dash. Dual dash gauges and switches were mounted on the dash (port hours 1385, stbd 1545). The switches were not clearly labeled. A Ritchie compass was mounted on the dash. A side locker contained the stereo unit and a Raymarine depth finder. An FM/TV antenna was mounted on the front of the cabin top. No other navigation electronics were installed.

View of helm station on flybridge

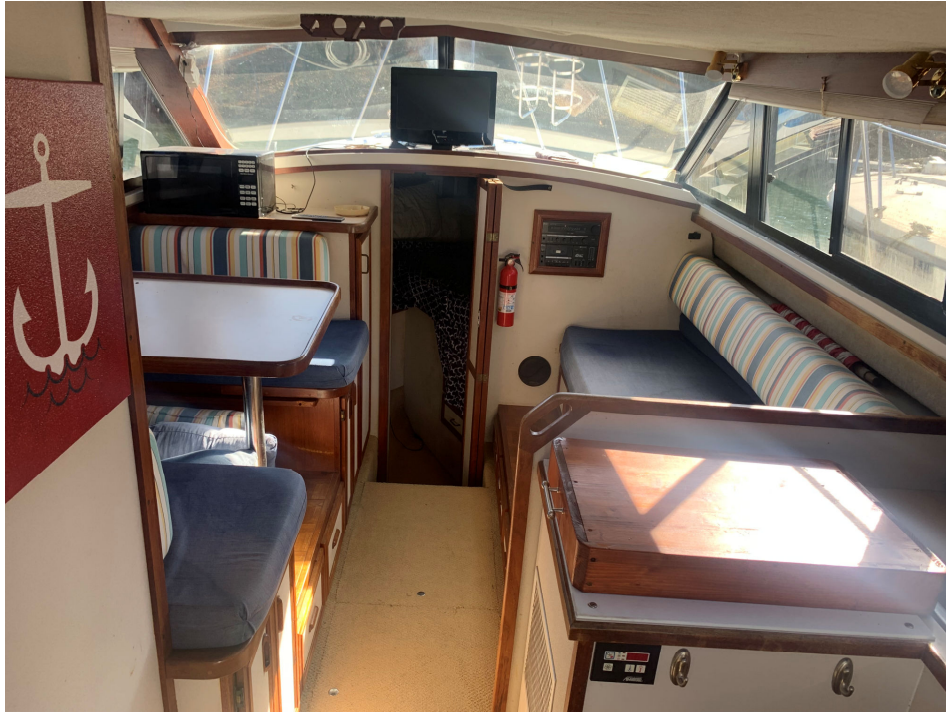
Large opening windows throughout the cabin provided light and ventilation. The cabin top and sides were covered with a fabric hull line. The fabric was soiled and stained throughout indication leaks in the overhead and around the windows.

The forward stateroom was on a lower level than the main cabin. The berth was arranged with an offset bunk and a small vanity sink. Storage compartments were located under the berth. A hatch in the overhead provided light, ventilation and egress. Leaks were evident throughout the forward cabin. A hatch in the forward bulkhead allowed for access to the anchor locker.

Forward facing view in cabin

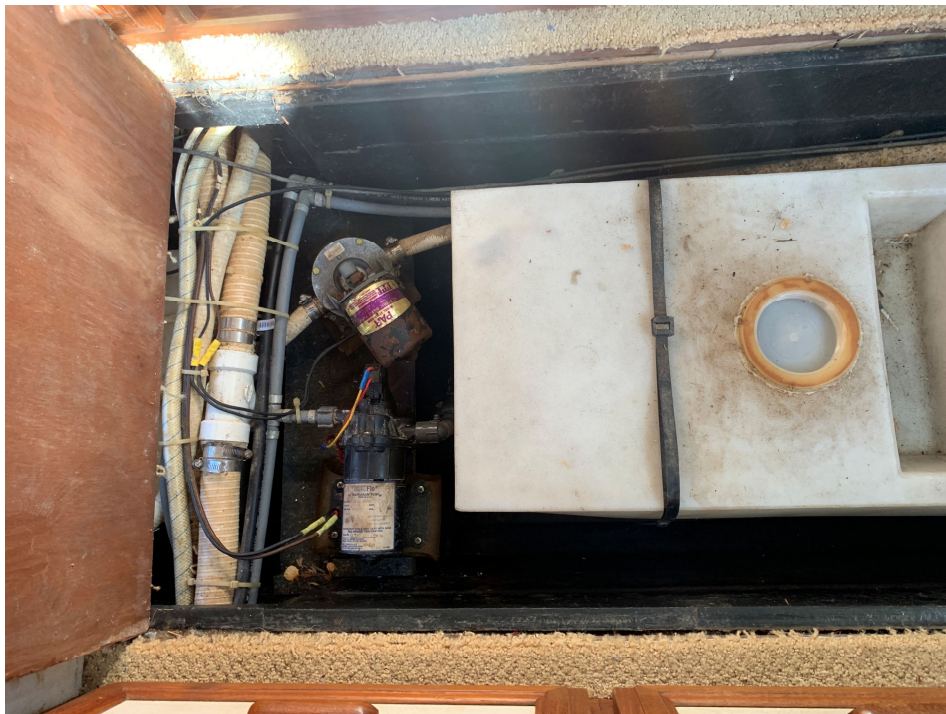
Hatches in the cabin sole provided access to the bilge compartments and tankage. The water and waste tanks were located in this area. The compartment was soiled and odiferous with standing water in the bilge. The tanks, pumps and plumber were secured but with soil and corrosion on most of the metal fittings.

View of plumbing in cabin bilge compartment

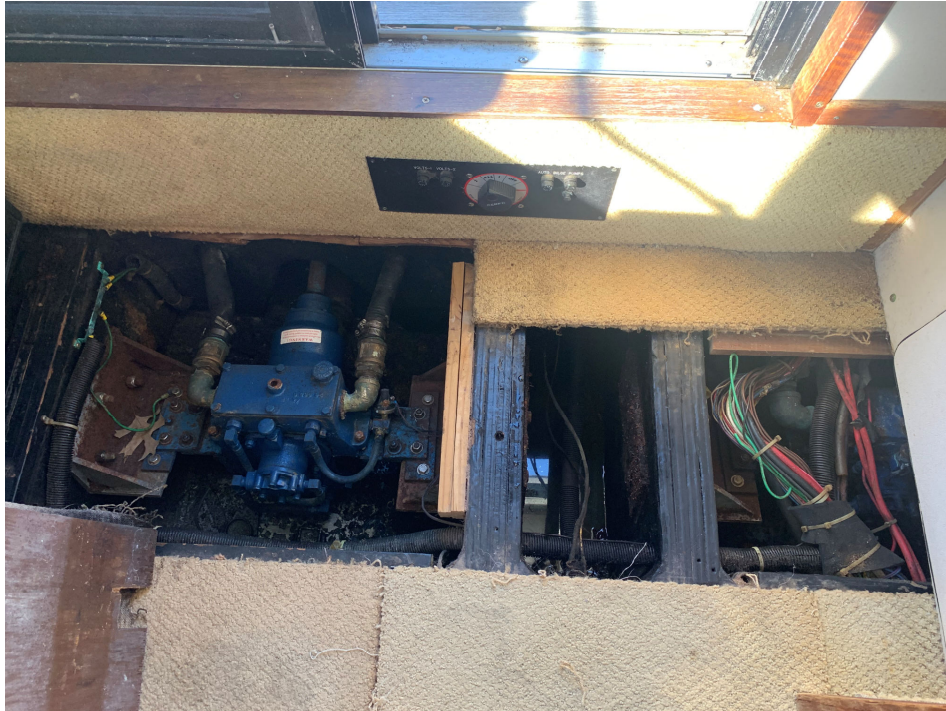
Hatches in the aft of the cabin allow for access to the Walter V drives, stuffing boxes, plumbing and mechanical spaces. These hatches should be sealed while the engine is operating. This compartment was soiled with standing water, corrosion was found throughout.

View of mechanical compartment in cabin

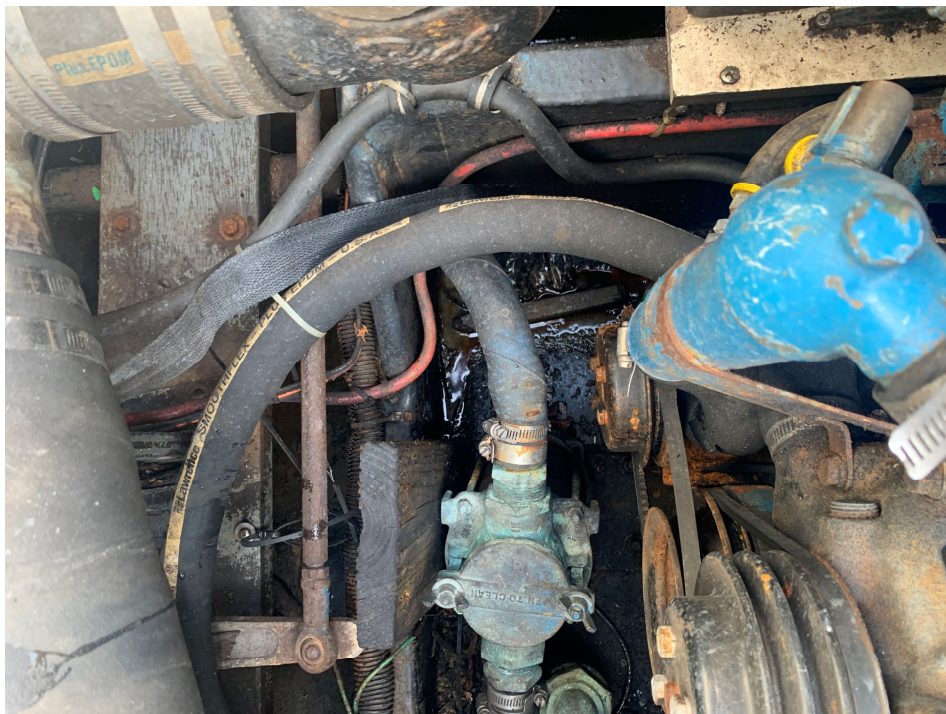
The large hatches were removeable for access to the engine compartment. The hatches were untethered. The engine compartment was found disorderly and soiled with standing oily water in the bilge. Corrosion was found throughout.

The model and serial numbers were not visible on the Crusader V8 fresh water cooled engines. The engines were mounted on steel engine brackets. Moderate corrosion was found on the engines and the engine mounts throughout. The cooling water entered the vessel through seacocks with raw water strainers. The hoses were cracked and weathered, replacement of the raw water cooling hoses is required. Full service is recommended.

Downward facing view of plumbing and bilge in engine compartment
