MARINE SURVEY REPORT ABOARD THE VESSEL

2007 MacKenzie Cuttyhunk 26 Bassboat *Scuppers*

MARINE SURVEY INSPECTION & REPORT CONDUCTED BY

FILE NUMBER & STATUS	No. 1599 Complete As Of 06/13/2025
MARINE SURVEY TYPE & DATE OF INSPECTION(S)	Condition & Valuation Survey 06/09/2025
MARINE SURVEY REPORT PREPARED EXCLUSIVELY FOR	[REDACTED]
VESSEL YEAR, MAKE, MODEL & HULL IDENTIFICATION NUMBER	2007 MacKenzie Cuttyhunk 26 Bassboat HIN: USZ00117G707
VESSEL NAME & HAILING PORT	<i>Scuppers</i> <i>Wando, SC</i>
USCG DOCUMENTATION NUMBER, GROSS & NET TONNAGE	No. 1202715 9 GRT & 7 NRT
MARINE SURVEY INSPECTION & SEA TRIAL LOCATION(S)	[REDACTED], Charleston, South Carolina 29492 N/A
MARINE SURVEY DAY WEATHER & SEA STATE CONDITIONS	85°F, mostly sunny, dry, wind SW @ 8 MPH, fair visibility, 76°F seawater, flood tide and calm sea state
VESSEL DESIGNER, BUILDER & HULL NUMBER	Ernest J. MacKenzie MacKenzie Cuttyhunk Boat Company Fall River, Massachusetts, USA
HULL MATERIAL, VESSEL TYPE, RIG TYPE & TOTAL SAIL AREA	Mahogany and White Oak wood monohull deep-V cuddy cabin bass powerboat

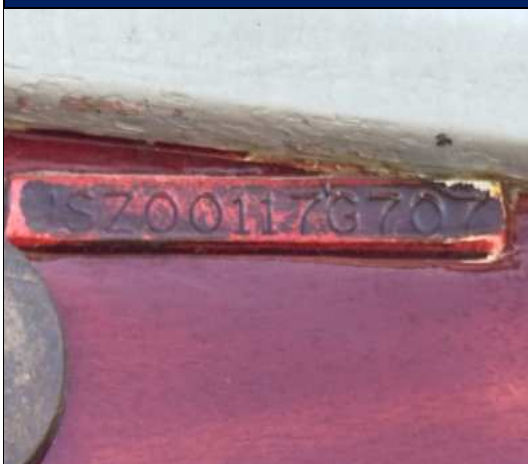
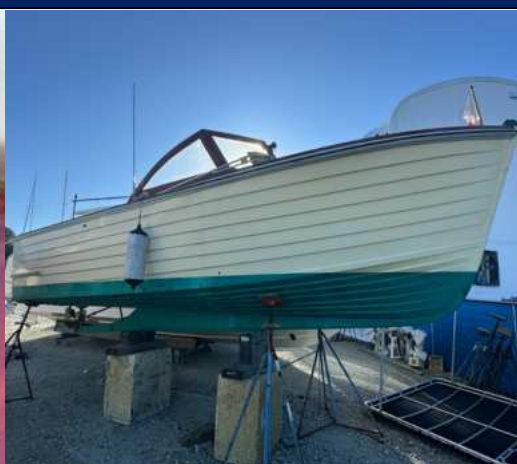
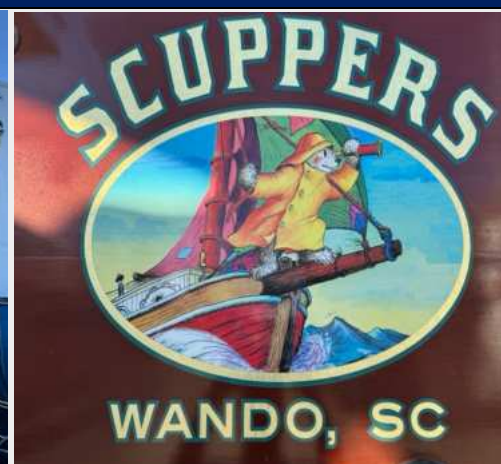
Hull identification number (HIN: USZ00117G707) shown on the 26B and the vessel was surveyed in Charleston, South Carolina on 06/09/2025

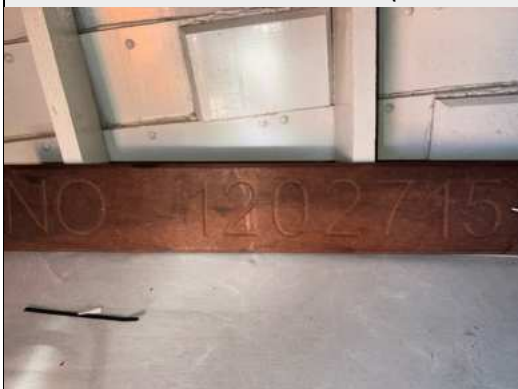
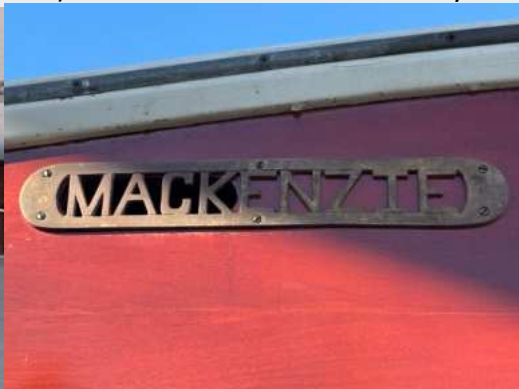
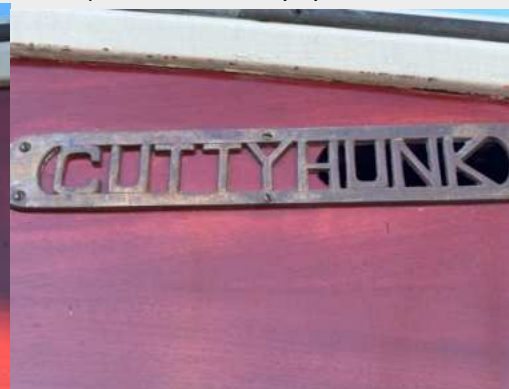
US Coast Guard Documentation Number shown in the cuddy cabinhouse interior (No. 1202715)

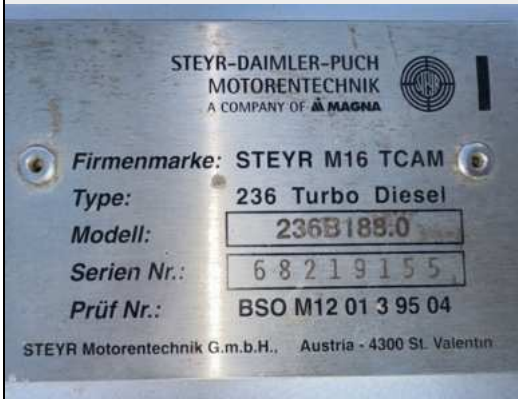
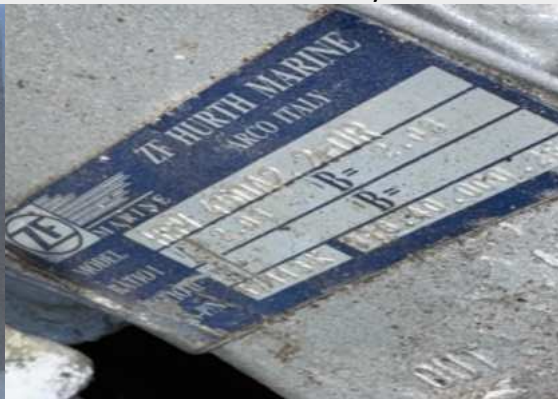
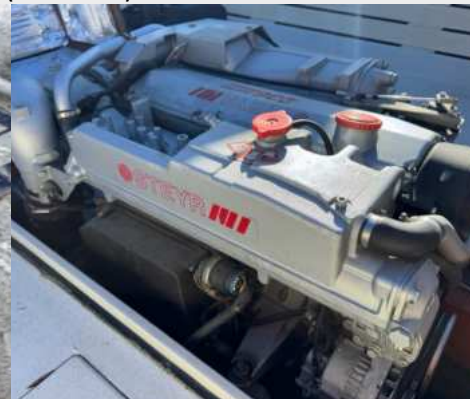
Steयर engine and ZF Hurth marine transmission serial number plates

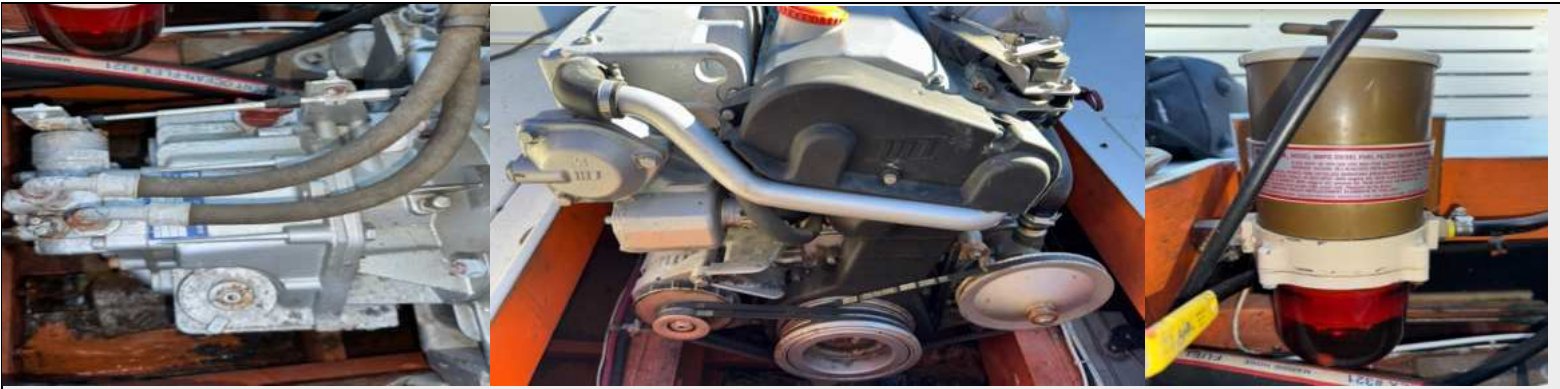
Engine room, Steyr 212HP diesel engine and ZF Hurth marine transmission and Racor diesel fuel-water separating with sightbowl are in serviceable shape

ENGINE CONDITION, ENGINE ROOM SPACE, SOUND INSULATION & BLOWER SYSTEMS The Steyr 212HP diesel engine, ZF Hurth marine transmission, engine oil, coolant, transmission fluid and all propulsion systems are in practical shape without fatal pitting, metal wear, fatigue, pinking to the metals, galvanic or stray current corrosion or active fluid leaks throughout the cold-check visual inspection. The engine powerhead, air filter, oil fill, oil lines, oil cooler, dipstick, oil pan, valve covers, spin-on fuel/oil filters, inline fuel filters, flywheel, timing belt, pulleys, belt tensioner, exhaust, manifold, rubber water hoses, fuel pumps, water pump, US Coast Guard approved type-A2 fuel lines, oil lines, gaskets, returns, shut-off valves, hoseclamps, seals, alternator, starter, conductors, harnesses, engine motor mounts, sacrificial zinc anodes and grounding wires are in useful shape without discovery. Engine oil, transmission fluid and coolant fluids are in working shape at suitable levels and not distinctively milky, watery, burnt or contaminated by noticeable metal wear, raw-water or fuel intrusion.

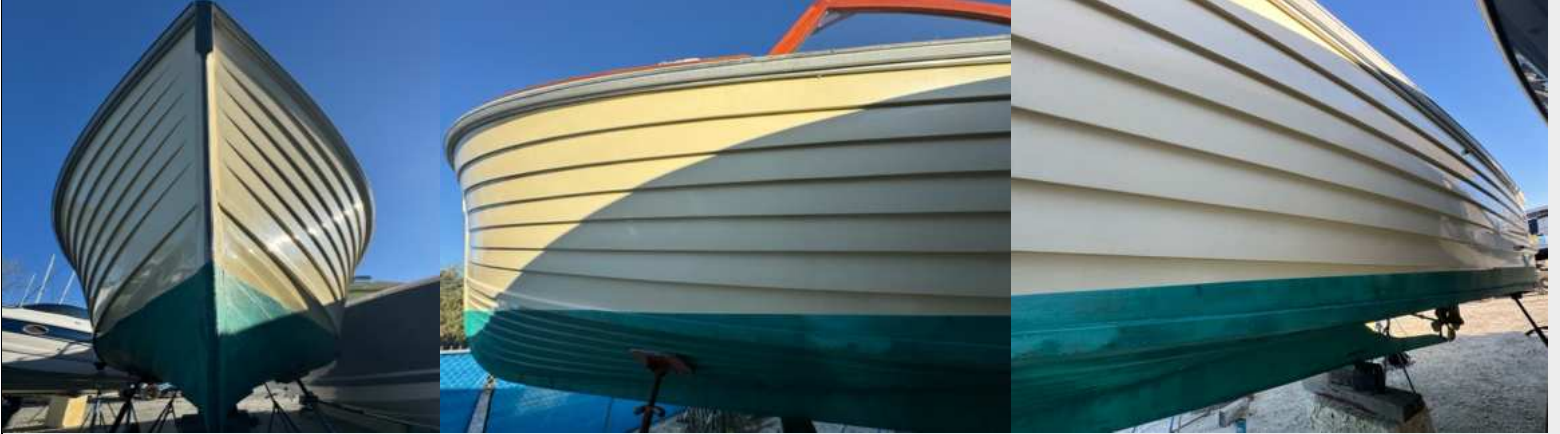
Port and starboard hull exterior, topsides, hulls wetted surface area, keel, stem, planks, fasteners and antifouling bottom paint are in satisfactory structural condition

HULL TOPSIDES, EXTERIOR FINISH, COATINGS, HULL-TO-DECK JOINT & SPRAY RAILS The port and starboard ¾" lapstrake Mahogany and White Oak wood lemon yellow painted hull topsides, coatings, bronze and galvanized iron fasteners and coatings are in serviceable physical and cosmetic shape, well-supported, well-secured and structurally sound for a vessel of this age, size and use. Hull topsides were analyzed for structural loss, deterioration and detached bonding without discovery. Percussion soundings, moisture and thermal readings were verified. Zero indicators of dry-rot, delamination, soft-spots, water intrusion, saturation, voids, acute physical impacts, stress cracks, decay, rot, fractures, pitting, haloing, saltwater corrosion, rust, oxidation, osmotic or paint blistering was discovered. The hull topsides and exterior finish are noticeably clean. **Routine, customary and average cosmetic wear and tear is present throughout the port and starboard ¾" lapstrake Mahogany and White Oak wood lemon yellow painted hull topsides including minor UV oxidation and isolated flaking paint.***

HULLS WETTED SURFACE AREA, CHINE, BOTTOM PAINT & BARRIER COAT The ¾" lapstrake Mahogany and White Oak wood hulls wetted surface area, chine and marine grade antifouling bottom paint are in practical physical and cosmetic shape, well-secured and structurally sound without grounding damage. The green ablative marine grade antifouling bottom paint is in bristol shape and ~15% wasted without bare spots, thinly coated areas, paint blisters, water intrusion or marine growth. Age and layup process of the bottom paint is unknown.

- 4. Routine, customary and average cosmetic wear and tear is present throughout the port and starboard ¾" lapstrake Mahogany and White Oak wood lemon yellow painted hull topsides including minor UV oxidation and isolated flaking paint.** Routinely detail and renew cosmetic finish of the hull exterior and topsides as needed.
- 5. Kidde multipurpose dry chemical portable fire extinguisher in the interior is missing an annual inspection tag.** Annually inspect and tag.

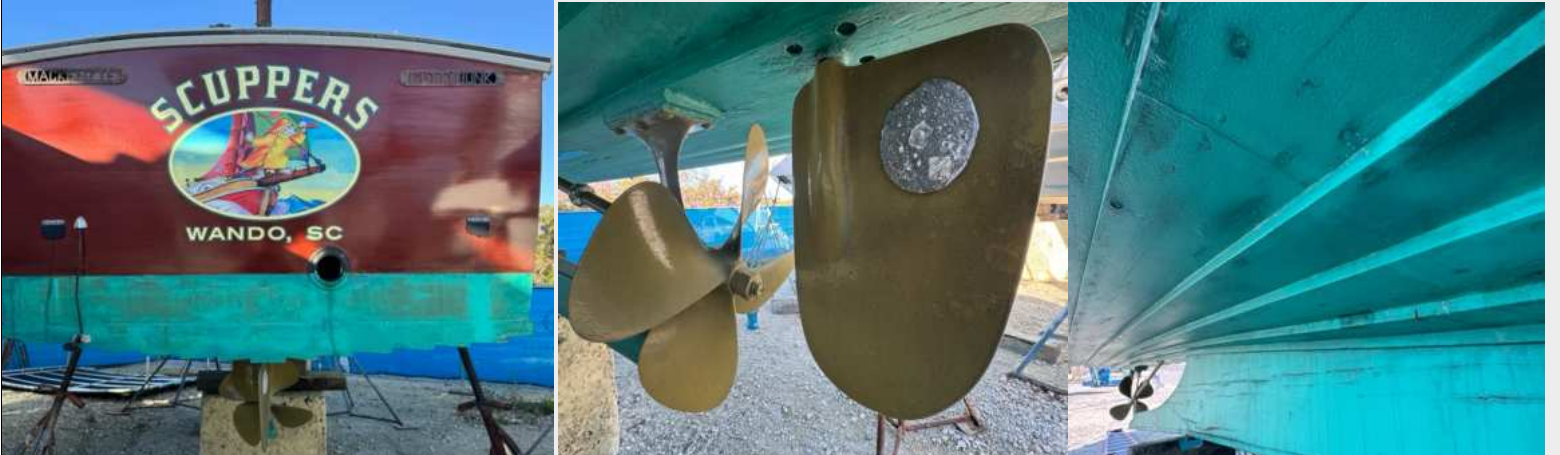
Transom, engine wet-exhaust, sonar transducer, scuppers, 1.25" stainless-steel propeller shaft, strut, cutlass bearing, 4-blade propeller and rudder are in practical shape

PROPELLER SHAFT LOG, STRUT, CUTLASS BEARING & SKEG The single propeller shaft log, bronze strut and cutlass bearing are in serviceable structural condition without grounding damage or other wear and tear discovered and the propeller shaft spun freely without difficulty.

PROPELLER QUANTITY, SIZE & MATERIAL The single bronze 4-blade 18" diameter x unverified pitch propeller, barrel, hub, blades, tips, propeller nuts and cotter pin are in satisfactory condition without visible wear and tear, stray current corrosion, pitting or marine growth.

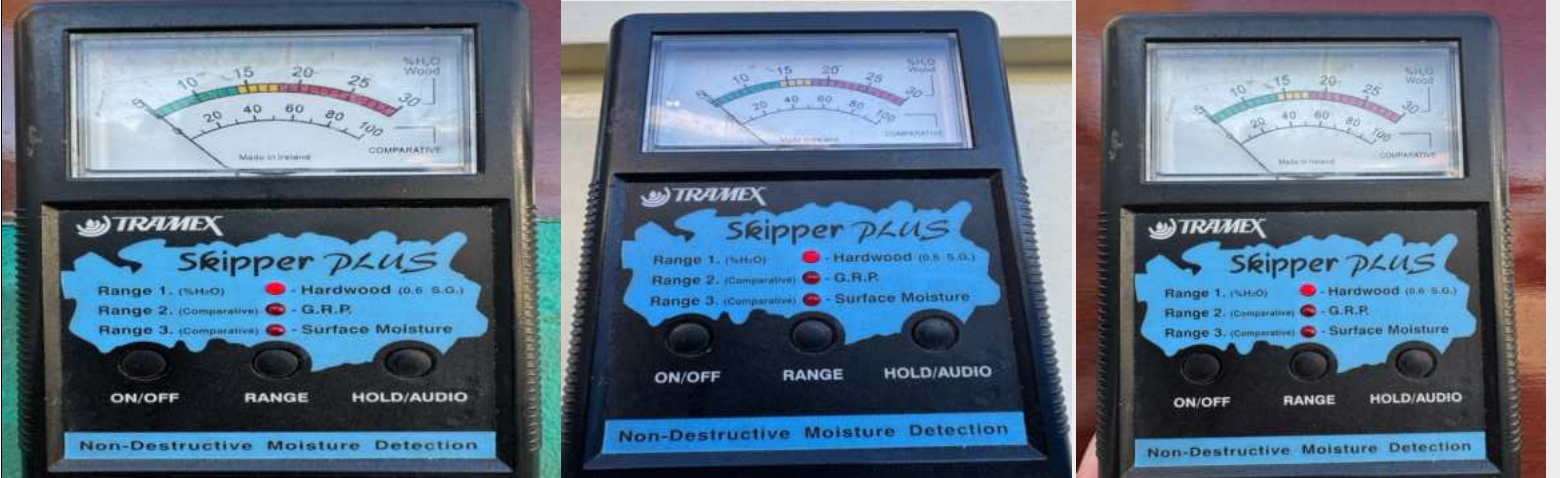
Dry TRAMEX moisture readings were taken on the hull exterior, interior, on deck and structural support members, where accessible

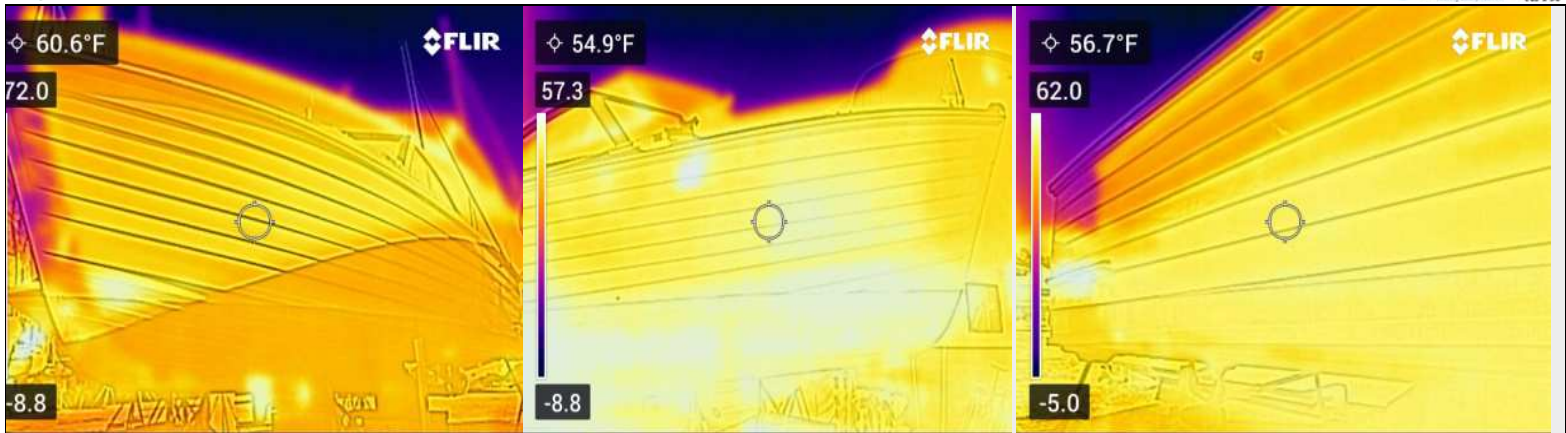
Dry FLIR thermal readings were taken on the hull exterior, interior, on deck and structural support members, where accessible

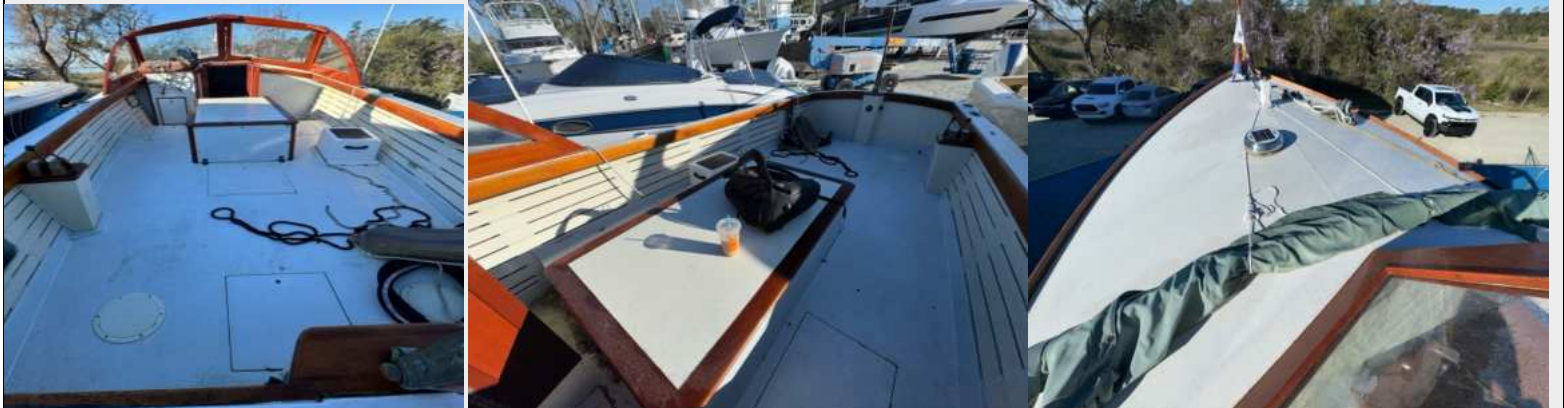
Cockpit, sole, gunwales, coaming, glass windshield panels, engine box, aft control box, foredeck, bimini and cabinhouse are in serviceable condition and structurally sound

WINDSHIELD, WIPERS, BIMINI, DODGER & SUNSHADE The 2x glass windshield panels, tracks, framing, gaskets and bimini with supports are in serviceable structural condition without cracks, water intrusion or other wear.

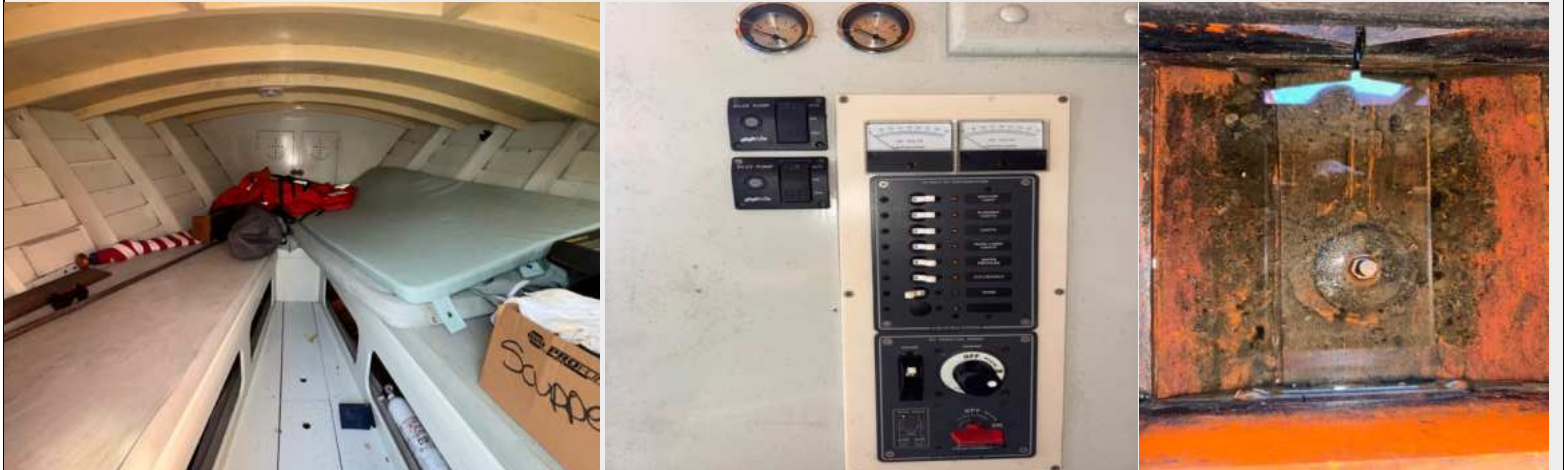
Cuddy cabinhouse interior, cushions, 2x diesel fuel tank level gauges, 2x 12V DC Rule-Mate bilge pump, 12V DC power distribution panel and bilges are in practical shape

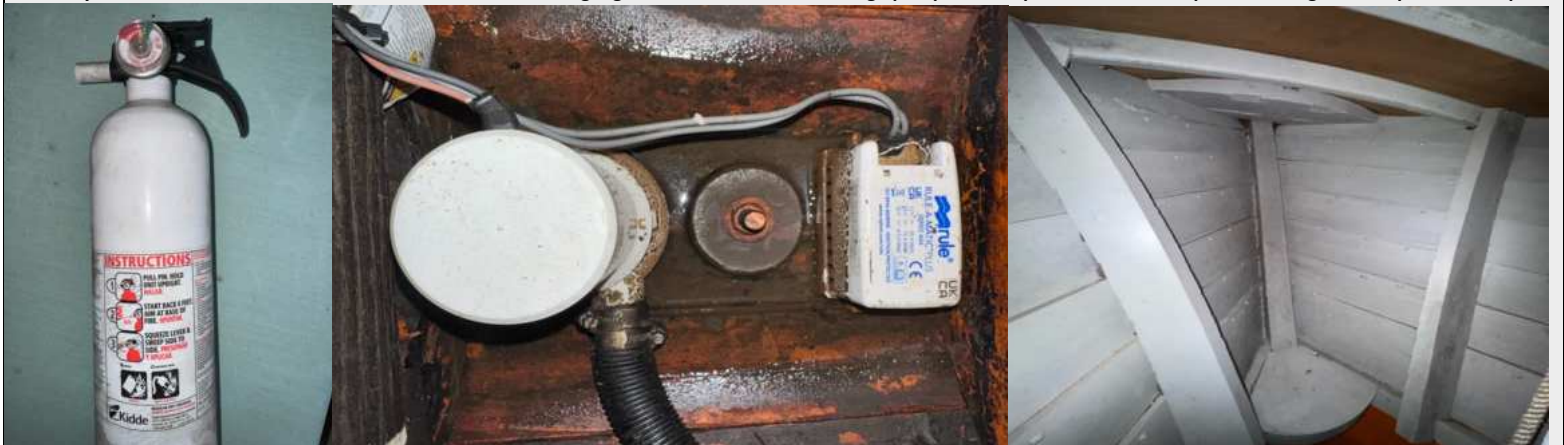
Kidde dry chemical portable fire extinguisher is fully-charged, 2x 12 DC Rule-Mate 2,000 gallon-per-hour bilge pumps and float switches power on chainlocker is secured

FIRE PREVENTION & SUPPRESSION SYSTEMS The single Kidde multipurpose dry chemical multipurpose portable fire extinguisher kept in cuddy cabinhouse interior is in serviceable shape and fully charged. **Kidde multipurpose dry chemical portable fire extinguisher in the interior is missing an annual inspection tag. Zero engine room fire suppression systems, fire blankets and fire axes are installed.***

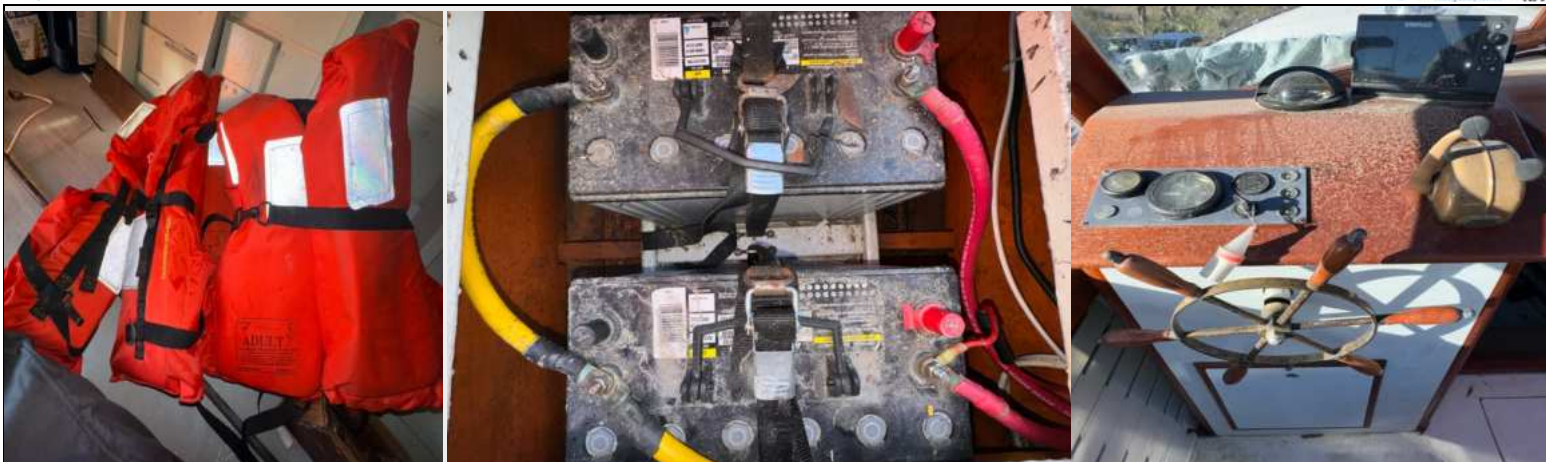
4x US Coast Guard approved type-I adult offshore lifejackets, 2x 12V DC Power-Tec Group 31 AGM batteries and helm station are in serviceable condition

BATTERY QUANTITY, AGE, DC SYSTEM VOLTAGE, TYPE & COVERS There are 2x total 12V batteries installed onboard in the aft cockpit bilge forward of the engine. The 2x 12V DC Power-Tec 8A31DTM Group Size 31 AGM 1,000MCA 800CCA black MacKenzie Cuttyhunk Boat Company house bank and Steyr engine starting batteries, bins, conductors, terminal posts, covers and connections are in serviceable shape, power up and voltage was strong on survey day (~13.6V DC). Ages, internal conditions and service histories of the batteries are unverified.

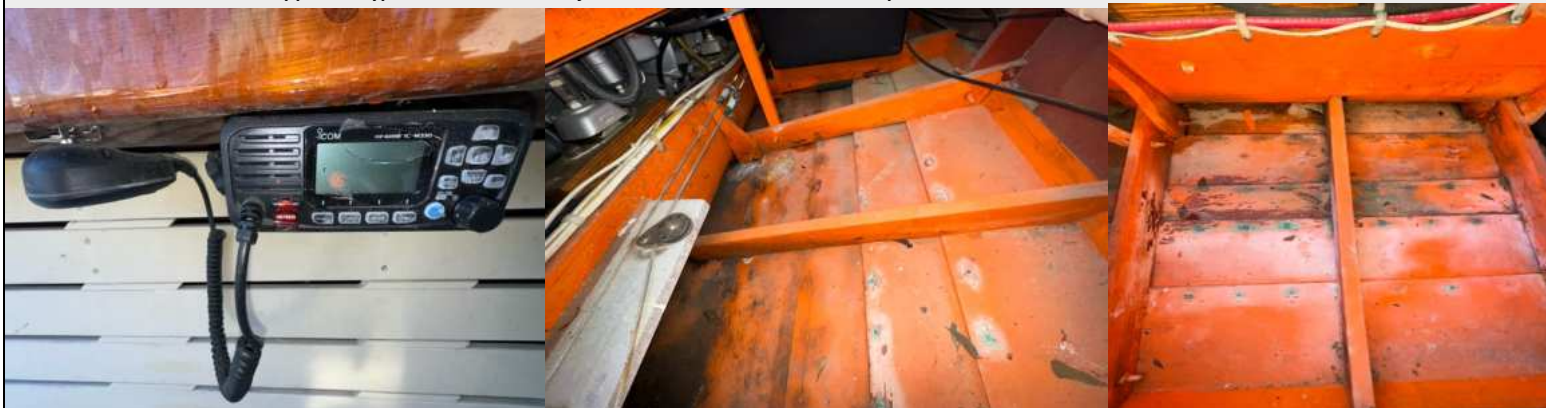
12V DC ICOM IC-M330 fixed VHF marine radio powers on, planks, fasteners, stringers, bulkheads and bilges are in serviceable condition without rot or saturation

AIS, MMSI, ANTENNA, LOUD Hailer, VHF MARINE & SSB RADIOS The 12V DC ICOM IC-M330 fixed VHF marine radio with mic to port of the helm station dash and VHF antenna is in serviceable overall condition, powers on and was successfully radio-checked by the surveyor on the Wando River. Zero AIS sending/receiving units, MMSI numbers, loud hailer, handheld VHF marine and SSB radios are installed.*
MAN OVERBOARD RESCUE, VIDEO, EPIRB & PLB SYSTEMS Zero man overboard rescue, video, EPIRB and PLB systems are installed.*
THERMAL IMAGING, NIGHT VISION, SATELLITE PHONE & WEATHER FORECAST SYSTEMS Zero thermal imaging, night vision, satellite phone and weather forecast systems are installed.*
WATERPROOF DITCH BAG, FIRST AID & TOOL KITS Zero waterproof ditch bag with supplies, first aid and marine tool kits are installed.*
REBOARDING LADDER, BOAT HOOK, PADDLE & TOW GEAR Zero reboarding ladders, boat hooks, paddles and tow gear are kept onboard.*

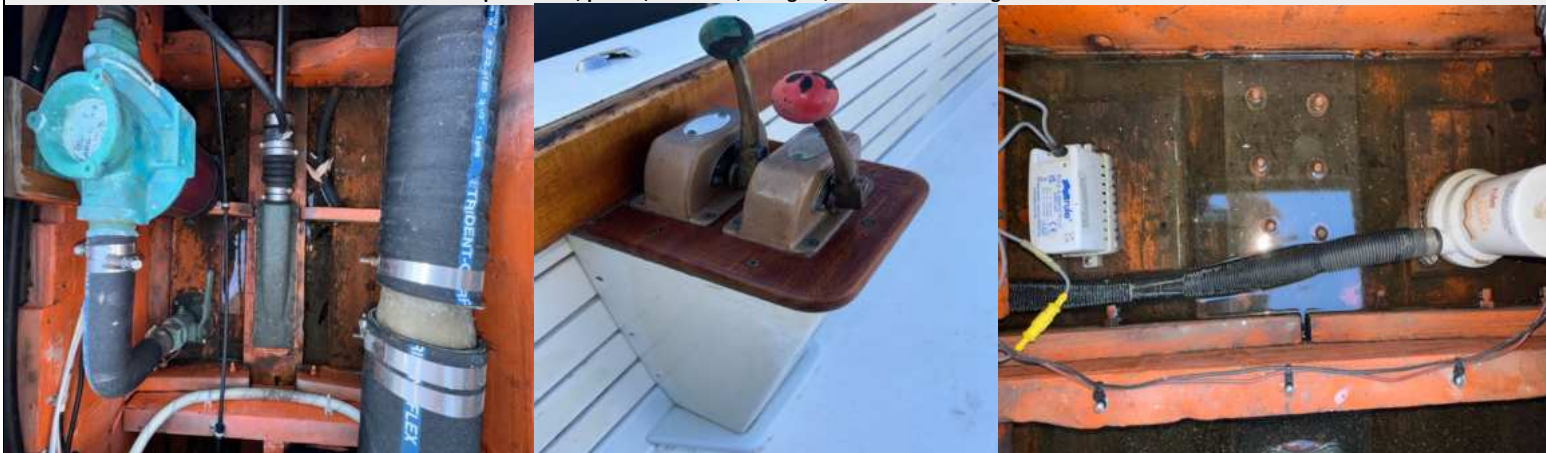
1.25" stainless-steel propeller shaft, propeller shaft seal, bronze thru-hulls, seacocks, sea-strainer, rubber hoses, hoseclamps, aft station and aft bilge pump power on

THRU-HULLS, BACKING PLATES, SEACOCKS, HOSES, HOSECLAMPS & SEA-STRAINERS The Groco bronze thru-hull for the Steyr 212HP diesel engine raw-water intake, seacock valves, 2x 12V DC Rule-Mate 2,000 gallon-per-hour bilge pump overboard discharges, backing plates, US Coast Guard approved rubber raw-water cooling system hoses and stainless-steel hoseclamps are in practical shape, unobstructed and operate normally, unless otherwise noted. All seacocks were able to be opened and closed by hand pressure without difficulty, noticeable leaks, haloing, pitting, corrosion, rust, oxidation, pinking to the metals, galvanic or stray current corrosion. Ages, internal conditions and service histories of the thru-hulls, backing plates, seacocks, hoses, hoseclamps and sea-strainers are unverified.

PROPELLER SHAFT, SHAFT SEAL, DRIPLESS STUFFING BOX & PACKING GLAND SYSTEMS The 1.25" stainless-steel propeller shaft, PSS dripless propeller shaft seal and components are in practical condition and operated routinely without corrosion or signs of leaks.

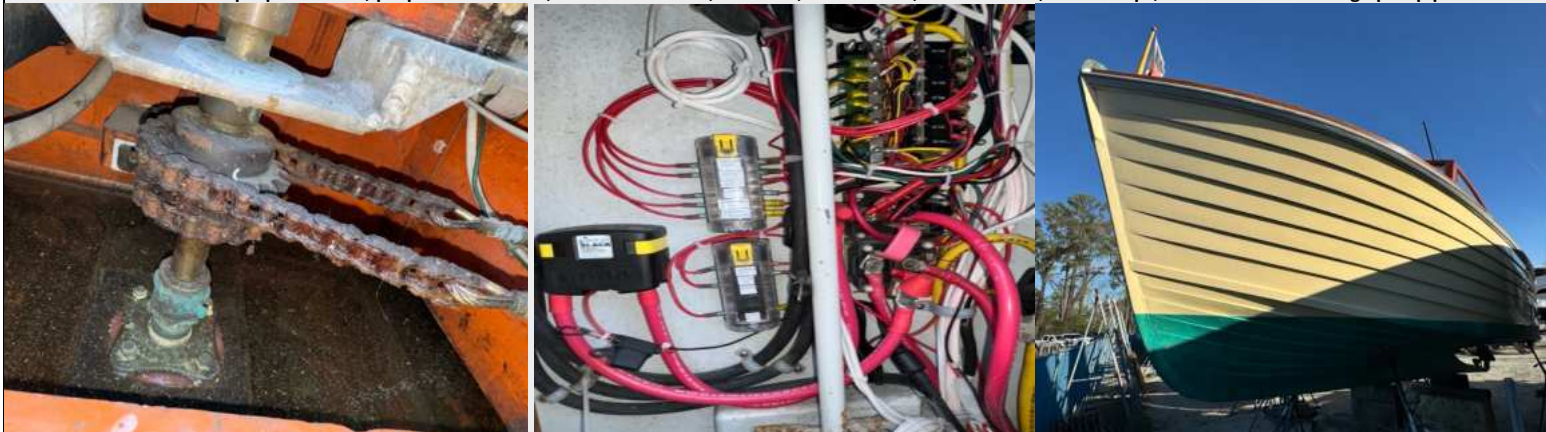
Rudder post, bearings, seals, rudder table, steering cables, chain, conductors and hull are in useful overall condition without wear and tear and well-secured

STEERING, AUTOPILOT & RUDDER ANGLE INDICATOR SYSTEMS The 15" 6-spoke teak and brass steering wheel with mechanical cable and chain driven steering system are in satisfactory condition and the helm turns over side-to-side smoothly without corrosion, slipping, vibrations, difficulty, resistance, knocking or interruption. Age, internal condition and service history of the steering system is unverified.

RUDDER, TABLE, POST & EMERGENCY TILLER SYSTEMS The single bronze spade-type rudder, rudder table, rudder post, bearings and seals are in serviceable condition without visible wear and tear or defects.
