**REPORT OF SURVEY
CONDITION AND VALUE SURVEY
FOR UNDERWRITERS CONSIDERATION**

FILE NUMBER: 25235R

VESSEL NAME : REEL SWEET

MODEL : Luhrs 290 Tournament

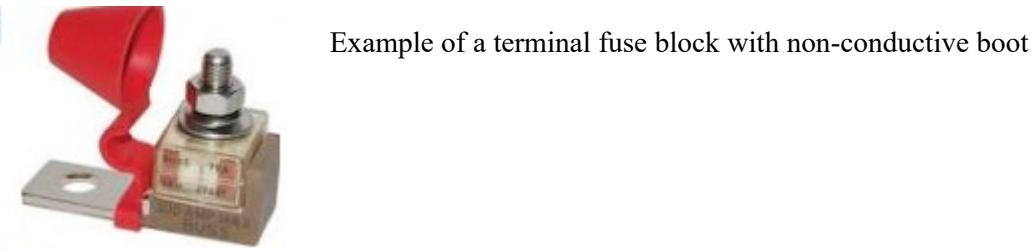
The two engine start batteries were noted to be properly secured in dedicated trays, with not conductive boots over the positive terminal posts. The single AGM house battery was secured from shifting however was in need of non-conductive boots over the positive terminal posts and was found to be absent overcurrent protection. The wiring harness accessible in the machinery spaces was found to be well led and secure. The wiring behind the panel was also noted to be in good condition, with upgraded electronics wiring harness and fuse panel. All bilge pumps, bilge exhaust blowers, navigation lights and associated systems were energized. The submersible bilge pump in the stern was operable in the manual override position however was not operable in the automatic mode, in need of repair as necessary. The shore power system was noted to be in good visual condition, fitted with ground fault protection (GFCI).

4* The house battery bank is in need of terminal fuse block. According to ABYC E-11.10.1.1.1 Over current Protection device Location-Ungrounded conductors shall be provided with overcurrent protection device(s) within a distance of 7 inches (178mm) of the point at which the conductor is connected to the source of power measured along the conductor.

Example of a terminal fuse block with non-conductive boot

It was also noted that the battery cables are secured with wing nuts which are no longer compliant with the latest version of **ABYC** Standard E-10 Section E-10, paragraph 10.7.7, etc. permits that an ungrounded battery terminal can be covered by a boot or non-conductive shield.
