True Blue Marine, LLC

REPORT OF MARINE SURVEY

“EOS”

1978 Tartan 30

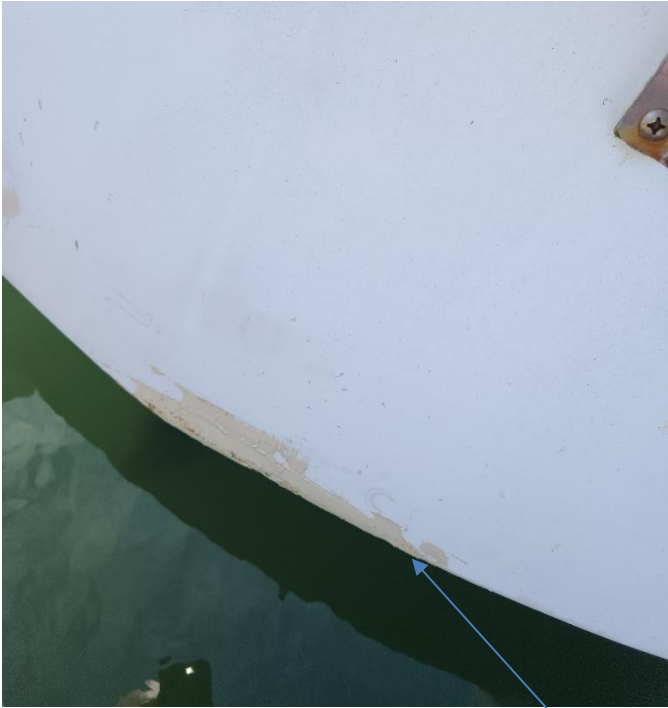
- There has been a poorly done repair at the bottom of the transom which is only a cosmetic issue. Also, there are minor gelcoat cracks on the port side of the transom. (Pic #1)

1. There has been a poorly done repair at the bottom of the transom which is only a cosmetic issue. Also, there are minor gelcoat cracks on the port side of the transom. (Pic #1)

Pic #1 There has been a poorly done repair at the bottom of the transom which is only a cosmetic issue. Also, there are minor gelcoat cracks on the port side of the transom.

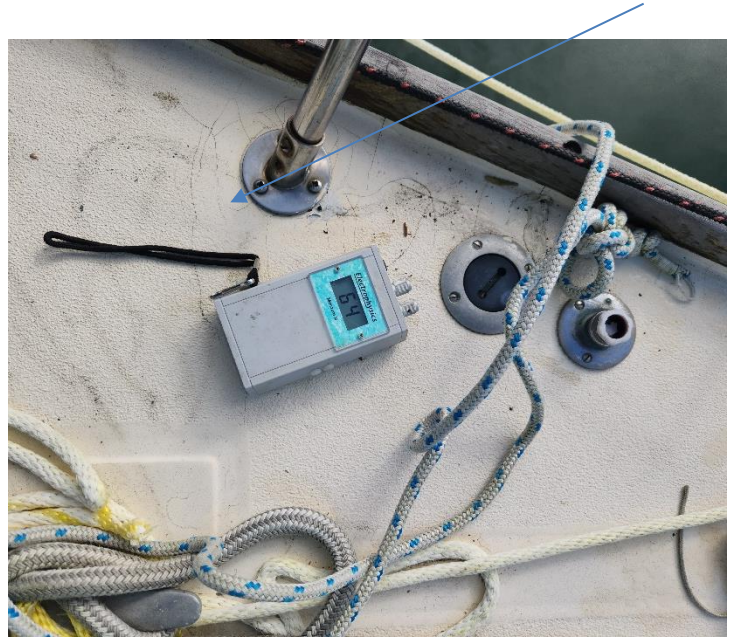
- The plexiglass fixed cabin windows have some ultraviolet craze cracking in the acrylic lenses.
- The foredeck has elevated moisture levels on the forward most 4 feet of the deck and gelcoat cracking around the bow rail bases. (Pic #2)

2. The plexiglass fixed cabin windows have some ultraviolet craze cracking in the acrylic lenses.
3. The foredeck has elevated moisture levels on the forward most 4 feet of the deck and gelcoat cracking around the bow rail bases. (Pic #2)

Pic #2 The foredeck has elevated moisture levels on the forward most 4 feet of the deck and gelcoat cracking around the bow rail bases.

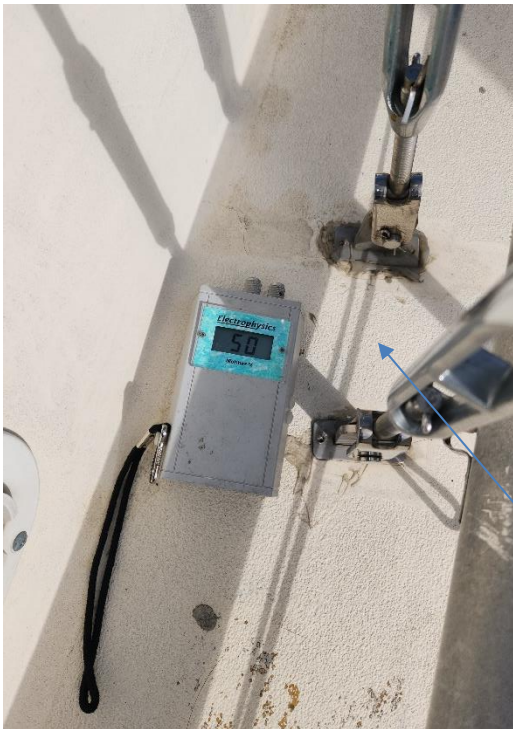
- The port side deck has highly elevated moisture levels in a 4 foot area in the midship area where the fuel fill, chain plate covers and stanchion base are located. This area sounds slightly soft in some areas with minor delamination. There are also gelcoat cracks around the chain plate covers. (Pic #3)

4. The port side deck has highly elevated moisture levels in a 4 foot area in the midship area where the fuel fill, chain plate covers and stanchion base are located. This area sounds slightly soft in some areas with minor delamination. There are also gelcoat cracks around the chain plate covers. (Pic #3)

Pic #3 The port side deck has highly elevated moisture levels in a 4 foot area in the midship area where the fuel fill, chain plate covers and stanchion base are located. This area sounds slightly soft in some areas with minor delamination. There are also gelcoat cracks around the chain plate covers.

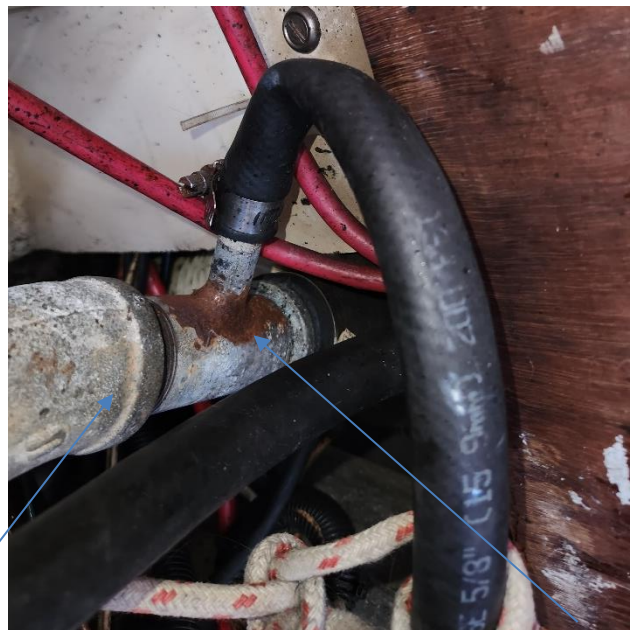
- The positive terminal post on the engine starter needs a protector rubber boot installed to comply with ABYC standards.
- The sections of exhaust pipe from the exhaust manifold to the exhaust hose is made of galvanized steel and should be replaced with either stainless steel, bronze or cast iron. Galvanized steel is not made to work with high temperatures and the heat combined with dissolved salts can create acids which can corrode the pipe from the inside. The forward section with the barb for the vented loop tee'd into it is already showing signs of corrosion. (Pic #4)

3. The positive terminal post on the engine starter needs a protector rubber boot installed to comply with ABYC standards.
4. The sections of exhaust pipe from the exhaust manifold to the exhaust hose is made of galvanized steel and should be replaced with either stainless steel, bronze or cast iron. Galvanized steel is not made to work with high temperatures and the heat combined with dissolved salts can create acids which can corrode the pipe from the inside. The forward section with the barb for the vented loop tee'd into it is already showing signs of corrosion. (Pic #4)

Pic #4 The sections of exhaust pipe from the exhaust manifold to the exhaust hose is made of galvanized steel and should be replaced with either stainless steel bronze or cast iron. Galvanized steel is not made to work with high temperatures and the heat combined with dissolved salts can create acids which can corrode the pipe from the inside. The forward section with the barb for the vented loop tee'd into it is already showing signs of corrosion.

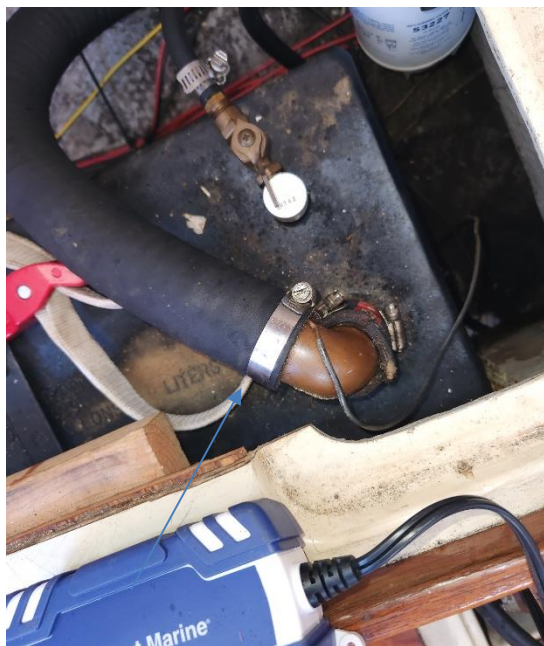
- The fuel tank fill hose is only single clamped at the tank and it is a federal requirement that fuel fill hoses are double clamped. Add clamps as needed. (Pic #5)

Pic #5 The fuel tank fill hose is only single clamped at the tank and it is a federal requirement that fuel fill hoses are double clamped. Add clamps as needed.

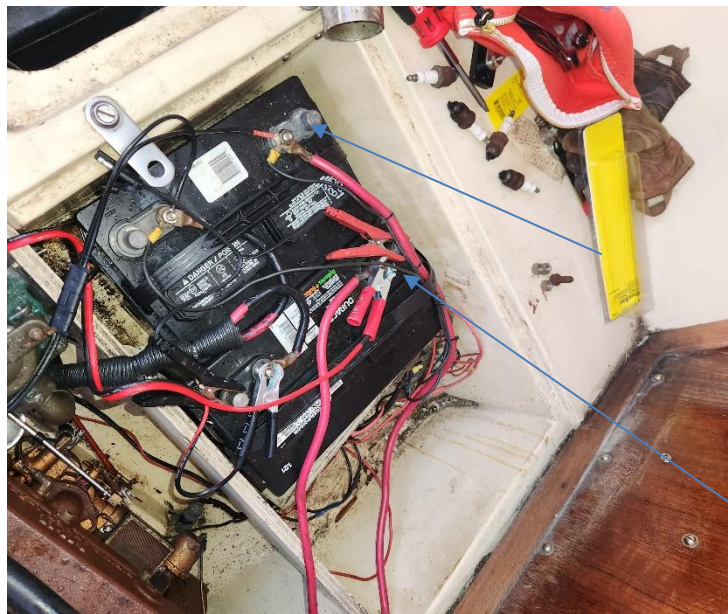
- Both batteries need protective rubber boots installed on the positive battery posts to comply with ABYC standards. (Pic #6)
- The terminal block in the battery compartment is loose and needs to be properly secured.
- Both batteries need to be better secured. ABYC standard E-10.7.4 states, "Batteries, as installed shall be restrained to not move more than one inch (25mm) in any direction when a pulling force of twice the battery weight is applied through the center of gravity of the battery."

6. Both batteries need protective rubber boots installed on the positive battery posts to comply with ABYC standards. (Pic #6)
7. The terminal block in the battery compartment is loose and needs to be properly secured.

Pic #6 Both batteries need protective rubber boots installed on the positive battery posts to comply with ABYC standards.

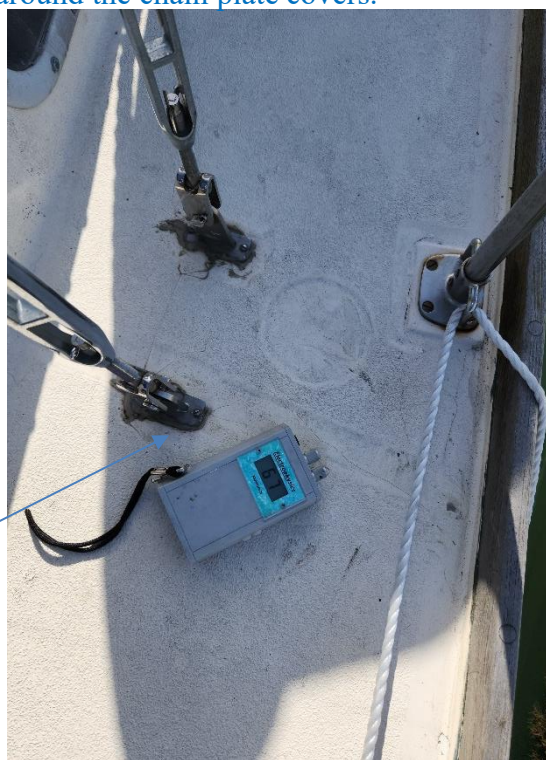
- There is another area on the port side deck between the two salon windows that has minor delamination in a 1 foot by 2 feet area.
- There are elevated moisture levels and delamination on the starboard side deck in a 4 foot area midship near the chain plates with minor gelcoat cracks around the chain plate covers.

5. There is another area on the port side deck between the two salon windows that has minor delamination in a 1 foot by 2 feet area.
6. There are elevated moisture levels and delamination on the starboard side deck in a 4 foot area midship near the chain plates with minor gelcoat cracks around the chain plate covers. (Pic #7)

Pic #7 There are elevated moisture levels and delamination on the starboard side deck in a 4 foot area midship near the chain plates with minor gelcoat cracks around the chain plate covers.

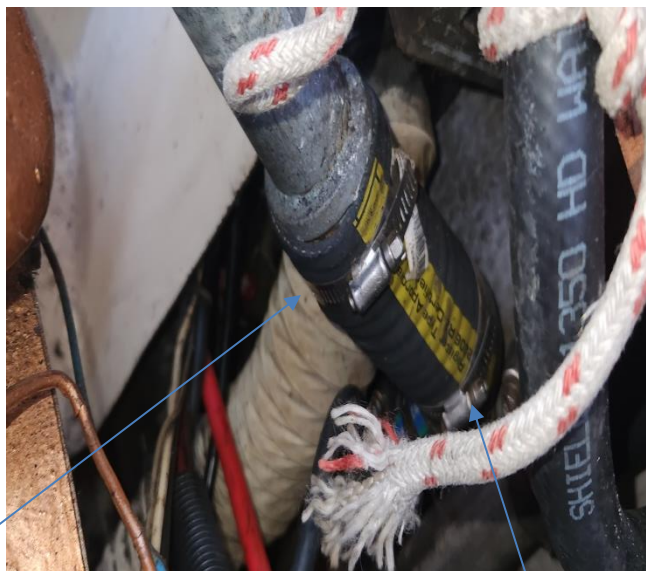
- All of the exhaust hoses are only single clamped. It is a federal requirement they be double clamped. Add clamps as needed.

Pic #8 All of the exhaust hoses are only single clamped. It is a federal requirement they be double clamped. Add clamps as needed.
