**1981 Nordic 44'**

***Traveler***

## **Report of Marine Survey**

SURVEY PREPARED FOR:.....	██████████
DATE OF SURVEY:.....	June 24, 2025
TYPE OF SURVEY:.....	Condition and Valuation Survey
PLACE OF SURVEY:.....	██████████
	Cheboygan, Michigan
VESSEL MANUFACTURE:.....	Nordic Yachts INC.
YEAR/MAKE/MODEL OF	
VESSEL:.....	1981 Nordic 44'
VESSEL NAME:.....	<i>Traveler</i>
HULL IDENTIFACATION	
NUMBER (HIN):.....	NYA441140581
UNITED STATES COAST	
GUARD DOCUMENTATION	
NUMBER:.....	653648
ESTIMATED MARKET VALUE:.	\$100,000.00
ESTIMATED REPLACEMENT	
COST:.....	\$880,500.00
HULL MATERIAL:.....	FRP
HULL TYPE:.....	Monohull
KEEL TYPE:.....	Fin Keel
LENGTH, OVERALL (L.O.A):.....	43' 10"
BEAM:.....	12' 11"
DRAFT:.....	7' 0"
DISPLACEMENT:.....	24000lbs
BALLAST.....	9340lbs
PROPULSION SYSTEM:.....	Yanmar 50hp diesel engine
FUEL TYPE:.....	Diesel
AC POWER:.....	120VAC 30AMP
DC POWER:.....	12VDC
INTENDED USE:.....	Not known at the time of the survey inspection
INTENDED CRUISING AREA:.....	To be determined by the underwriter

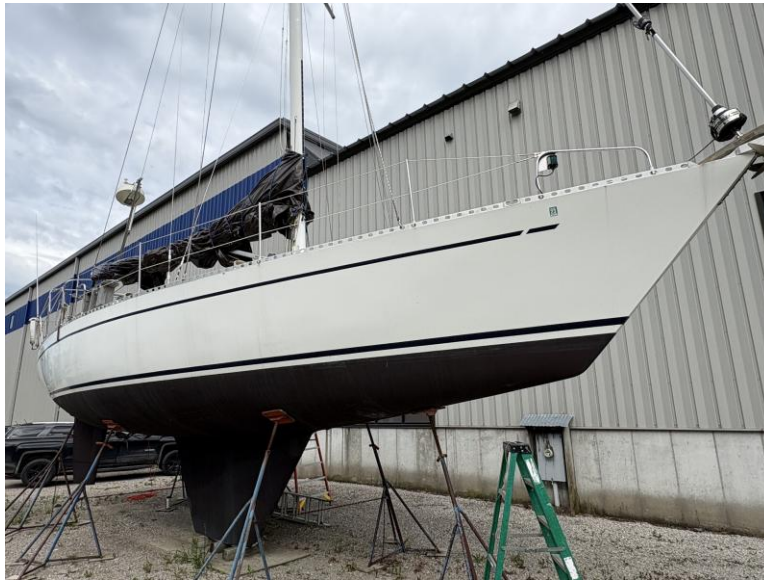
**Topsides:** The topsides were inspected for elevated levels of moisture and delamination. The topsides do not contain any delamination or elevated levels of moisture. General wear scratches sighted in areas. In good condition.

Starboard topside.

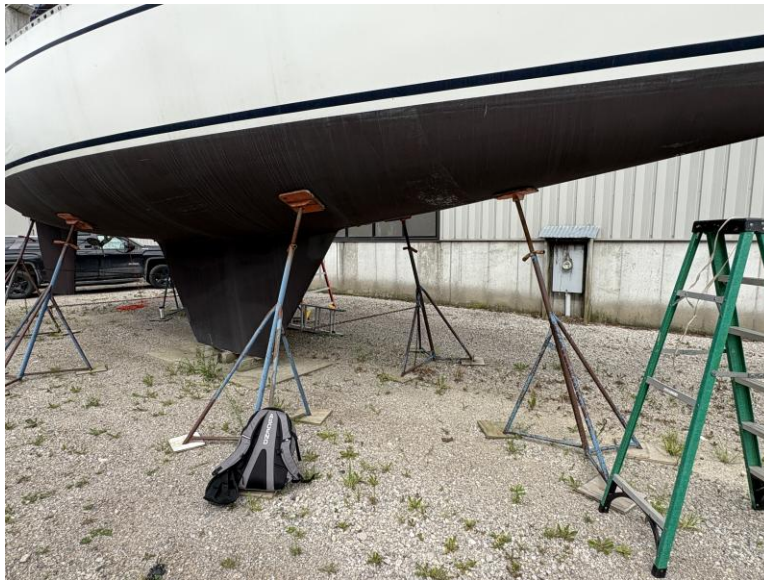
**Wetted Surface:** The wetted surface was inspected for elevated levels of moisture and delamination. The wetted surface does not contain any delamination or elevated levels of moisture. In good condition.

Starboard side wetted surface.

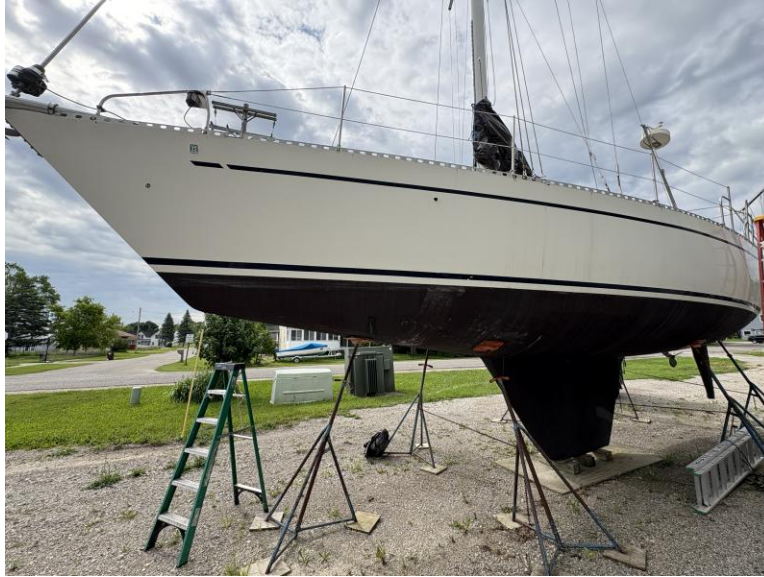
Port topside.

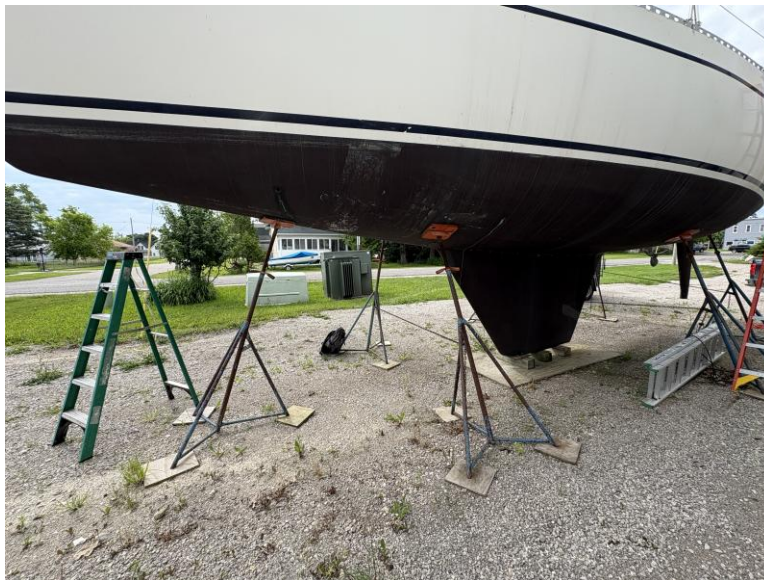
Port side wetted surface.

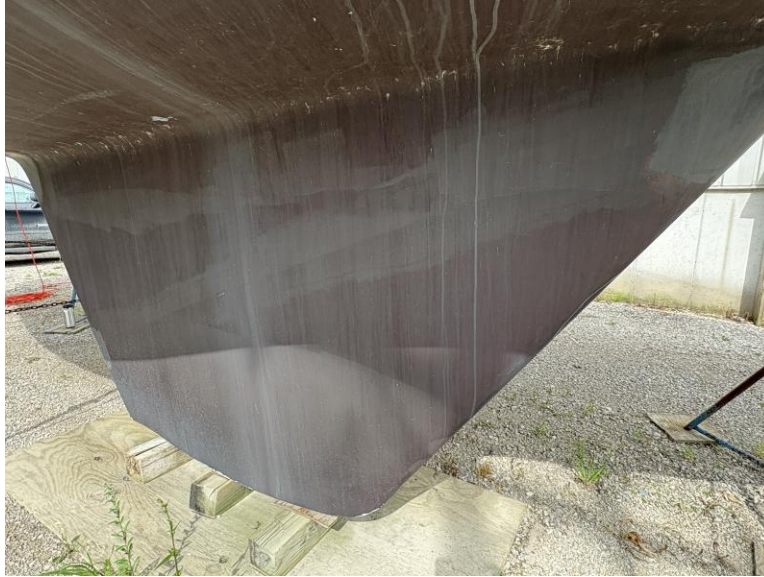
**Keel External:** The hull to keel joint and the surfaces of the keel were visually inspected from the exterior of the vessel. The hull to keel joint does not contain any separation along the port and starboard sides of the keel. In good condition.

Starboard side keel to hull joint.

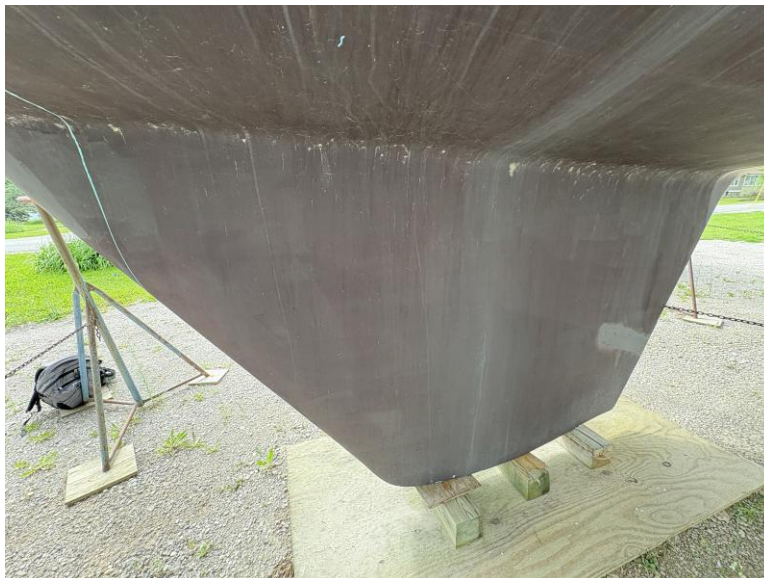
Port side keel to hull joint.

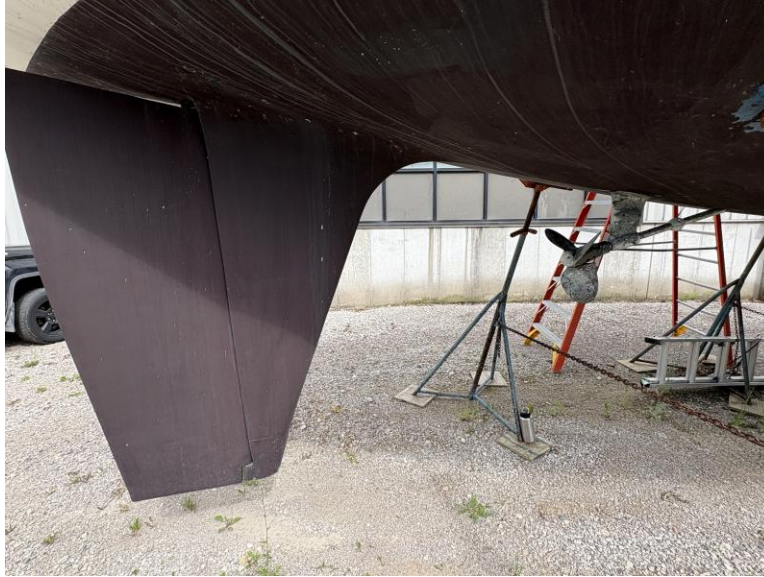
**\*Rudder:** The rudder was inspected for elevated levels of moisture and delamination. The rudder does not contain any sounds consistent with delamination. Elevated levels of moisture were noted in the port and starboard sides of the rudder's structure. In good condition.

Rudder and propeller.

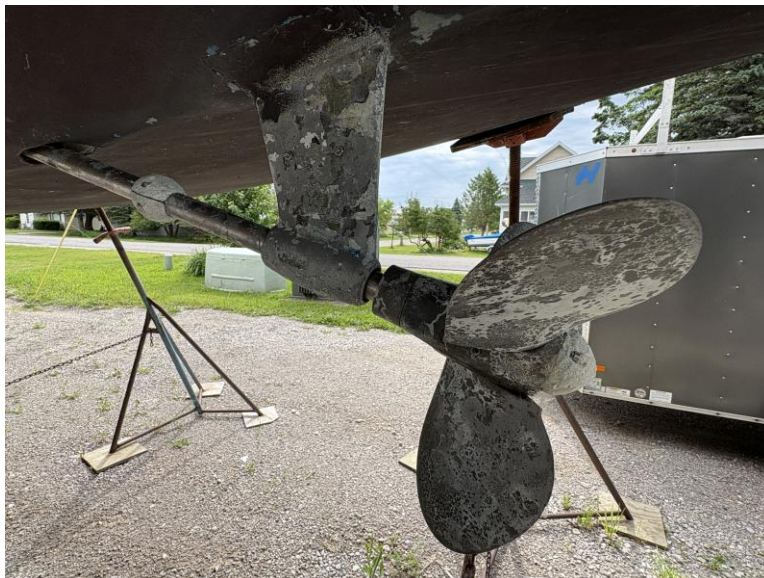
**Propeller:** Mfg: Not sighted. The propeller's size was not sighted on the propeller's housing. The propeller is a 3-blade feathering propeller. The propeller blades do not contain any damage. The propeller was turned by hand and operates well. In good condition.

Propeller.

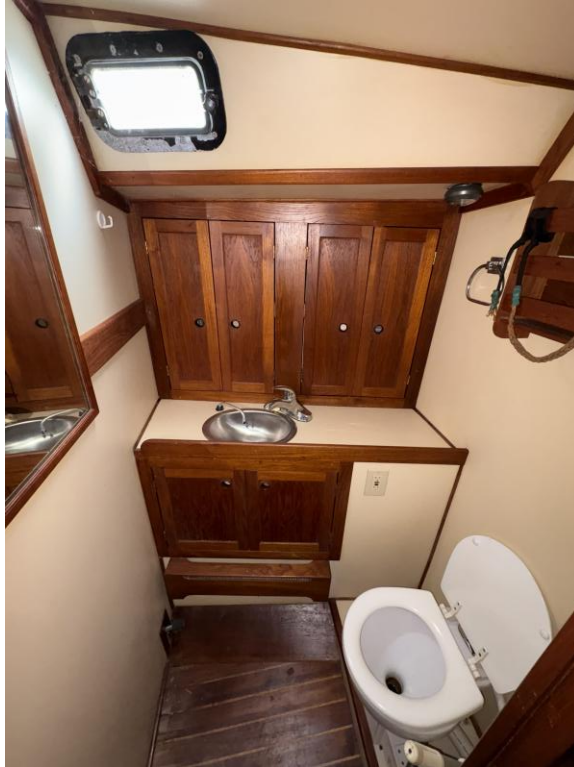
**\*Cabin Sole:** The cabin sole is wood. The wood sole contains damage in the forward head compartment. No other signs of damage in the interior of the vessel. There are access panels for getting into the lower bilge. In good condition.

Forward head compartment.
