# BRYAN SHROCK MARINE SURVEYING

1982 Marinette 28 Sportsman

# Report of Marine Survey

April 29, 2024

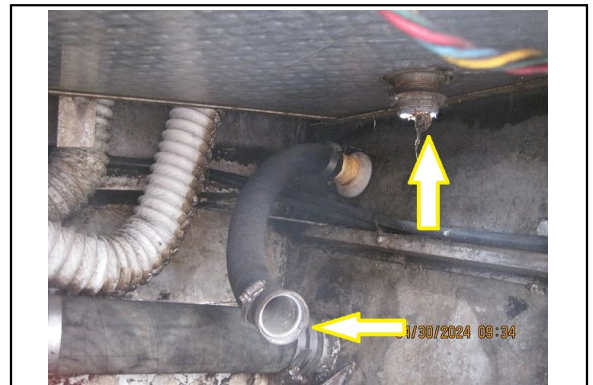
As sighted in the aft bilge compartment, the starboard drain hose is disconnected from the deck fitting, which will allow deck water to drain directly into the bilge.

**Starboard deck drain hose is not properly**

FINDINGS	RECOMMENDATIONS
As sighted in the aft bilge compartment, the starboard drain hose is disconnected from the deck fitting, which will allow deck water to drain directly into the bilge.	Properly connect the hose so that deck water will drain overboard.

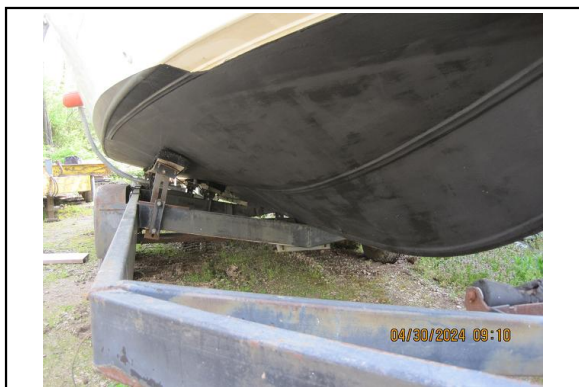
**Trailer is nicely fitted to the boat. Bottom**

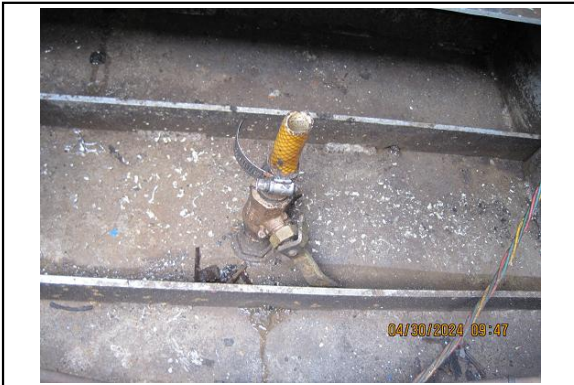
The sea cock is a ball valve and was in the CLOSED position. The sea cock was showing some damage.

**Abandoned raw water intake.**

FINDINGS	RECOMMENDATIONS
<p>The sea cock is a ball valve and was in the CLOSED position.</p> <p>The sea cock was showing some damage.</p>	<p>Recommend installing a new sea cock or securely plug off the raw water intake.</p> <p>Monitor the raw water intake during and after launching the boat.</p>

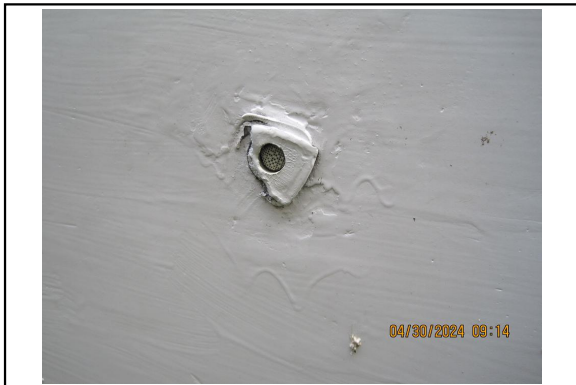
The gas vent at the aft port hull side has sustained some impact damage.

**Port hull fuel vent showing some damage.**

FINDINGS	RECOMMENDATIONS
<p>The gas vent at the aft port hull side has sustained some impact damage.</p>	<p>Further investigate and determine if the vent is still serviceable.</p>

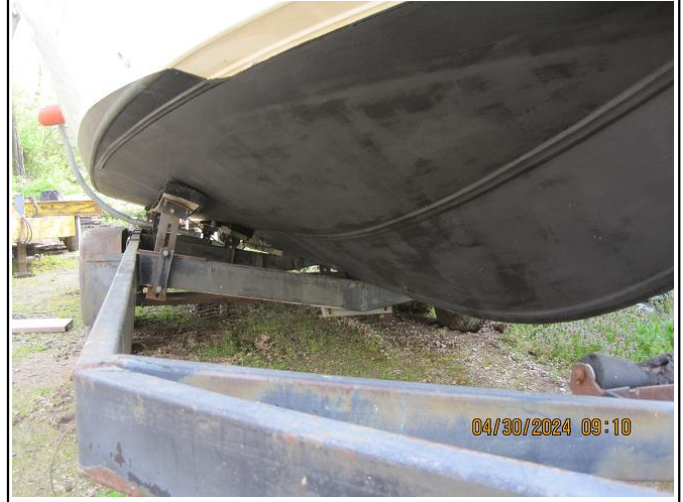
**Trailer is nicely fitted to the boat. Bottom paint is in good condition.**

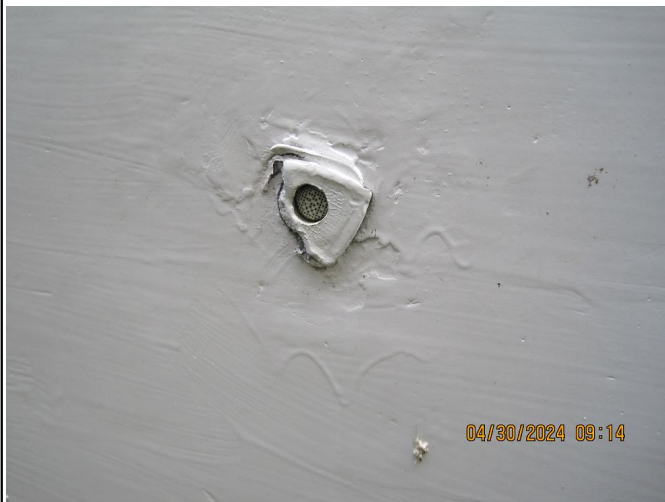
**Port hull fuel vent showing some damage.**

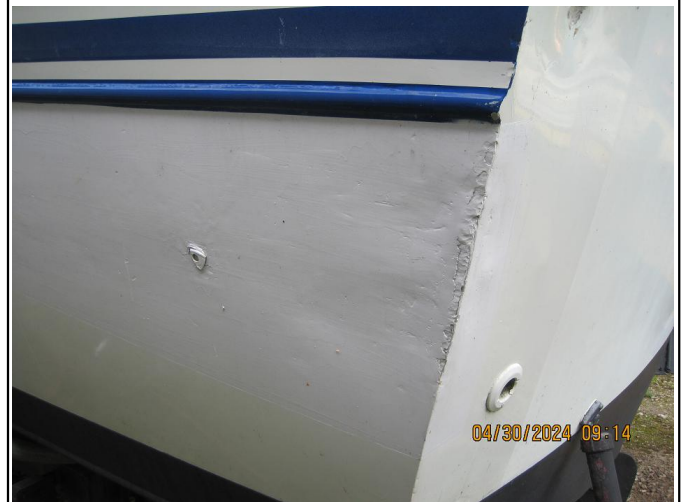
Cosmetic paint repair areas were sighted on each hull side.

**Cosmetic damage at the port stern corner.**

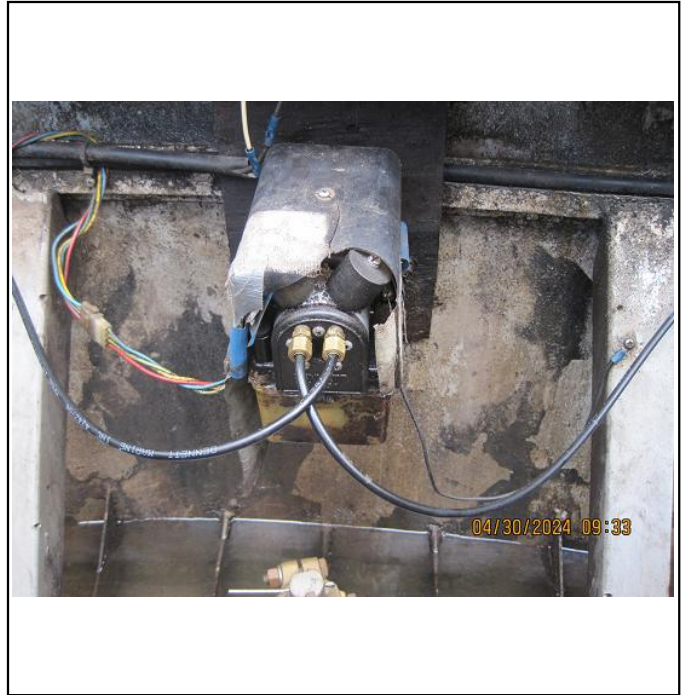
The plastic cover of the pump is damaged, but the pump remains serviceable.

**Trim tab hydraulic pump.**

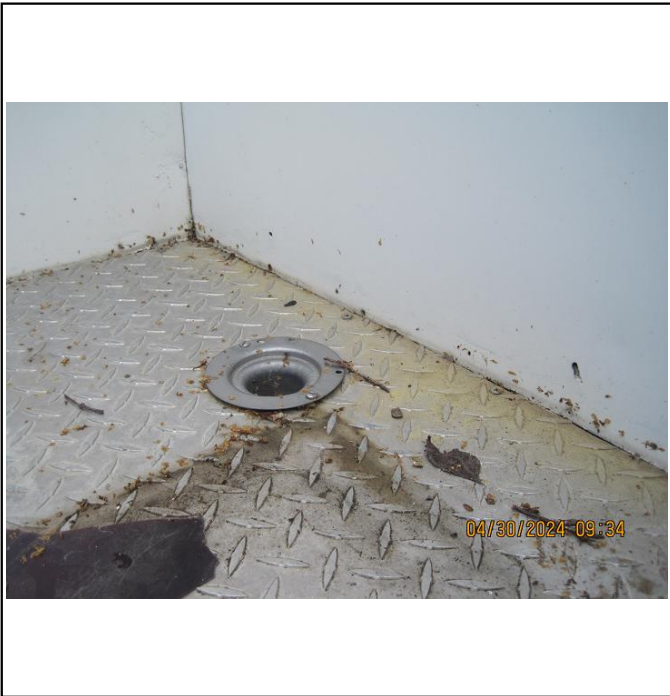
**Aft cockpit starboard drain.**

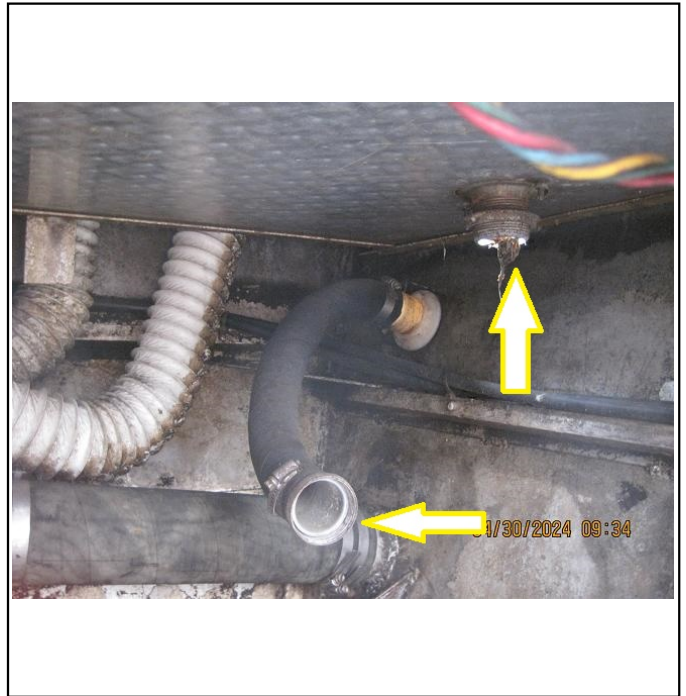
**Starboard deck drain hose is not properly attached.**

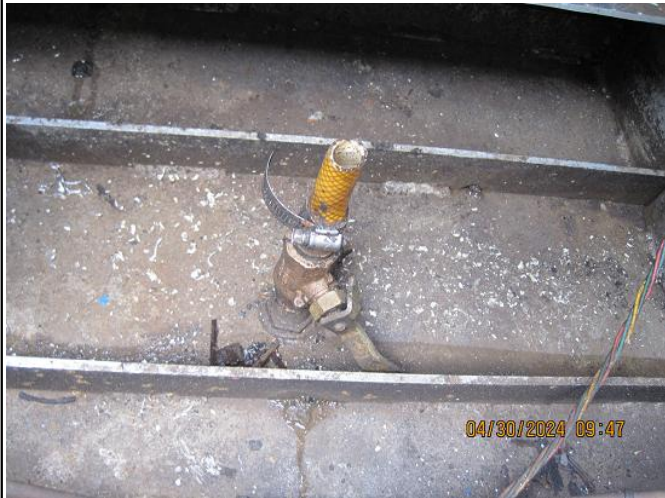
**Abandoned raw water intake.**

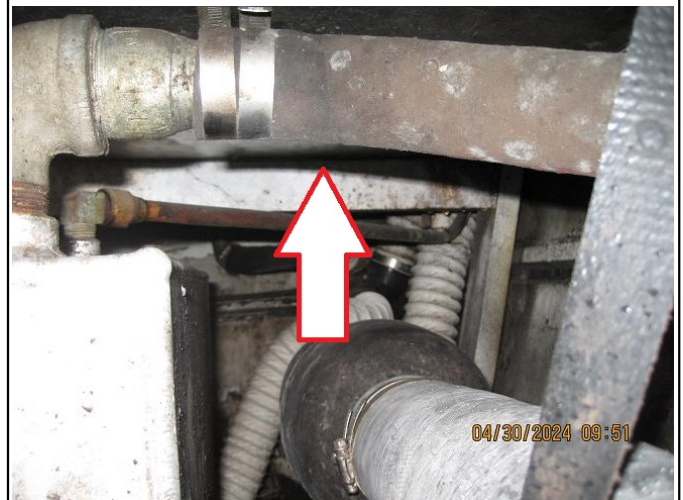
FINDINGS	RECOMMENDATIONS
<p>As sighted at the neck of the gas tank, the fill hose is showing age and could be original.</p>	<p>Give consideration to replacing the gas fill hose.</p>

**Gas fill hose at the gas tank neck.**
