Appraisal for Wellcraft 2800 Martinique

Date inspected Sept 16, 2022 (visual, nondestructive survey)

Type: Cabin/ Express cruiser with Volvo Inboard/ outboard drive

Purpose for survey Appraisal for donation

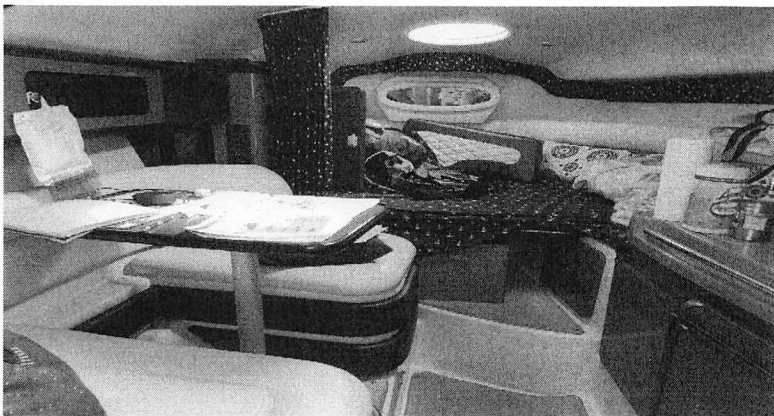
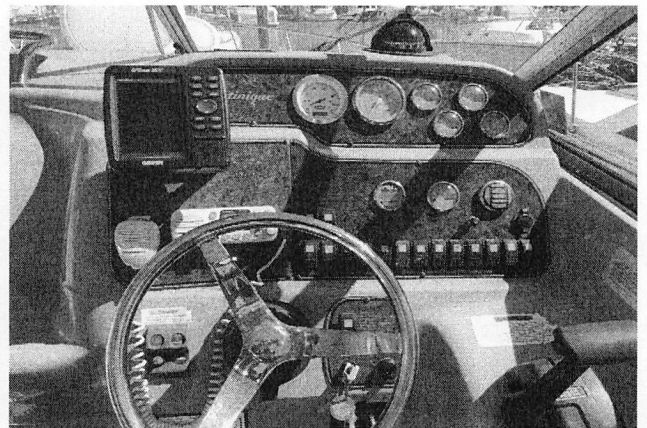
Layout:

Layout description – Swim platform with swim ladder all the way aft. Next forward is the engine room with cockpit shower & swing boarding door to port with wrap around cockpit seat to starboard. Next to starboard is the Helm station with passenger sofa across to port. Companionway is next with AC panel & switch controls to port and an enclosed head across to starboard with sink & shower. A double berth/cabin is immediately aft under the helmstation. The galley is area next forward complete with refrigerator, cook top stove, microwave and sink with pressurized water. A dinette with table is

across to port with a double berth all the way forward. up seat back/berths for extra sleeping accommodations & outboard shelves. All the way forward there is a hatch to access the forward chain locker. The boat has an attractive full weather enclosure with an SS frame and tan "Sunbrella" fabric.
