So Cal Surveys, LLC

Survey Report

Rinker Fiesta Vee 266

FILE NUMBER.....	23-0503
DATE AND TIME OF SURVEY.....	03 May 2023
PLACE OF SURVEY.....	Dana point, CA
SURVEY PREPARED FOR.....	██████████
TYPE OF SURVEY.....	Condition and Value
OVERALL VESSEL RATING.....	Average
ESTIMATED MARKET VALUE.....	\$20,000
ESTIMATED REPLACEMENT COST.....	\$120,000
HULL IDENTIFICATION NUMBER (HIN)...	RNK52743D696
CALIFORNIA REGISTRATION NO.....	CF 4345 SV
MAKE OF VESSEL.....	Rinker
MODEL OF VESSEL.....	Fiesta Vee 266
BUILDER.....	Rinker Boat Co Inc, Syracuse, IN
YEAR BUILT.....	1996
HULL MATERIAL.....	Fiber Reinforced Plastic
HULL TYPE.....	Modified V
LENGTH OVER ALL (LOA).....	27' 5" (per BUC Guide)
BEAM.....	8' 6" (per BUC Guide)
DISPLACEMENT.....	5,875 Lbs (per BUC Guide)
PROPULSION SYSTEM.....	Single Inboard/Outboard
FUEL TYPE.....	Gasoline
FUEL CAPACITY.....	100 Gallons (estimated)
AC POWER.....	120 VDC 30-amp
DC POWER.....	12 VDC
FRESH WATER CAPACITY.....	20 Gallons (estimated)
HOLDING TANK.....	20 Gallons (estimated)

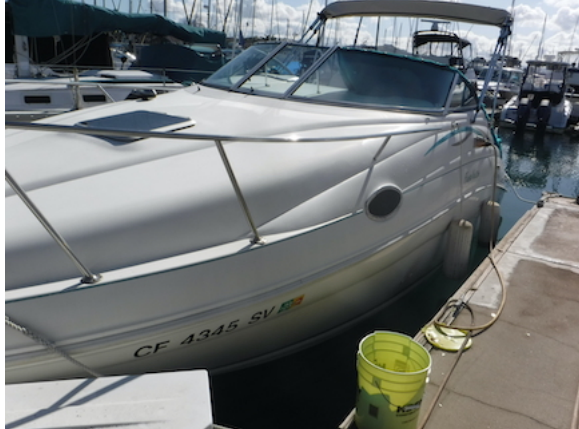
The hull is constructed of fiber-reinforced plastic in a V configuration with hard chines and strakes. The hull is stiffened by stringers and partial and full bulkheads. The hull is in good condition above the waterline. The interior of the hull is in good condition where accessible.

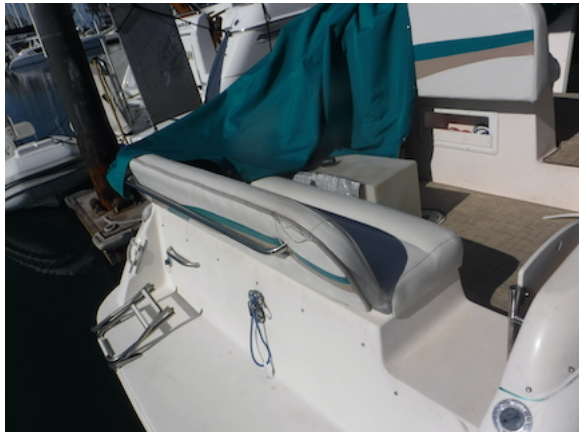
The transom is in good condition with an integrated swim step. The swim step is secure and in good condition.

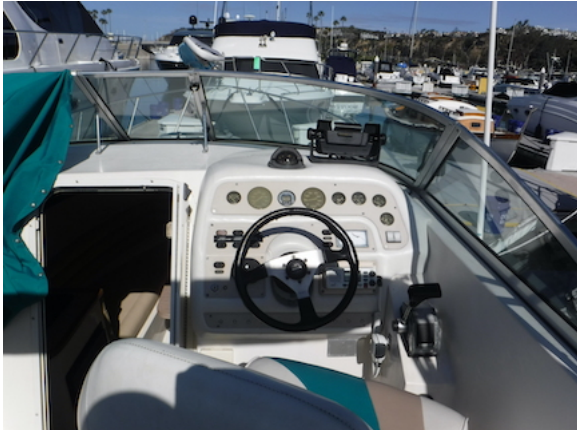
The vessel is operated from the cockpit offering good visibility with a full set of controls and gages.

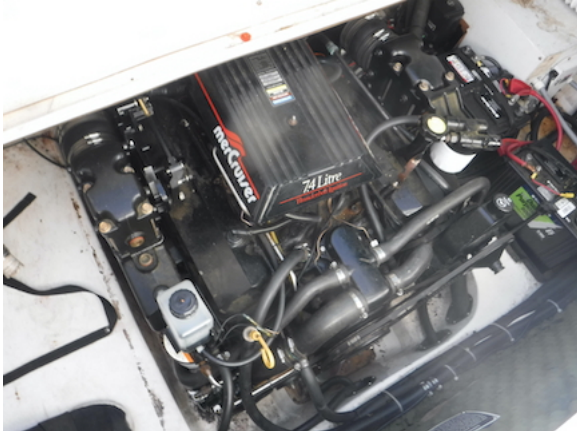
B.2 (see findings and recommendations)

The engine in good operational condition with signs of regular maintenance. The engine compartment is clean and orderly. There is oil in the bilge.

FINDINGS	RECOMMENDATIONS
B.1 The trim tabs are not operational.	Repair the trim tab system.
B.2 There is oil in the bilge.	Clean the oil from the bilge and keep bilge pads under the engine.
B.3 The shifting controls are stiff and could not be operated.	Repair or replace the shifting cables and prove the outdrive is operational.
B.4 The bilge pump float switch is not operational. The forward bilge pump is not operational.	Make the bilge pumps operational with the float switches.

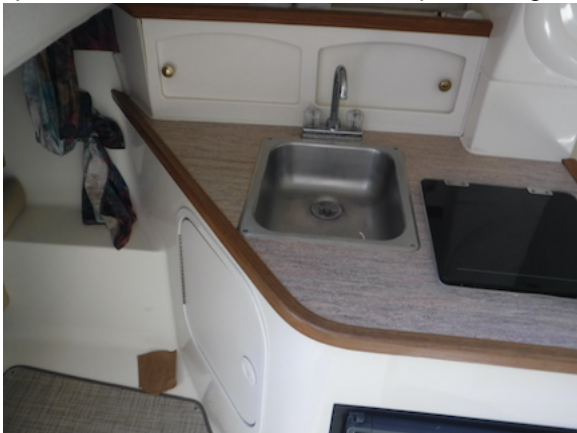
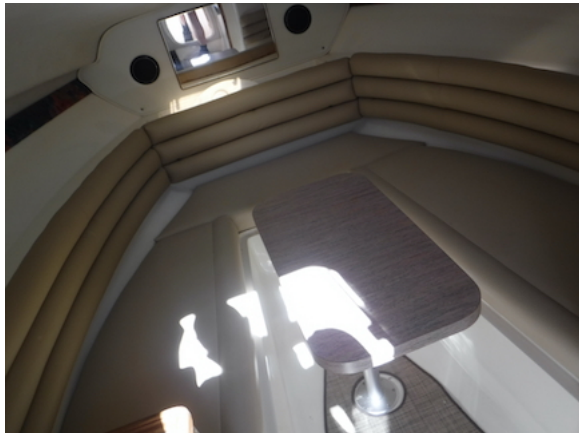
The galley is in good condition. The Norcold AC/DC refrigerator appears operational and in good condition. The Goldstar microwave oven is operational. The single-burner electric/alcohol stovetop is operational. The sink and countertops are in good condition.
