# Marine Survey Report

#22-0909

*“Havanita”*

Condition & Valuation

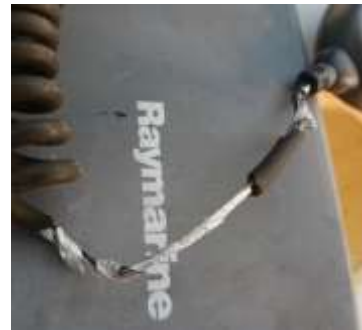
- 6) **FOUND:** The VHF radio has a broken microphone cord

**Recommended:** replace VHF radio cord as found necessary before cruising

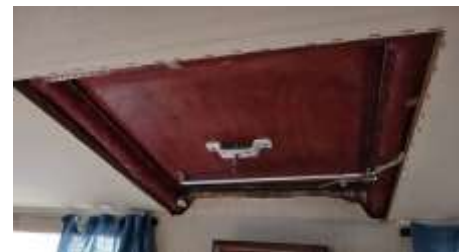
- 8) **FOUND:** The Aft cabin has an egress hatch that is covered with a decorative cover which would not open during the survey

**Recommended:** Inspect further to provide emergency egress at this location.

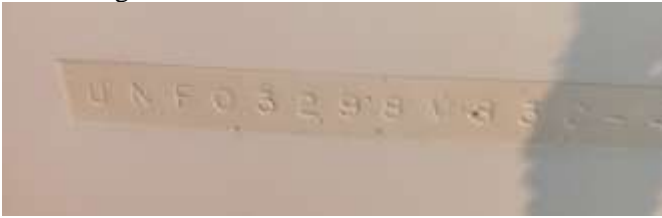
Vessel Registration Not onboard
