## Captain Vic's Marine Services

CVMS-210526

M/V Wellcraft St Tropez 3200

### Condition and Valuation Survey

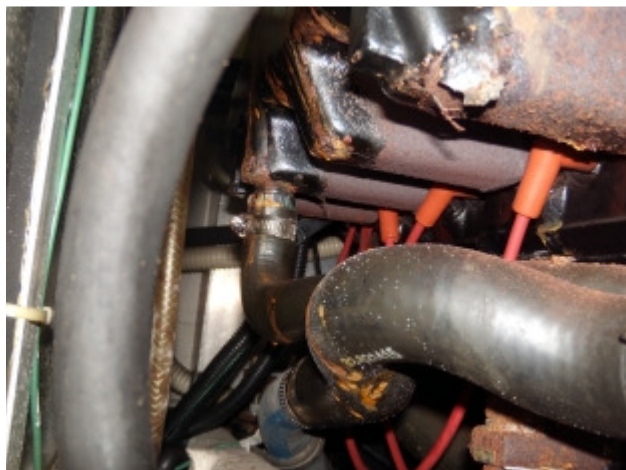
Underside of Port Main Engine Exhaust Manifolds

Wet type exhaust on the main engines exiting through inline mufflers to the port and starboard sides. The water cooled exhaust manifolds and risers appeared to be in serviceable condition. There was evidence of iron oxide corrosion (rust) from the riser to manifold gaskets. (\*) No evidence of cracking. Double all stainless steel hose clamps were sighted at all exhaust connections.

| Finding | Recommendation |
|---|---|
| 7) Riser gaskets showing signs of leakage. | Replace as necessary. |

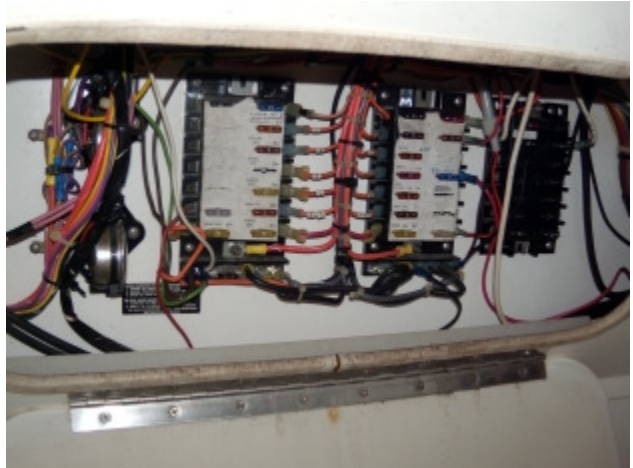
Main Battery Switches

| Finding | Recommendation |
|---|---|
| 5) Bilge pumps wired through main battery switch. | Rewire bilge pumps with float switch power supplied directly from the battery as recommended per ABYC H-22.8 |
