## VESSEL APPRAISAL REPORT

**1980 Hunter 30' Masthead Sloop**

***Sabbatical***

## **Report of Marine Survey**

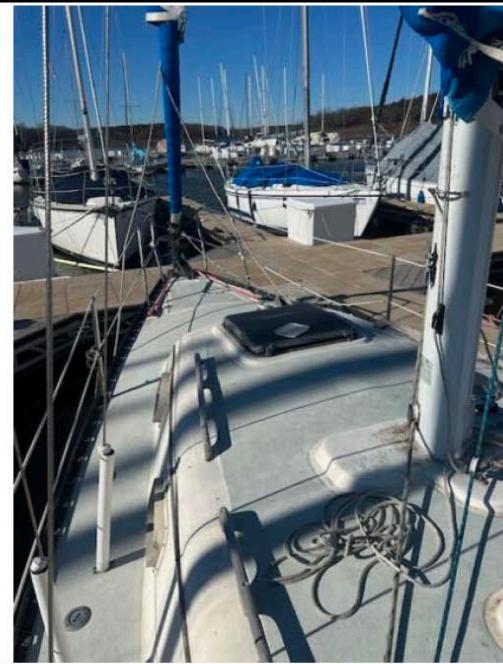
Bow Deck

Stainless steel bow pulpit w/anchor chute, roller. Serviceable.

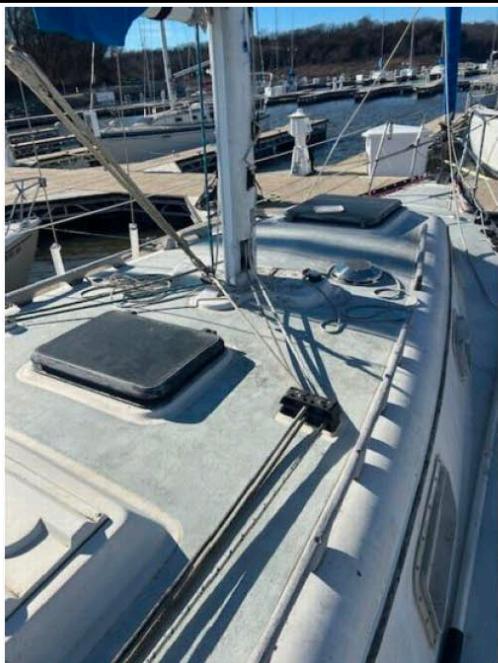
Cabin House

For the most part, the deck is clean and uncluttered. The cosmetic condition of the superstructure was found to be in good condition.

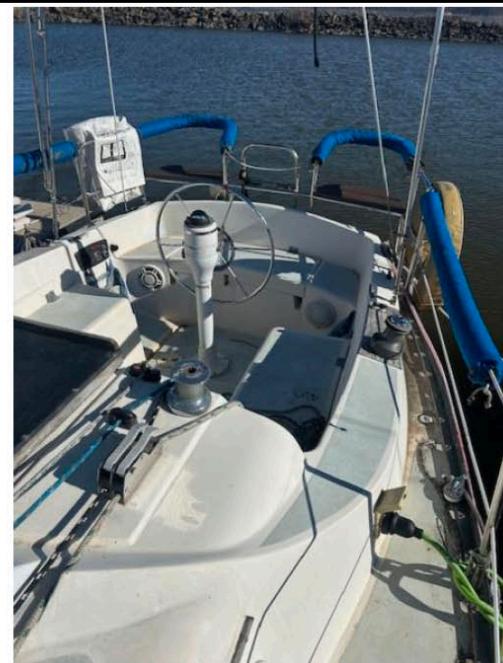
Cockpit

ABYC H 41.6.2 The outside periphery of helm station shall be provided with coamings, liferails, deckrails, lifelines or an enclosure at least 30 inches (762 mm) above the deck, or by seat backs that shall be no less than 24 inches (610 mm) above the deck. Combination of FRP coaming and 1" stainless steel rail. Good condition.

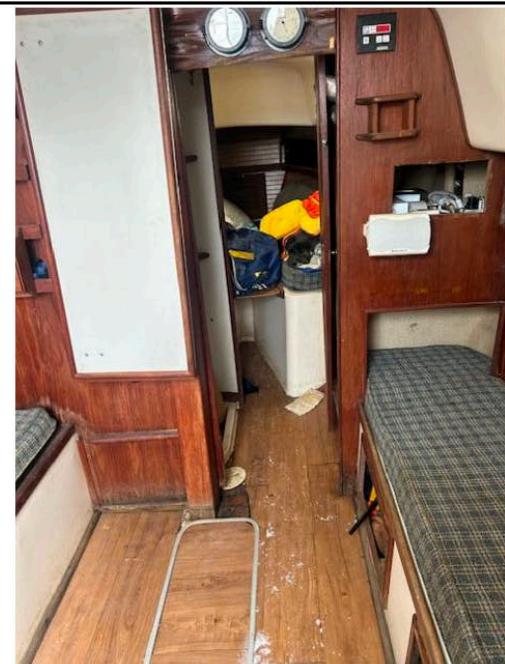
Cabin

Faux wood cabin sole thru-out in good condition

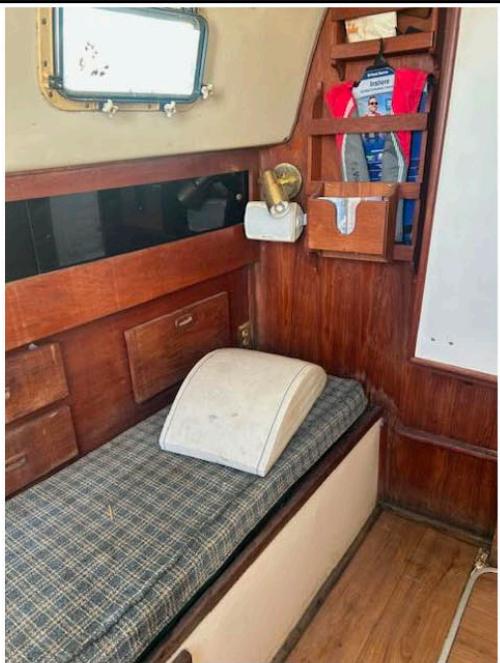
Port Berth

Light colored fabric for cushions, that reflected the excellent care and attention to a vessel of this vintage. Good Condition.

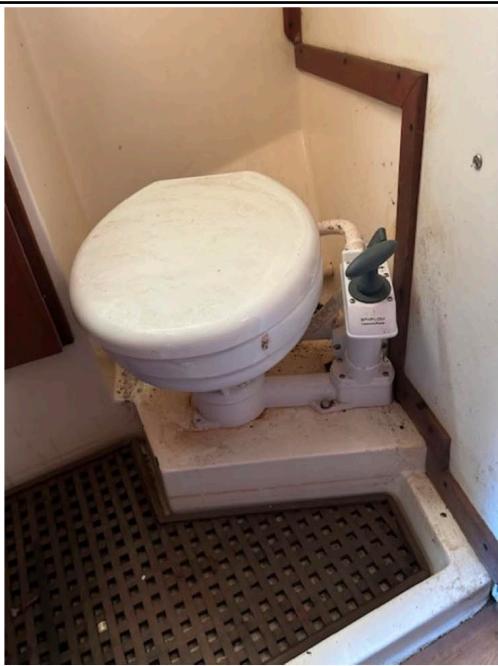
Head

Master HEAD - full head/shower, on-demand pressure hot and cold fresh water, molded counter with stainless sink, 12V electric sump and vacu-flush marine toilet, mirror, and cabinet storage. U.S.C.G. CERTIFICATION - Serviceable Type III Marine Sanitation Device (MSD) holding tank with associated pump out on deck located aft Starboard side of swim platform. System is legal for Inland waterway cruising as required by U.S.C.G. Federal and Florida State Clean Water Act law if holding tank is used. Serviceable.

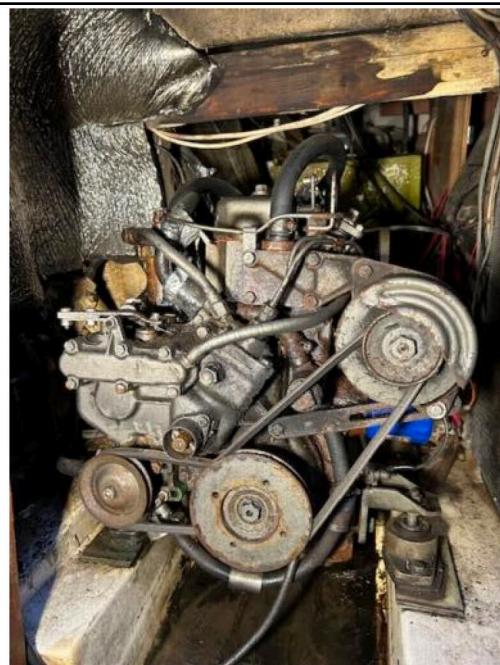
Engine Mounts and Bed: Engine beds are aluminum thru-bolted to heavy FRP encased coniferous wood longitudinal stringers laminated to hull substrates. Main engine bed scantlings beneath engine appear of adequate heft and proper design for the application. No historic evidence of unwanted engine movement noted, as sighted. Rubber vibration dampening mounts in place. Condition appears serviceable.

Raw water Cooled Exhaust System, Cast Manifold and elbows, exhaust-grade rubber hose, double clamped to Fiberglass Reinforced Plastic (FRP) horizontal muffler, in bilges, below the aft cabin, exhaust exits starboard aft, through cast-in outlet. NO leaks sighted during sea trial.
