### Report of Marine Appraisal

2005 Sea Ray 200 Sport Bowrider

**Report file no:** 251001

**Type of survey:** Appraisal and valuation only

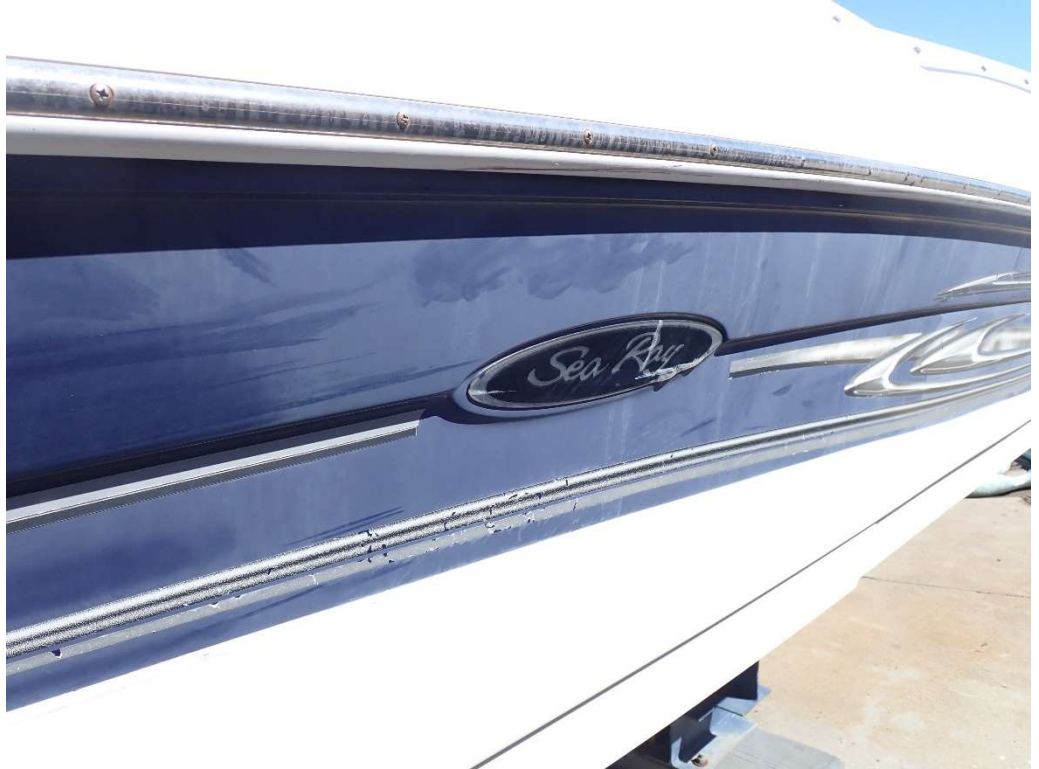
Photo 7

- The vessel gelcoat was chalky from age and deterioration. Some minor scuffing was noted on the hull sides (Photos 7 & 8).
- A  $\frac{3}{4}$  inch section of gelcoat was missing from the keel about two feet from the base of the stem. There was a  $\frac{3}{4}$  inch U-shaped crack on the starboard side of the missing keel gelcoat (Photos 9 & 10).

Chalky gelcoat on hullsides.

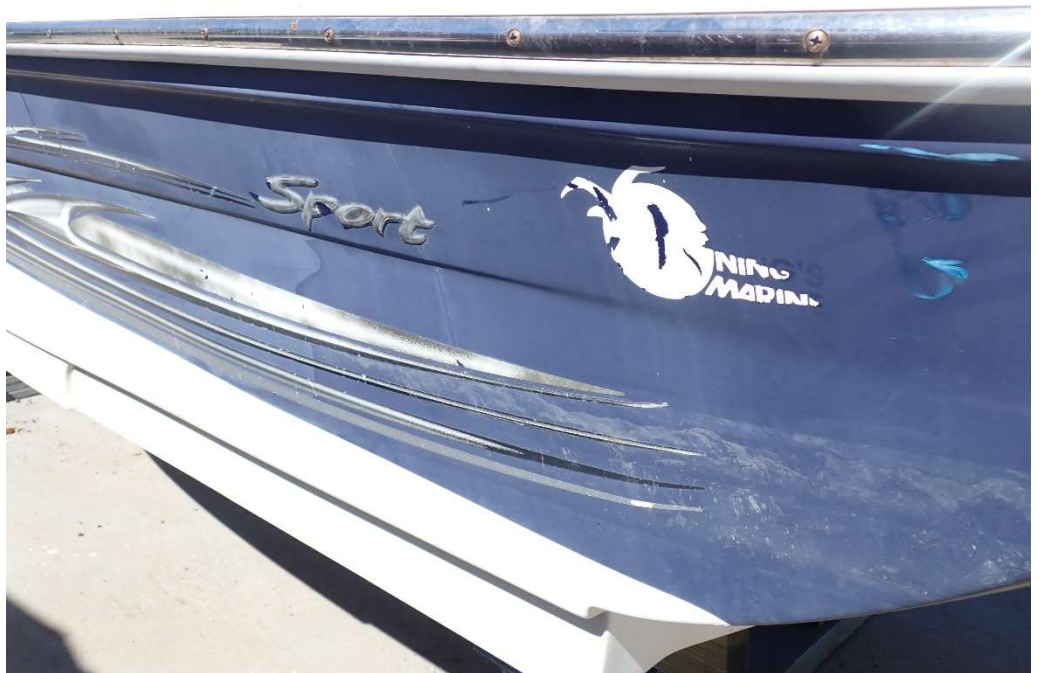
Photo 8

Chalky gelcoat and scuffs on hullsides.

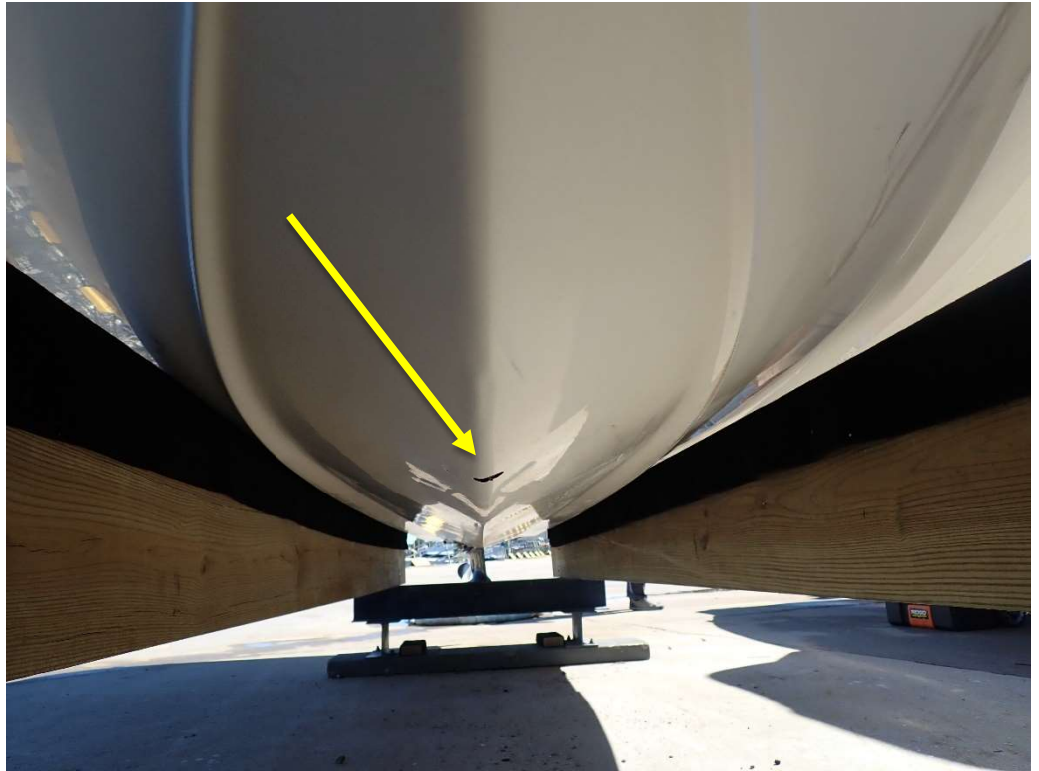
Photo 9

Arrow indicates missing gelcoat on keel about 24 inches from the stem.

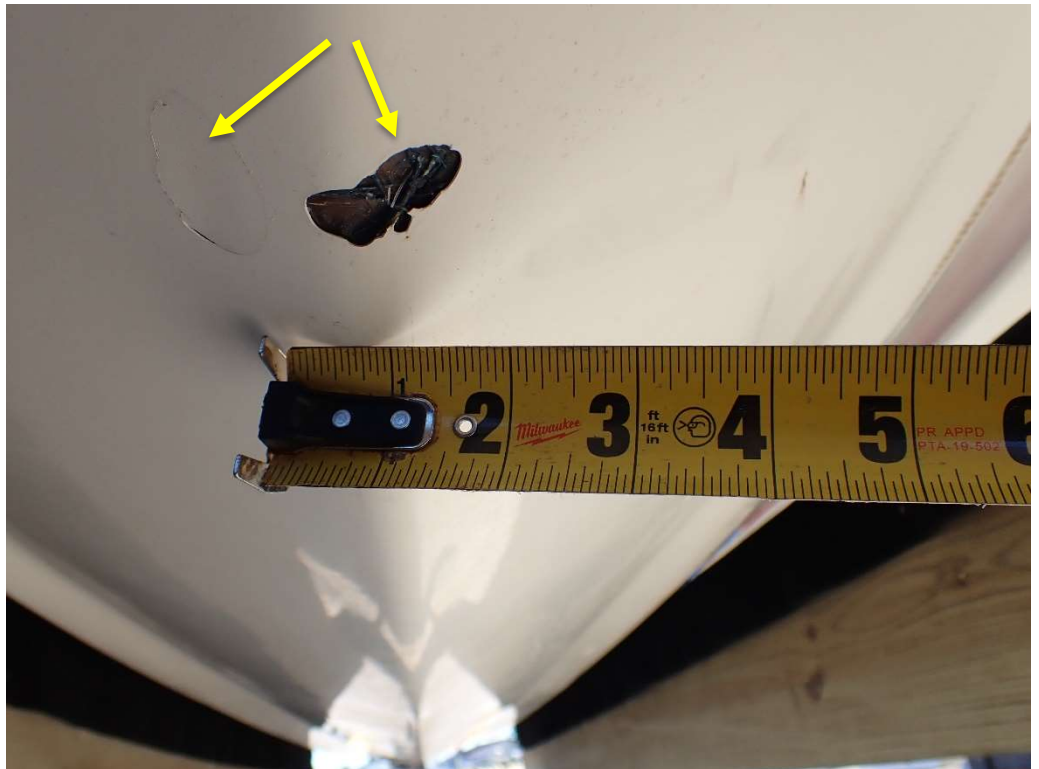
Photo 10

Close-up of damaged gelcoat/laminate in above photo. There was a  $\frac{3}{4}$ " area of missing gelcoat and a  $\frac{3}{4}$ " crack to starboard.

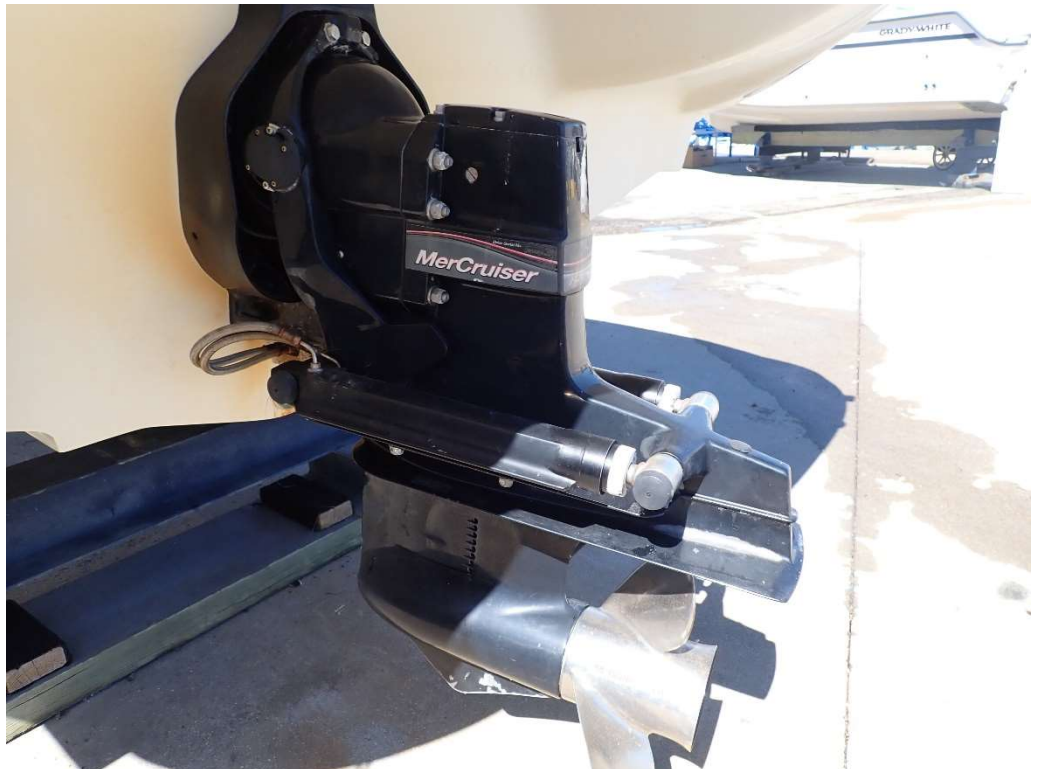
Photo 12

- The sterndrive lower unit skeg was missing a lower aft section (Photos 12-14). The sterndrive appeared otherwise to be in clean condition. The stainless-steel prop was in good condition (Photo 15).

MerCruiser Alpha One  
sterndrive, serial number  
OW170568.

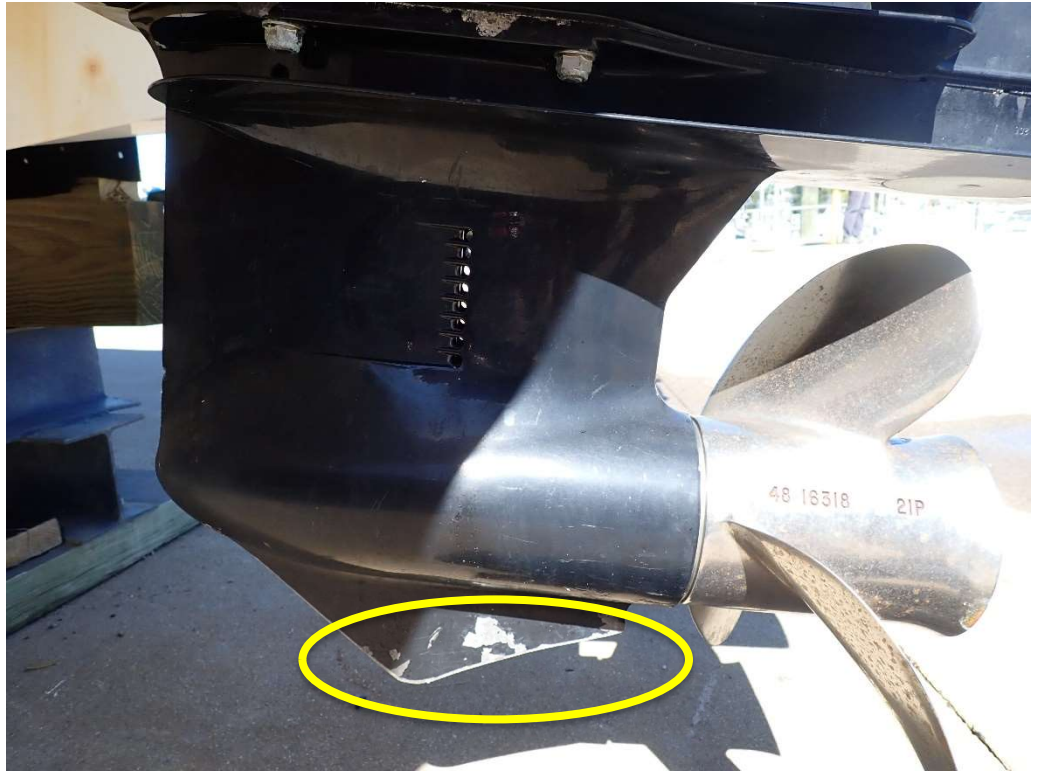
Photo 13

Drive lower unit. Lower aft  
portion of skag missing.

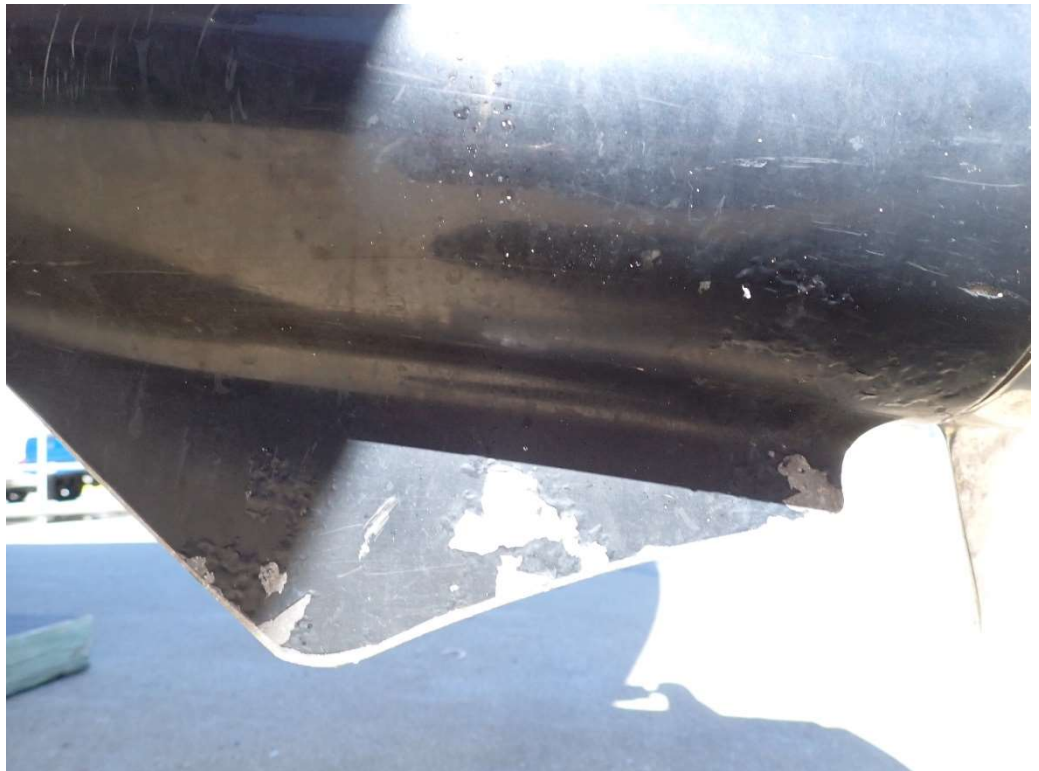
Photo 14

Close-up of skag in above  
photo.

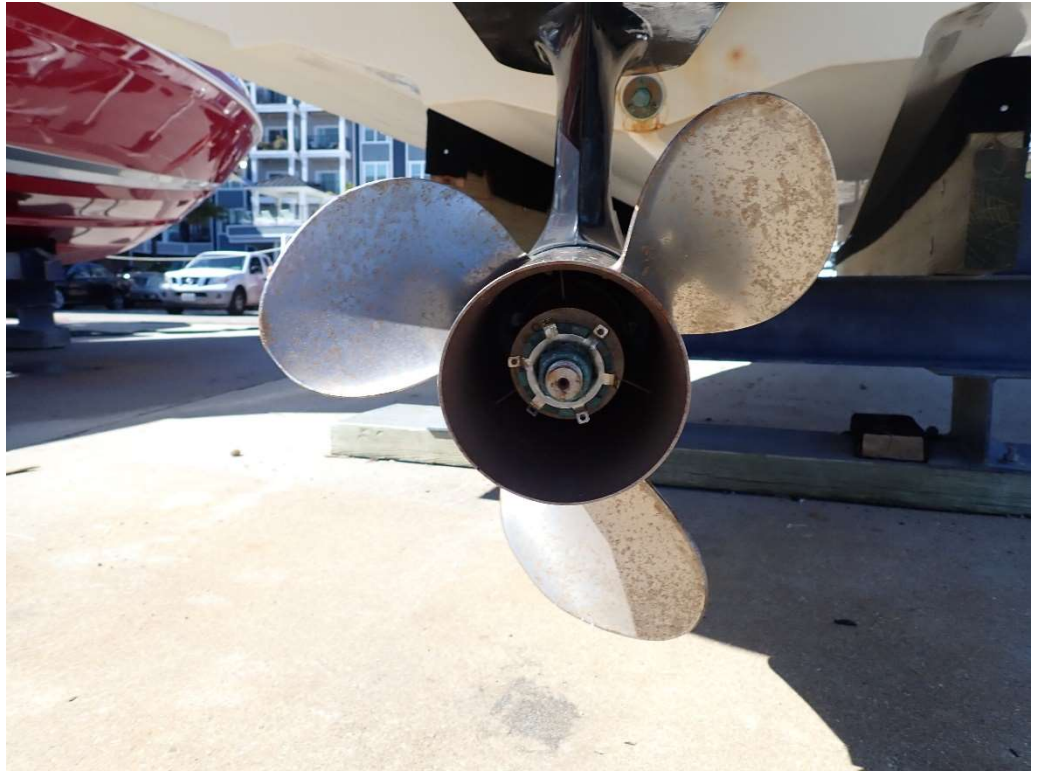
Photo 15

Mercury Marine  
Vengeance stainless steel  
prop.

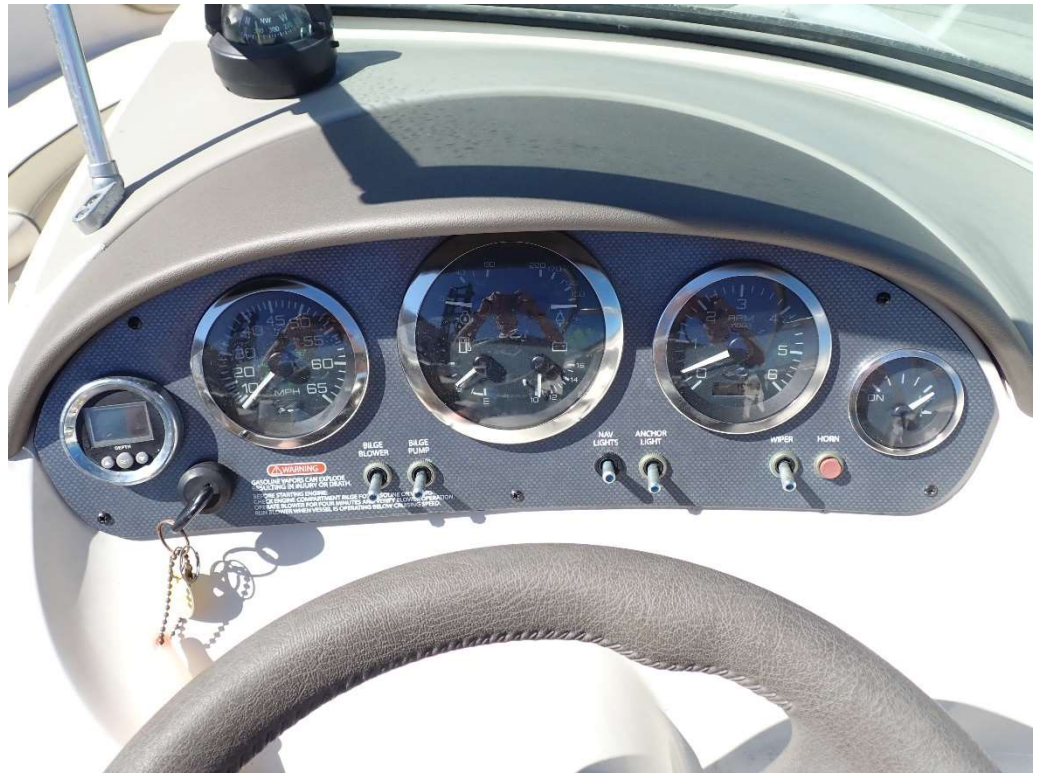
Photo 17

- Switches at the helm were tested for power-up and the following were functional; bilge blower, bilge pump (manual checked only) and horn (weak) (Photo 17). Wiper switch but no wiper.

Instrument panel and switches.

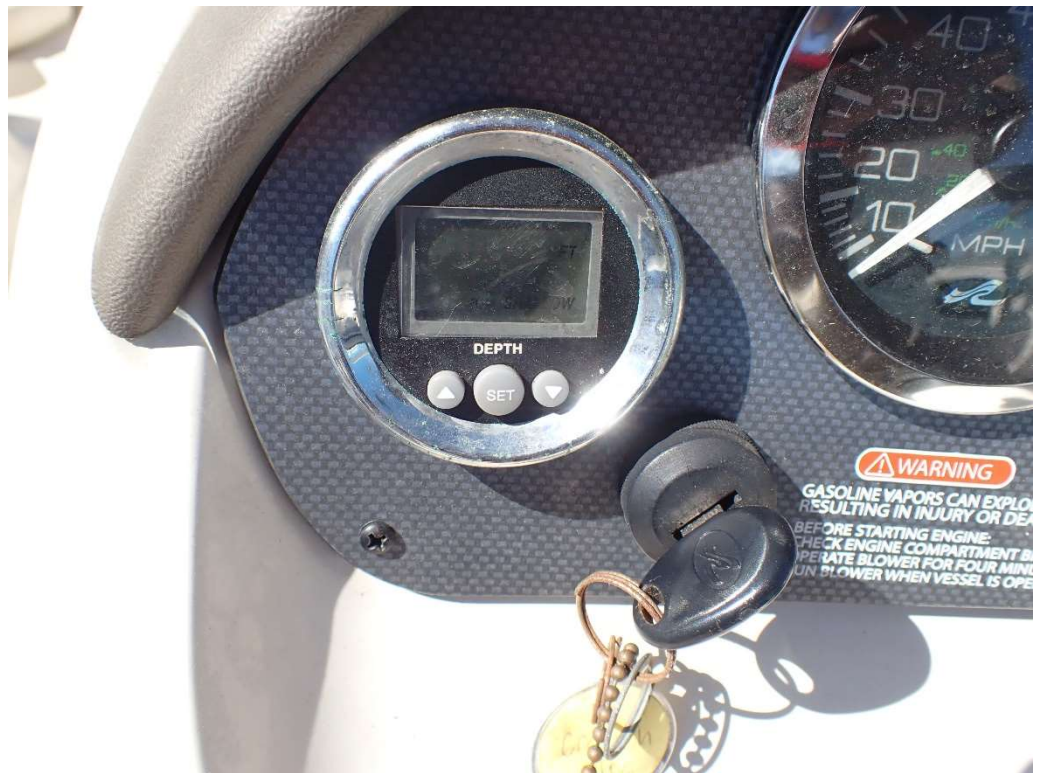
Photo 18

- The digital depth sounder powered-up but was not readable (Photo 18).
- The Clarion Marine M235 Stereo powered-up (Photo 19).
- The nav light switch powered up the light, but the cover was missing, making the light illegal to operate (Photo 20). The removable all-around pole light at the stern was missing and a new replacement pole light found on the boat would not fit in the existing hole.

Digital depth sounder powered up, but display was not readable.

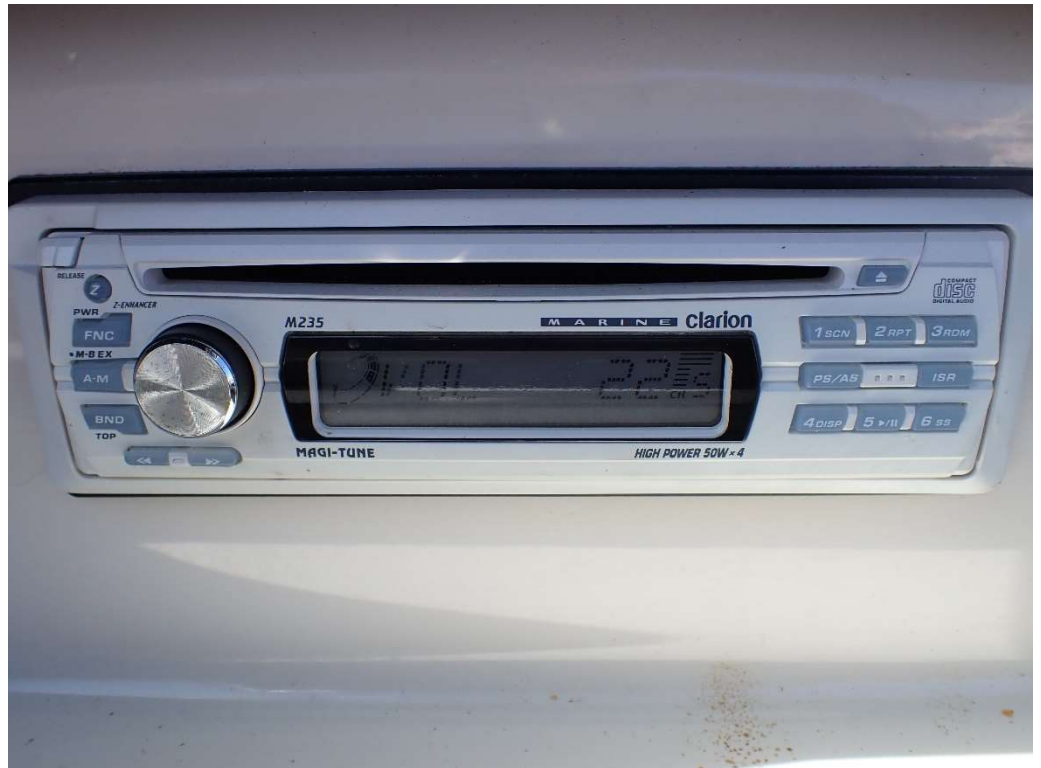
Photo 19

Clarion Marine M235  
stereo powered up.

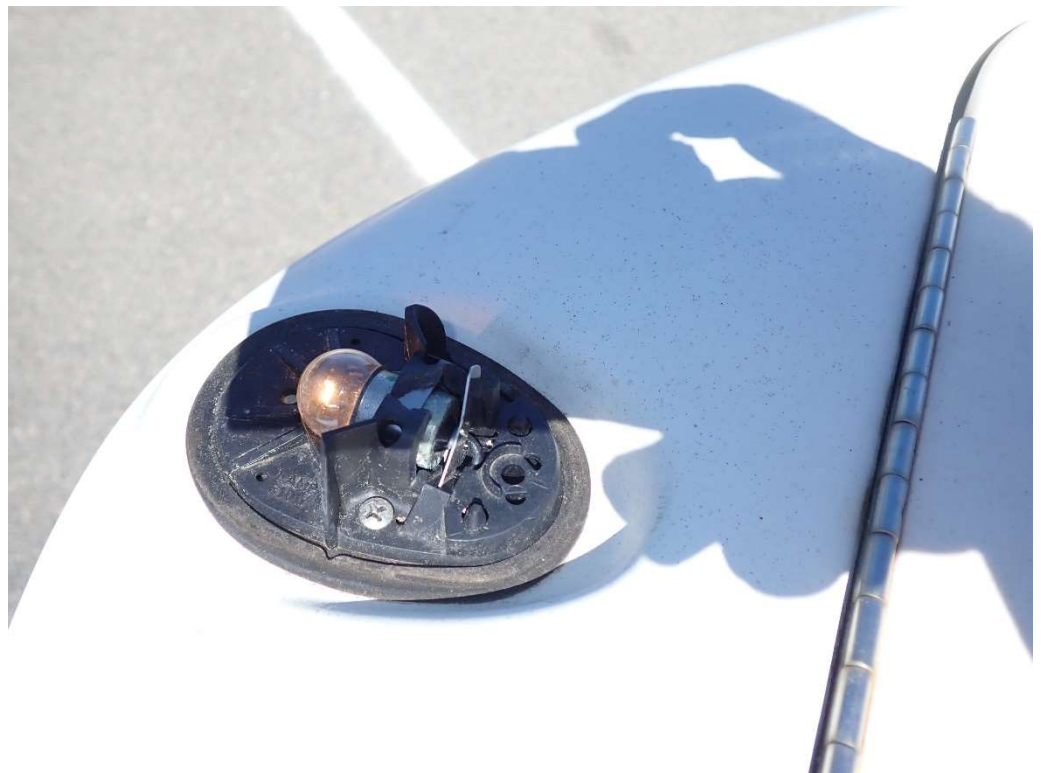
Photo 20

Navigation light powered  
up, but was missing cover.

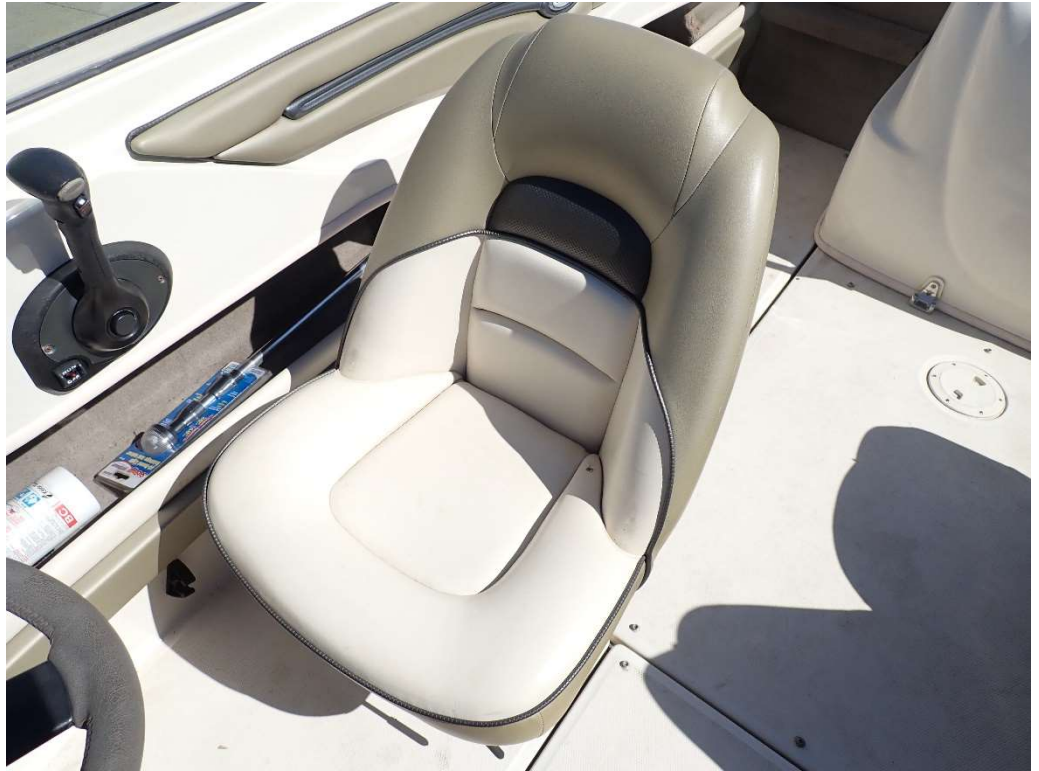
Photo 21

- The boat's upholstery was in generally good condition (Photos 21 & 22).
- The engine was clean, very minor amounts of rust and dirt (Photos 23 & 24). The oil indicated on the dipstick was clean and full.

Helm seat.

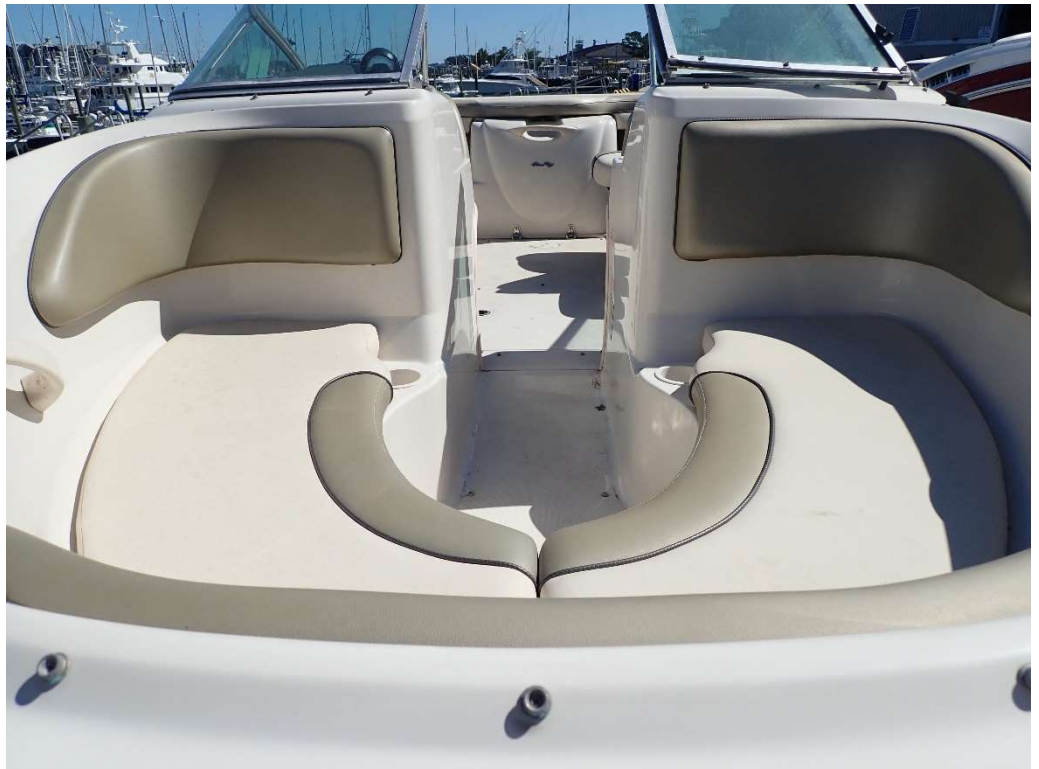
Photo 22

Bow seating.

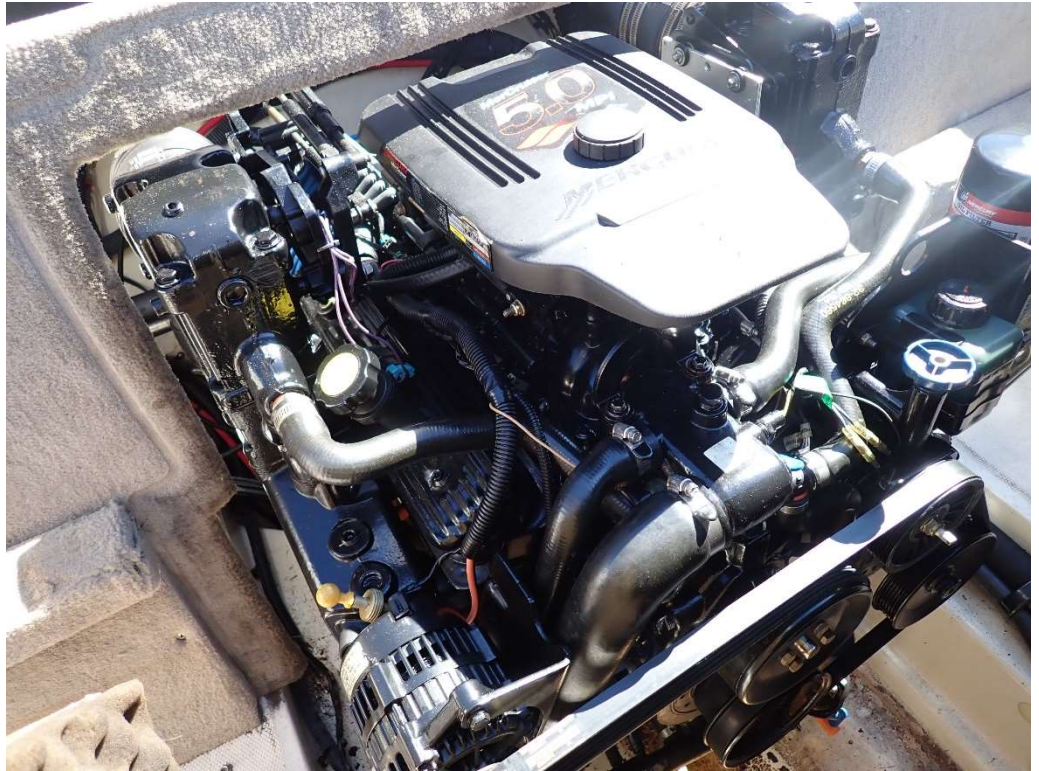
Photo 23

Starboard side of engine.

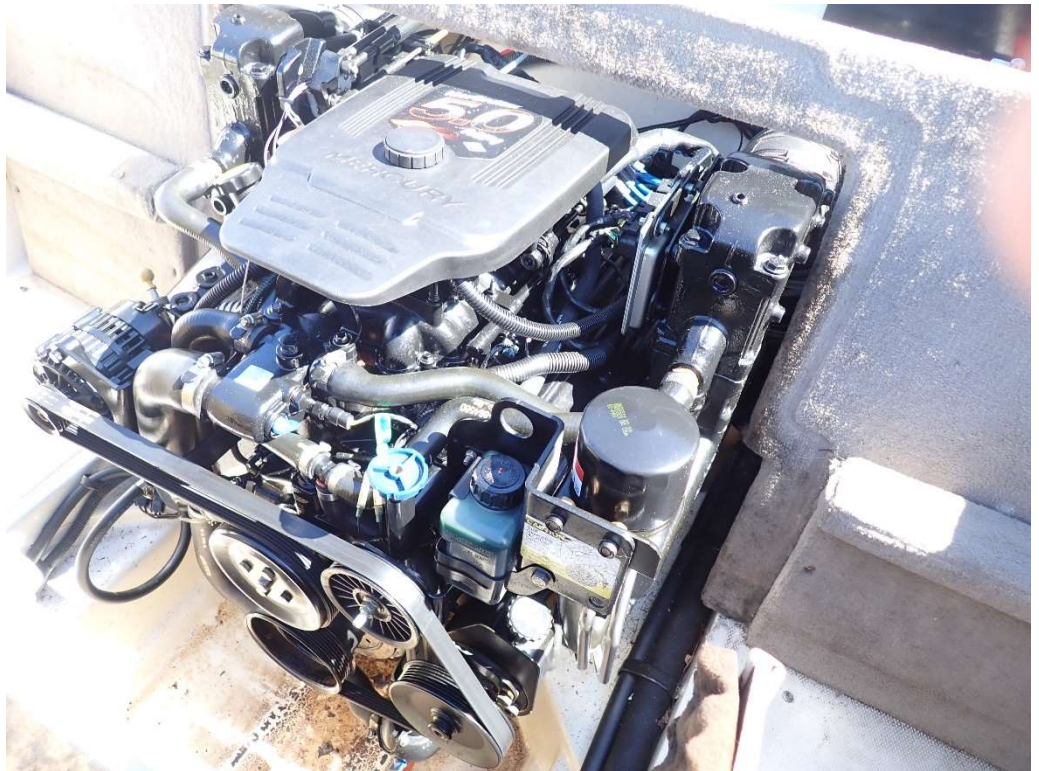
Photo 24

Portside of engine.

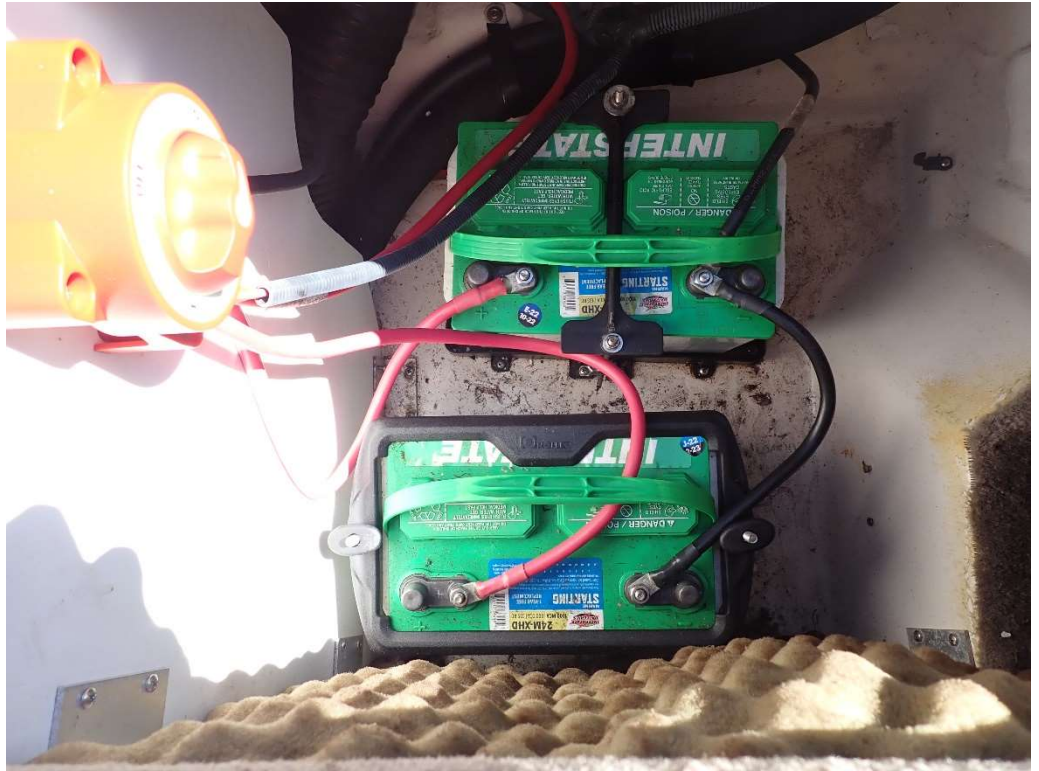
Photo 25

- Two G24 lead acid batteries were well secured in the port lazarette. No corrosion was noted. The ungrounded terminals were not covered (Photo 25).

Two G24 lead-acid batteries and a battery switch were installed in the port lazarette.
