MARINE SURVEYS: PRE-PURCHASE • INSURANCE • APPRAISAL

Vessel: Silverton 351 Sedan Cruiser

HIN: STNAA0311697

Survey Date: May 15, 2023

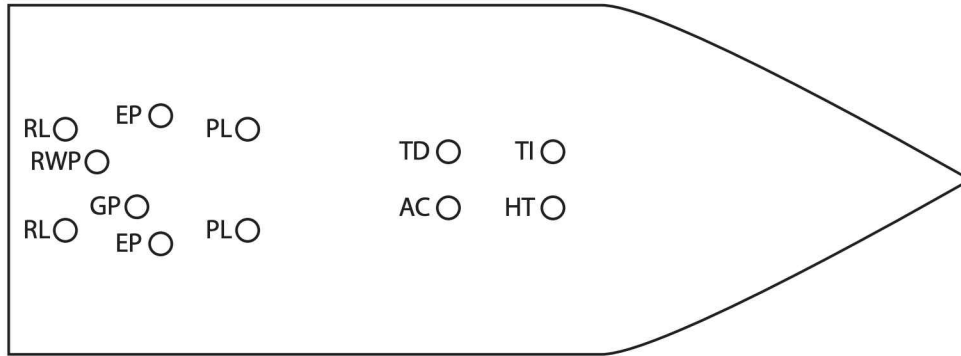
Thru-Hull Key (Below Water Line)

Below the water line: (7) bronze thru-hull fittings with seacocks; (2) rudder logs; (2) propeller shaft logs; and (1) transducer. Seacocks and thru-hulls were in average with minor corrosion/verdigris observed. **Exercise seacocks on a regular basis.** Thru-hulls above the water line are nylon in average condition with typical oxidation observed (where visible).

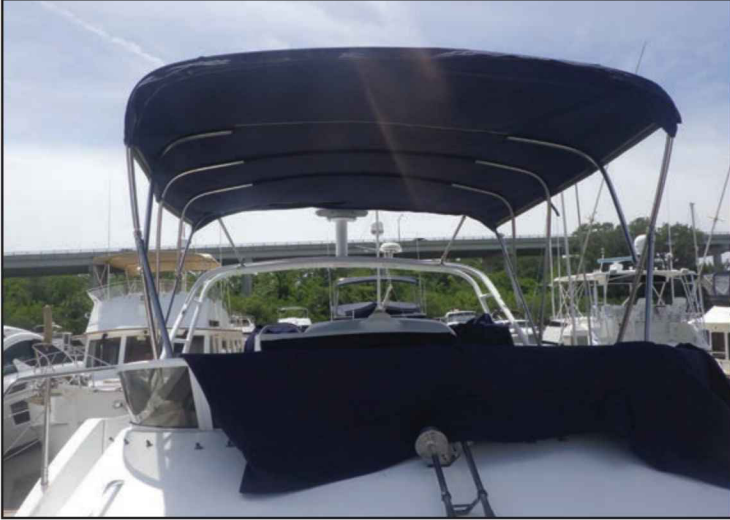
Flybridge

The flybridge has a canvas bimini top, affixed to a stainless steel frame; in fair condition with minor wear and damaged zippers observed. The cockpit features a nylon awning mounted to an aluminum frame; in fair condition with wear observed.

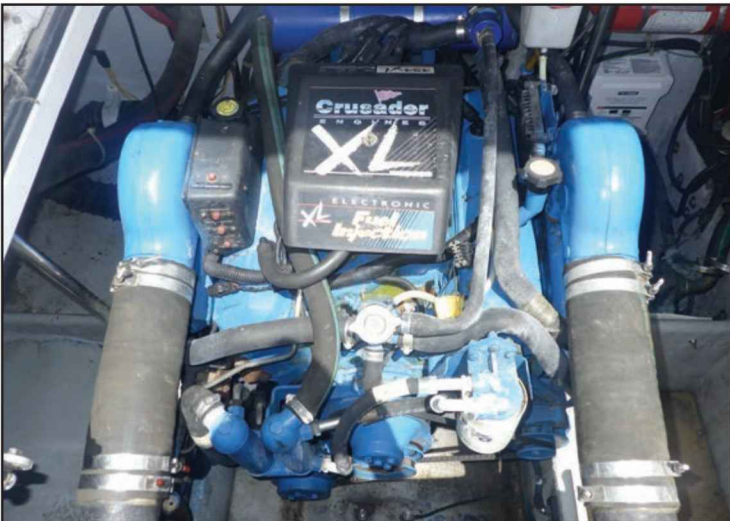
Port Engine

(2) Crusader, inboard gas engines. Both engines are in average condition. Paint finishes were in average condition with minor rust and paint wear observed on the blocks, heads, manifolds, and accessory brackets. Belts and water/cooling system hoses are in average condition, supple with a clean finish, minor crunching observed when compressed; hose clamps are in above average condition throughout with clean surfaces observed; fuel lines (type A1) are supple are in average condition with clean surfaces, fuel line fittings from fuel supply to engines were secure and free of corrosion. Pulleys are in average condition with minor surface rust observed, minor belt dust observed on engines. Wiring and terminal fittings are in average condition, clean, securely bundled and routed neatly. Performance unknown - no water trial took place.

SERIAL NUMBER(S): Port: Not observed, tag missing Starboard: 100074 (per engine label)

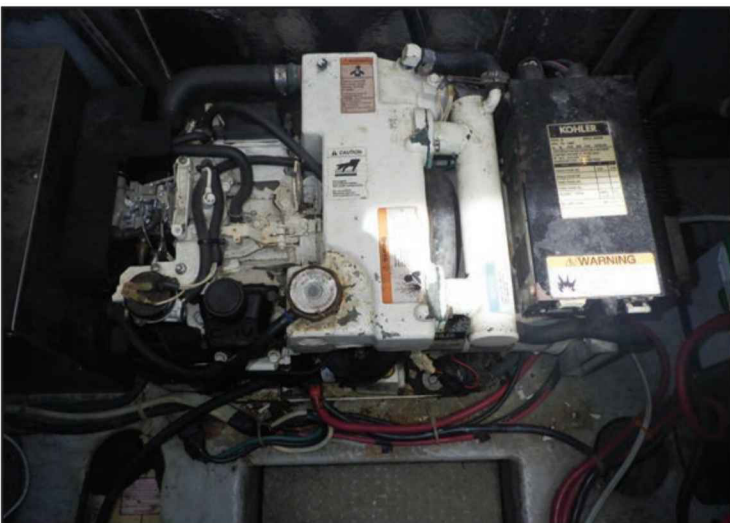
Kohler; M/N: 5E; S/N: 0699086; Spec: PA19905; 934.3 hours observed on unit meter. Engine and generator paint surfaces were in average condition with minor surface rust and corrosion observed. Belts, clamps, and hoses were average condition with minor wear observed; hoses were supple with minimal crunching observed when compressed; the catch pan was in average condition with minor surface rust observed, mounting bolts were clean and secure. Generator "hunted" some during dockside testing, power output observed at the main electrical panel.
