Marine Survey Report for Vessel Donation  
of  
Tarkenton Heating Bros. Inc, a 1979 Chris Craft 310 Catalina

Date of Survey 6/7/2022

By: Donald W. Beeck, NA  
Shoreline Marine Services  
4609 Ashley Lane  
Sheboygan, WI 53083

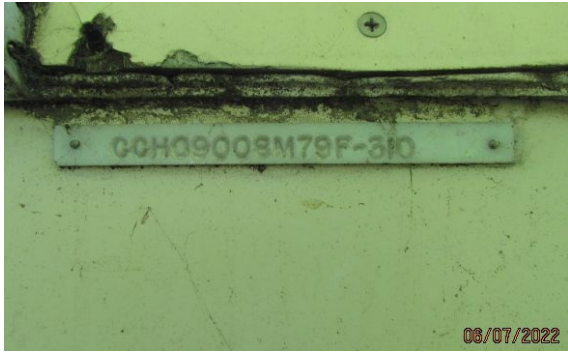
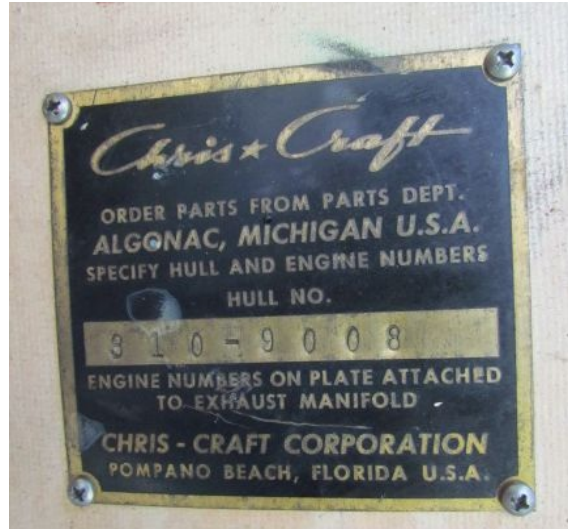
VIII Hull Identification Number: Photograph of actual imprinted number placard on the starboard transom of the vessel. No evidence of tampering or alteration noted. Number matches the imprinted placard on the underside of the port engine hatch cover.
