**2014 Hurricane SunDeck 2000**

# **Report of Marine Survey**

November 25, 2022

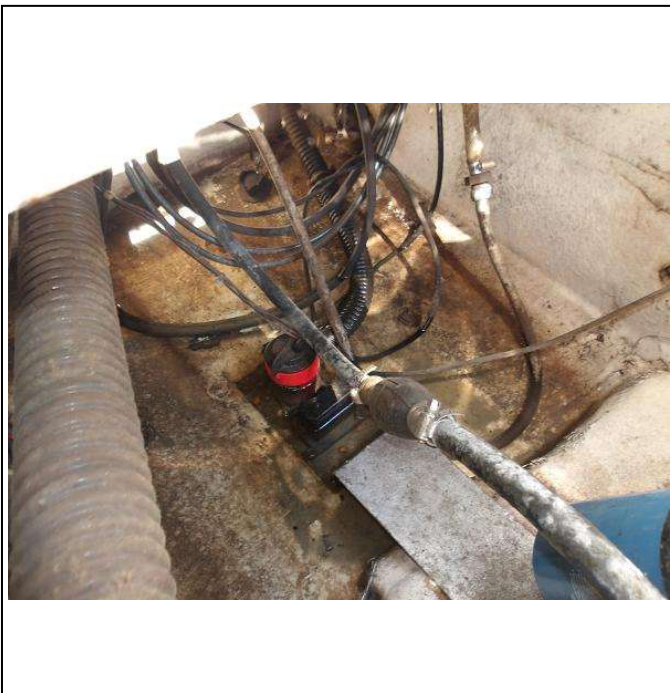
Aft Bilge

[C.1] Aft bilge area dirty, see photos.

FINDINGS	RECOMMENDATIONS
<b>C.1 (PAGE 4) BILGE:</b> <b>Aft bilge area dirty, see photos.</b>	<i>Inspect all lockers and stowage areas and remove any loose debris that could find its way to the bilge area clogging limbers and/or pumps.</i>
<b>C.2 (PAGE 4) SEATS:</b> <b>All cushions are sun faded and in need of cleaning.</b>	<i>Investigate further and repair for cosmetics.</i>
<b>C.3 (PAGE 5) SINKS:</b> <b>Faucet fixture is broken and not operable.</b>	<i>Further investigate and repair as necessary.</i>
<b>C.4 (PAGE 5) MANUFACTURER:</b> <b>Observed paint loss and dent on lower unit skeg and scratches on engine cowl.</b>	<i>Investigate further and repair or renew as necessary for metal protection and cosmetics.</i>

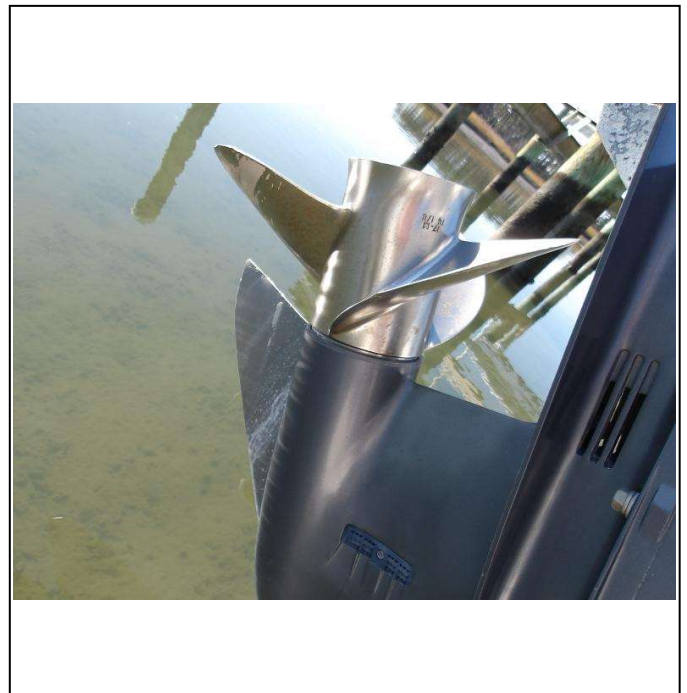
Engine Prop & Skeg

[C.4] Observed paint loss and dent on lower unit skeg and scratches on engine cowl.

**PROPELLER(S):** One (1) stainless steel, three bladed propeller, size stamped on hub 17-M 14 1/4". Prop has small dent noted on outer blade.

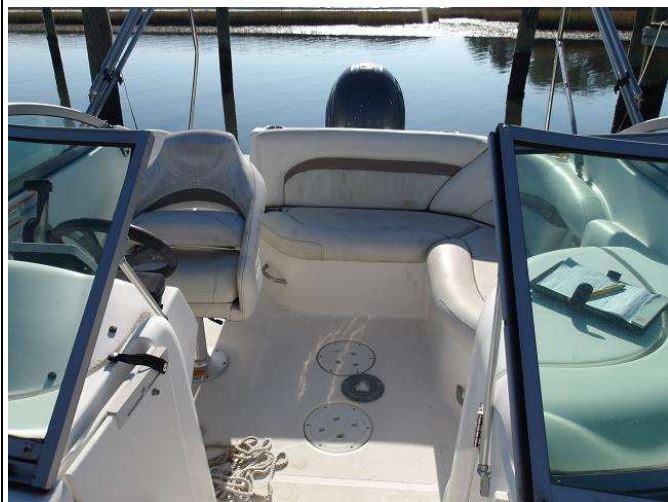
**Aft Seating**

[C.2] All cushions are sun faded and in need of cleaning.
