CORSICA RIVER MARINE SURVEYS, LLC MARINE SURVEYS & LOSS INVESTIGATIONS

CONDITION & VALUATION SURVEY

Client	[REDACTED]
Address	[REDACTED]
Cell	[REDACTED]
Email	[REDACTED]
Date survey written	7/18/22
Vessel Name	Easily Amused
Hailing Port	Smith Mountain Lake, VA
Year, Make & Model	1995 Cruisers Yachts 3570 Esprit
Hull ID	CRSUSA36F495
Doc/Registration #	MD 2429 CS
LOA	39'2"
Beam	13'
Max Draft	3'4" estimated
Hull Material/Design	FRP/Modified Vee
Fuel Type & Engine HP	Gasoline, 310hp/engine(s)
Displacement	16,000 lbs. Estimated

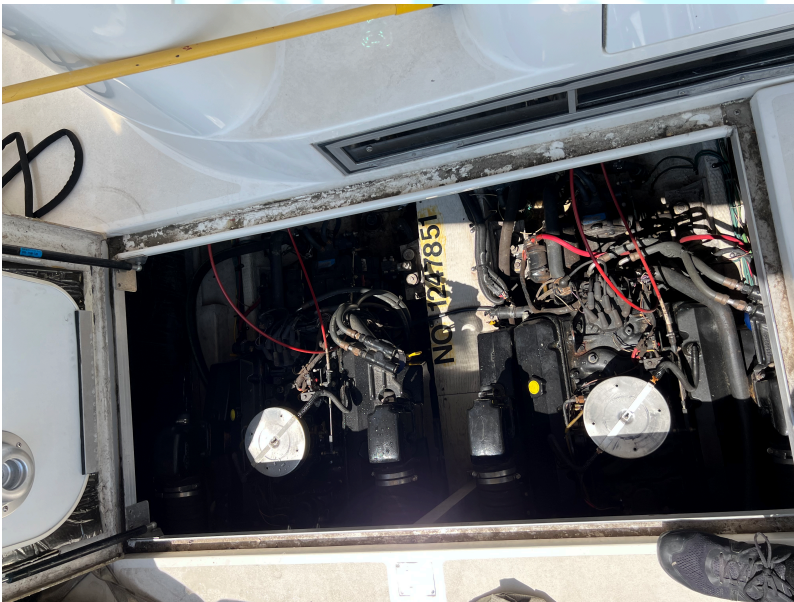
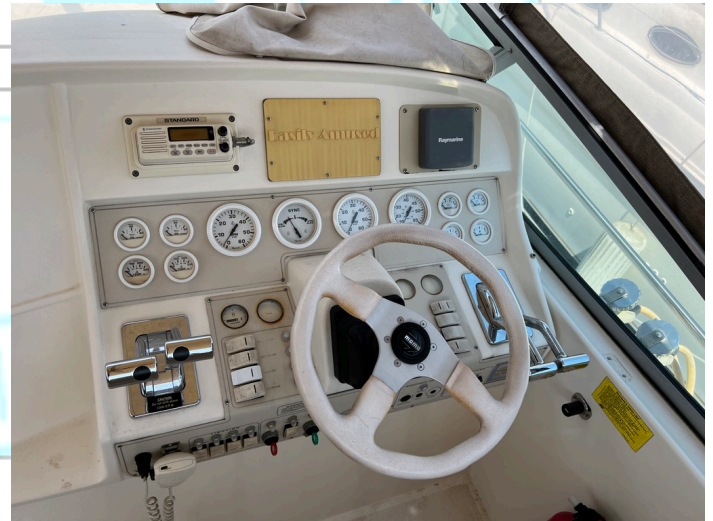
<i>Horns & Bells</i>	Mounted correctly. Handheld horn present	SERVICEABLE
<i>Engine Room Blowers</i>	Blowers were fitted but had holes in them	ISSUES FOUND SEE BELOW
<i>First Aid Kit</i>	Equip as desired.	PRESENT
<i>Smoke Detectors</i>	NONE	NONE
<i>CO Detectors</i>	Present The American Boat and Yacht Council recommends that a carbon monoxide detection system be installed on all boats with enclosed accommodation compartments and, a gasoline generator set, or an inboard gasoline propulsion system. It is also a good idea to install them on diesel-powered vessels because carbon monoxide can be carried aboard from external sources. Detectors shall be located to monitor the atmosphere in the main cabin and each sleeping area.	SERVICEABLE

- #1. Replace all vessel fire extinguishers with up to date versions
- #2. Fix broken blower hose aft of engines
