1997 Hunter 45CC
'GREAT ESCAPE'

Report of Marine Survey

1997 Hunter 45CC

July 09, 2023

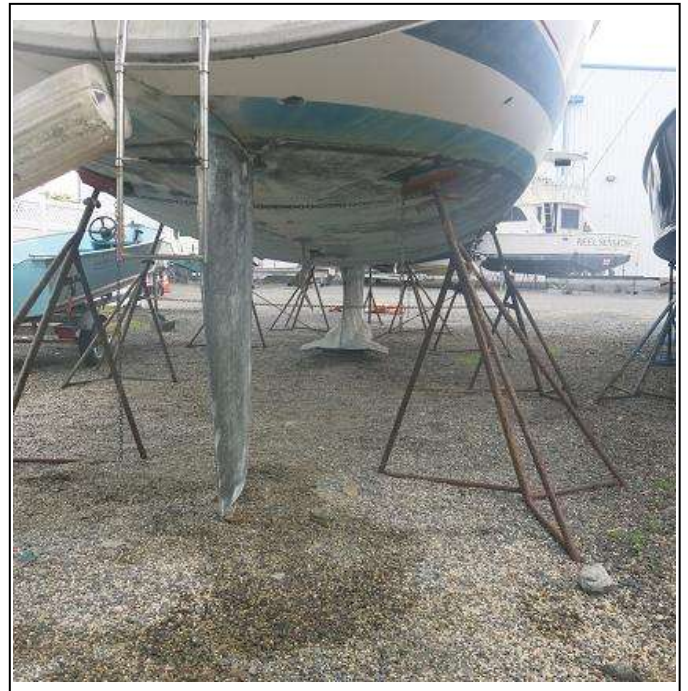
Bottom View

* **CONDITION OF BOTTOM PAINT:** Bottom paint in poor condition.
[C.4] Bottom paint in poor condition.

FINDINGS	RECOMMENDATIONS
C.1 (PAGE 6) MANUFACTURER: Areas of surface rust noted on engine exterior.	<i>Sand, prime and paint for metal protection.</i>
C.2 (PAGE 6) ENGINE MOUNTS AND BED: Surface rust noted on engine mounts.	<i>Remove the rust and apply a protective coating.</i>
C.3 (PAGE 10) ZINCS: Shaft zinc is worn.	<i>Replace zinc.</i>
C.4 (PAGE 10) CONDITION OF BOTTOM PAINT: Bottom paint in poor condition.	<i>Sand, prime and paint prior to next launch.</i>
C.5 (PAGE 11) MAST: Windex was broken and found on side deck.	<i>Investigate further and repair or renew as necessary.</i>

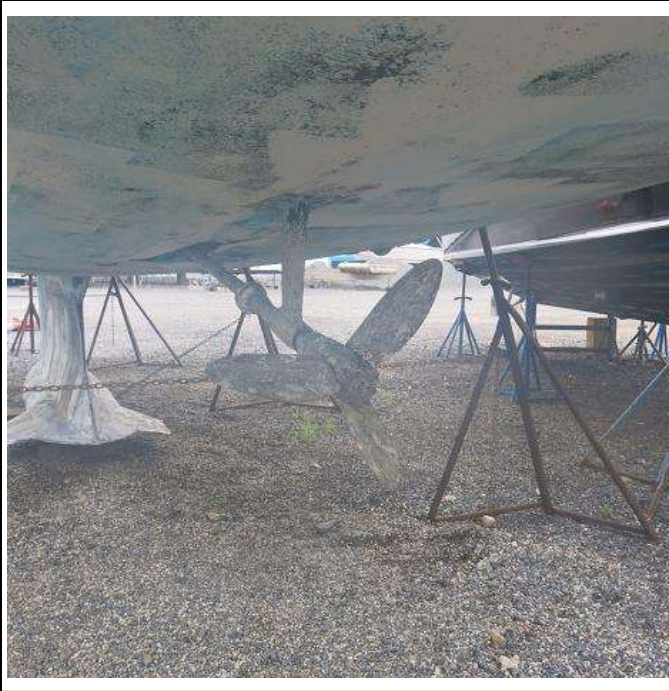
Running Gear

* **ZINCS:** One shaft zinc was observed.
[C.3] Shaft zinc is worn.

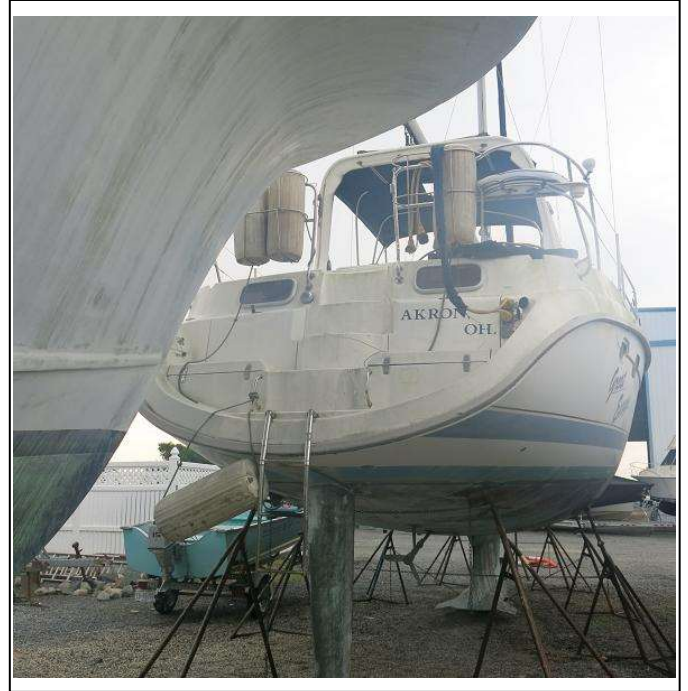
Transom

[B.1] Multiple stress cracks noted on transom.

FINDINGS	RECOMMENDATIONS
B.1 (PAGE 4) TRANSOM: Multiple stress cracks noted on transom.	<i>Further investigate and repair as necessary.</i>
B.2 (PAGE 4) MATERIAL: Multiple stress cracks noted on fore and aft deck, cockpit and elevated moisture was detected.	<i>Further investigate and repair as necessary.</i>
B.3 (PAGE 4) STANCHIONS: The stanchions sighted had stress cracks noted and elevated moisture detected.	<i>Further investigate and repair as necessary.</i>
B.4 (PAGE 6) SEACOCKS AND STRAINERS: All seacocks sighted were inoperable.	<i>Investigate further and find a way to make the seacocks more readily operable.</i>
B.5 (PAGE 10) VISUAL DISTRESS SIGNALS: Day/night visual distress signals and hand held flares. All out of date.	<i>Comply with USCG regulations for Visual Distress Signals.</i>
B.6 (PAGE 11) RAW WATER COOLING PUMP: Raw water intake fitting is broken on aft cooling pump in owner's stateroom.	<i>Investigate further and repair or renew as necessary.</i>

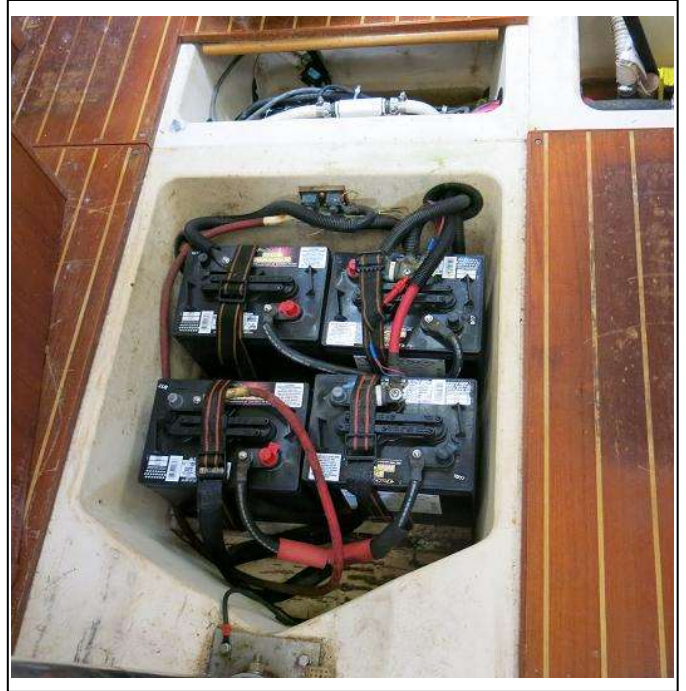
BATTERIES: Four (4) batteries, Deka Pro model GC10, batteries were wired in parallel. Note: Batteries are not operable and all need to be replaced.

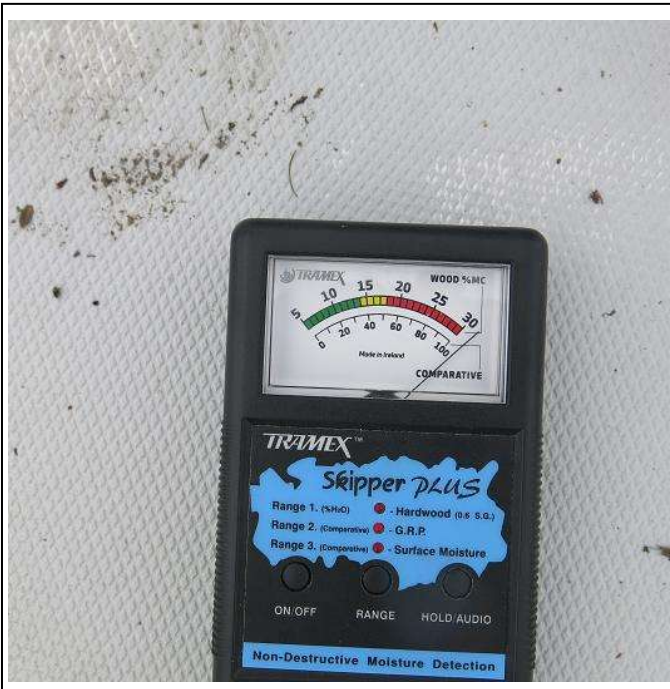
Deck Moisture Reading

[B.2] Multiple stress cracks noted on fore and aft deck, cockpit and elevated moisture was detected.

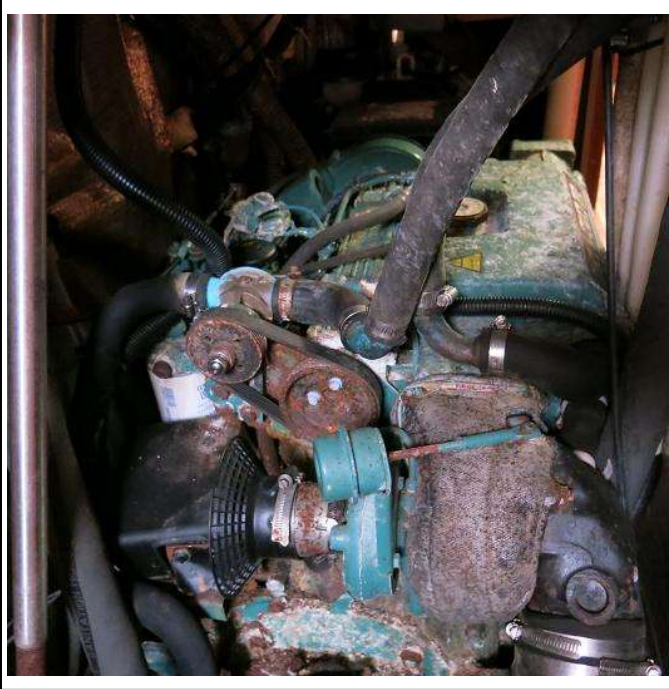
Volvo Engine

[C.1] Areas of surface rust noted on engine exterior.
