Associated Marine Consultants, Inc.

1997 Chaparral Sunesta 232

Report of Marine Appraisal

March 04, 2023

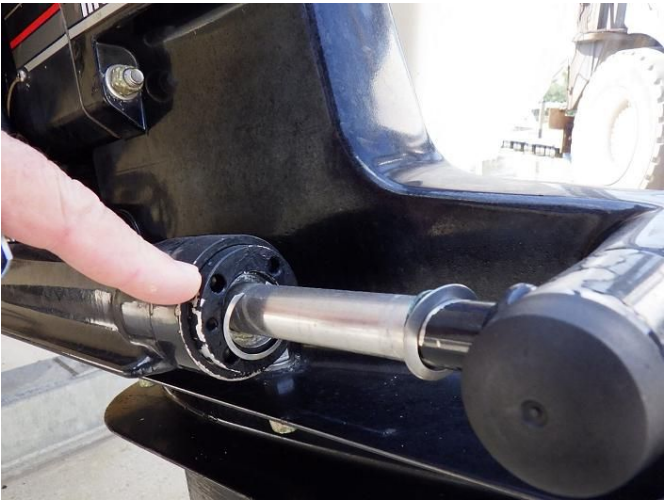
TRIMS SYSTEM: Poor visual condition with seal failure at the ram actuators: Not tested.
The braided fluid hoses were in: Fair visual condition.

Seals on drive trim rams are shot.

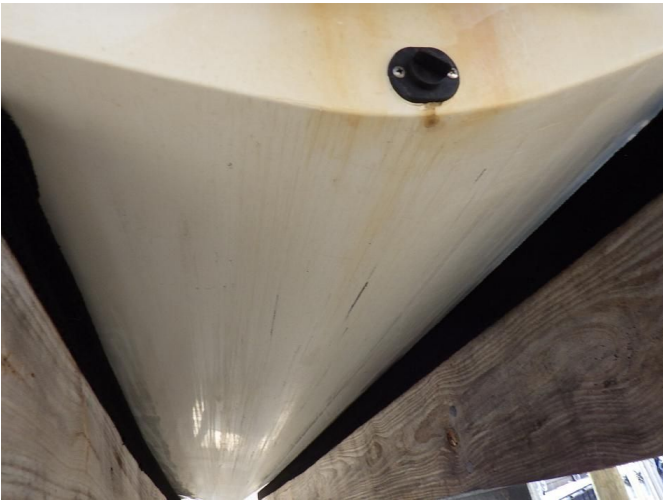
Some gel coat scratches on the hull bottom.

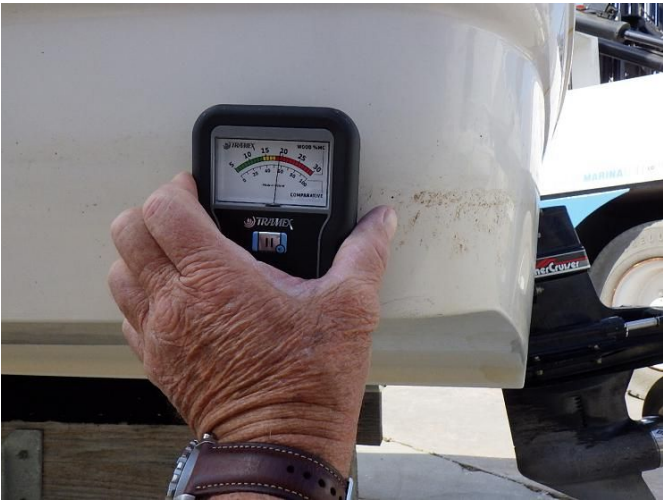
EXTERIOR HULL: Off-White and tan colored gel coat: Good overall condition, with some scratches, rub marks and imperfections. Gel coat stress cracks were noted on the port side hull, near the transom.

MOISTURE CONTENT: Moisture readings taken with a Tramex SMM5 moisture meter were: Unremarkable with exception to the port side hull stress crack area near the transom.

This one area had elevated moisture readings at the gel coat impact stress cracks.

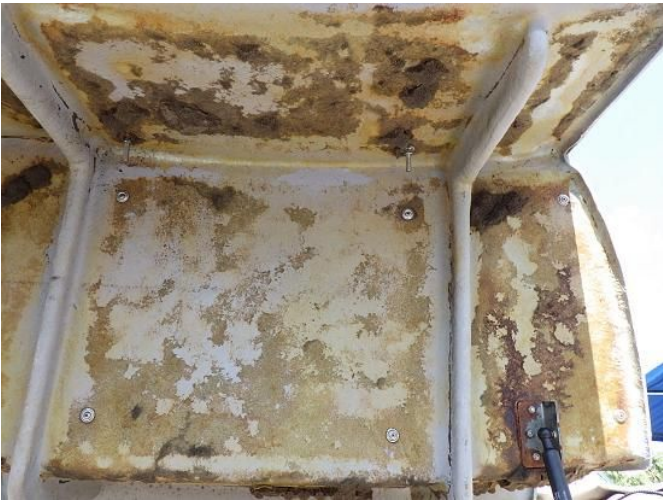
INSULATION: Poor condition, mostly gone or deteriorated.

Machinery space insulation is deteriorated/gone.

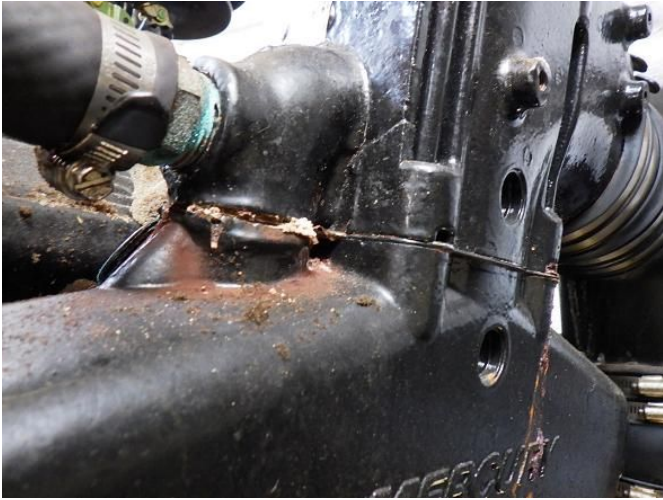
EXHAUST SYSTEM: Cast iron manifolds and risers to flexible hoses to cast iron elbows and discharge through the propeller:
Poor visual condition with evidence of leaks.

Evidence of deterioration at exhaust components of the engine.

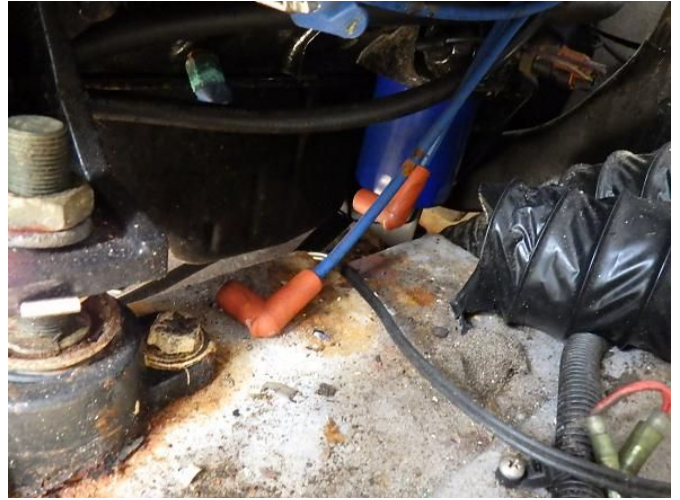
CONDITION AND DEFICIENCIES: Two (2) spark plug wires were off on the left side of the engine.

Two spark plug wires were not installed.

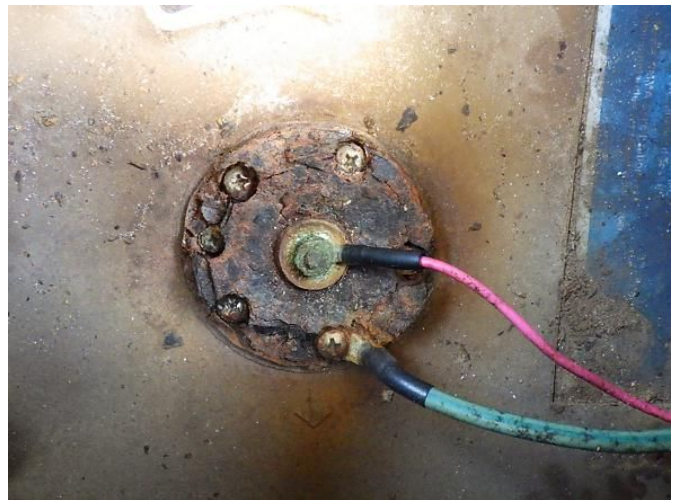
FUEL LEVEL SENDER: **Poor condition with substantial rust deterioration.**

Fuel sender on plastic tank is rusty. DANGER.
