**2004 CHAPARRAL**  
**290 SIGNATURE**  
**FGBA0635E404**

## **APPRAISAL REPORT**

**REPORT NO. 6188DS**

The vessel is a Chaparral 290 Signature built by Chaparral Boats Inc., 300 Industrial Park Blvd, Nashville, Georgia, 31639, (phone number 229-6867481), in the year 2004, as hull identification number FGBA0635E404. The vessel's approximate measurements are: LOA 30'8" BEAM 10'0", and DRAFT 2'9". The vessel's name is CRUISE ALTITUDE.

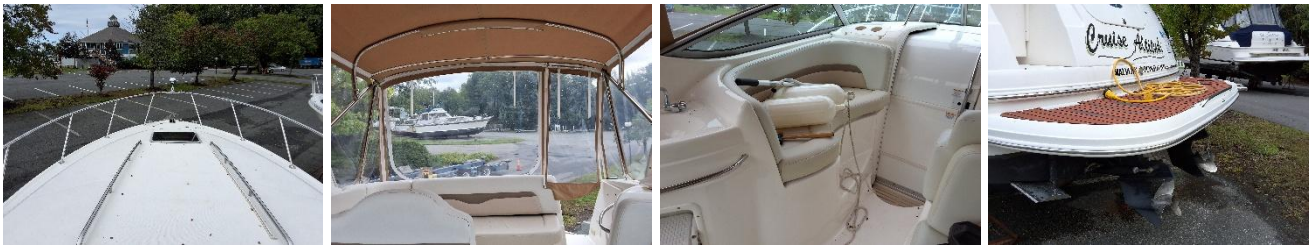
- a) The foredeck, catwalks, aft deck, and swim platform appear to be solid and in good condition with no significant voids or delamination.

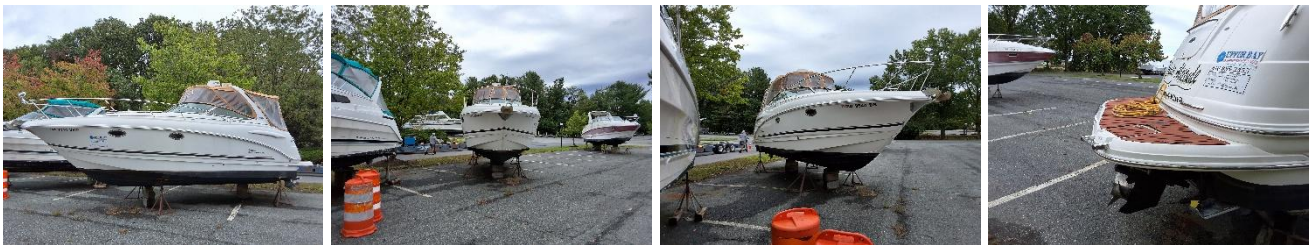
- b) The hull and transom above the waterline appear to be in good condition.

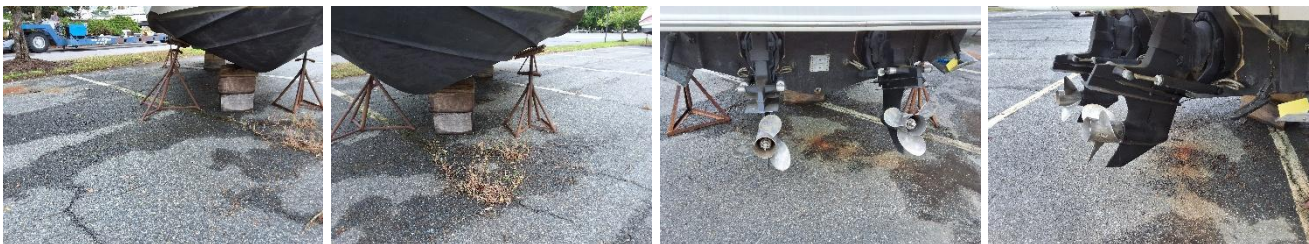
- c) The deck supports, bulkheads, stringers, and tabbing accessible for inspection appear to be in good condition.
- d) The bottom and transom below the waterline appear to be in good condition with no signs of damage or repair.

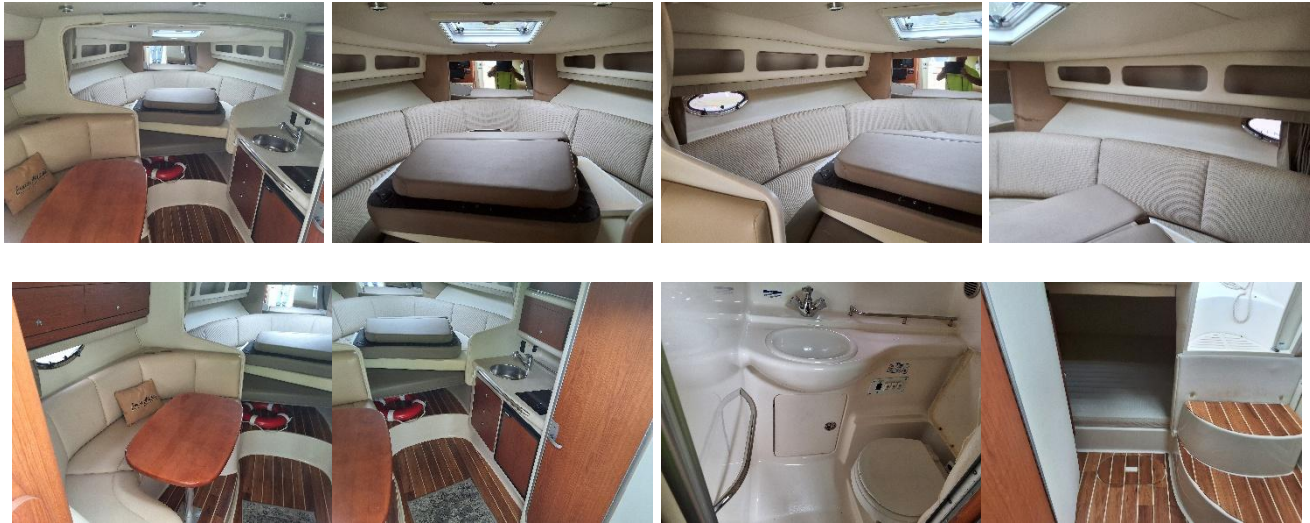
The interior shows well, showing signs of normal wear.

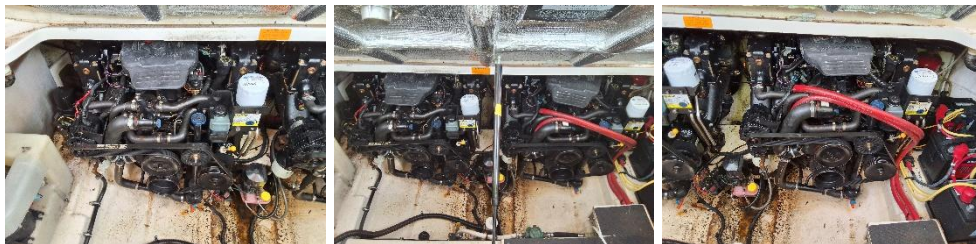
**ENGINES:** said vessel is powered by twin Mercury Mercruiser 4.3, 262ci, V-6, 190-225hp, raw water cooled, gas engine. The starboard engine's serial number is OW027897. The port engine's serial number is OW027890. The engines appear to be in good condition. Note, this is a visual inspection, the engines were not started.

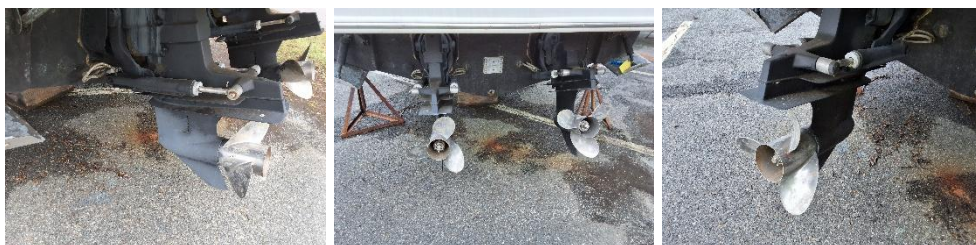
**STERNDRIVES:** the vessel appears to be equipped with Mercruiser Alpha one sterndrives. The stern drives appear to be in good to fair condition.
