**WILLIAMS MARINE SERVICES**  
**Po Box 131**  
**Mattituck, NY 11952**  
**631 873 6800**  
**REPORT OF MARINE SURVEY**

**Appraisal Inspection.**  
**of the vessel**  
**"The Cariku. "**  
**1997 Egg Harbor 38 Golden Egg**

**CONDUCTED BY:**  
**Brian Williams AMS®**  
**on**  
**10/7/2025.**

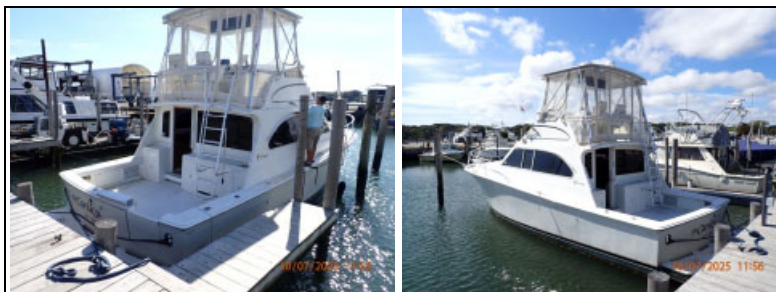
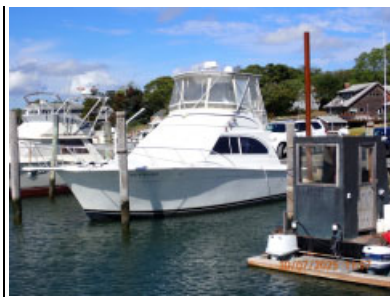
**Photos:**

**Condition summary:** Appears to be in very good condition.

**Condition summary:** Convntional flat transom with attached swim platform well secured and in good condition.
