BOLZ MARINE SURVEY & CLAIMS, LLC
MARINE SURVEYOR AND CONSULTANT

1988 20' Champion Fish and Ski

Report of Marine Survey

September 19, 2023

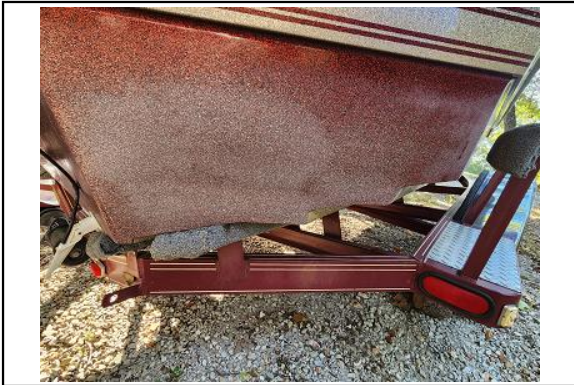
*B.1

The gel coat is slightly oxidized

(B.1) Forward stem view

FINDINGS	RECOMMENDATIONS
The gel coat is slightly oxidized	No recommendations.

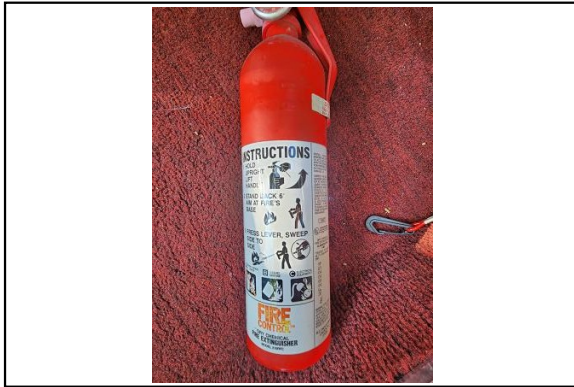
*A.1

The extinguisher is expired past twelve years.

Single hand held extinguisher

FINDINGS	RECOMMENDATIONS
The extinguisher is expired past twelve years.	<i>Comply with USCG Code (46 CFR 25) Fire extinguishers must be current within 12 years. Vessels 26' to less than 40' with no fixed or expired fixed system require 2 B-I or 1 B-II.</i>

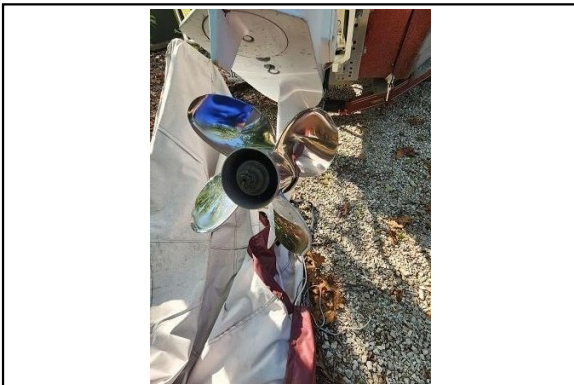
*B.2

Stainless prop has slight dog ear bends at the tip on at least two of the blades.

Stainless prop

FINDINGS	RECOMMENDATIONS
Stainless prop has slight dog ear bends at the tip on at least two of the blades.	No recommendations.

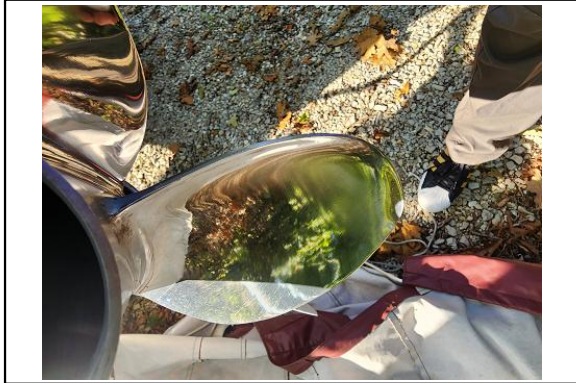
Stainless blades
