**1980 39'9" Irwin Citation 39 Shoal**  
**"Archipelago"**

# **Report of Condition & Value Marine Survey**

**1980 39'9" Irwin Citation 39 Shoal**

Inspection performed on: 11/18/22

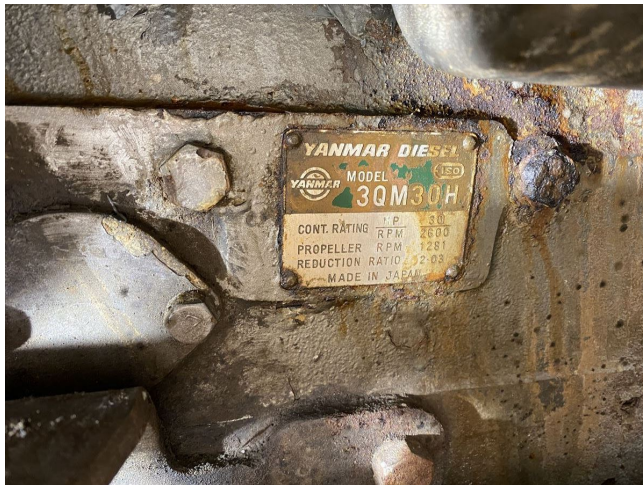
### ENGINE MODEL

The vessel's main propulsion is a single Yanmar 30 HP Diesel Engine.
