Vessel Name: M/Y "DIXIE"

REPORT of APRIL 23 & May 10, 19 & 24, 2021 INSPECTIONS

"CONDITION AND VALUE INSPECTION"

DESCRIPTION OF VESSEL: Down East style Wooden Picnic Yacht with Black topsides and tan decks powered by a Single Mercruiser 5.7L Gas Inboard Engine (2016).

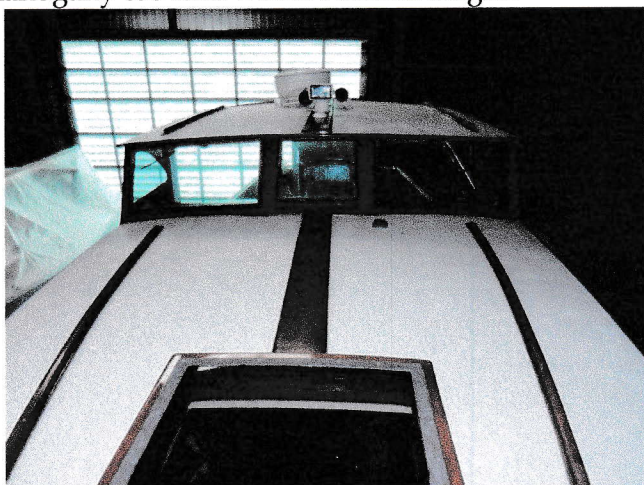
April, 2016

The raised foredeck is constructed of buff painted Dynel fabric over plywood with painted non-skid. Most forward is a SS anchor roller with 35# Quick Set Plow anchor with 30' of 3/8" chain and 200' of 5/8" twisted nylon rode handled by a bronze Muir vertical 12VDC windlass with helm and foot controls forward. A single 4" bronze mooring bitt and chocks set into the toe rails were present for mooring the vessel. The trunk top varnished mahogany hand rails were in good position for gaining access to the foredeck and there are raised mahogany toe rails which run full length.

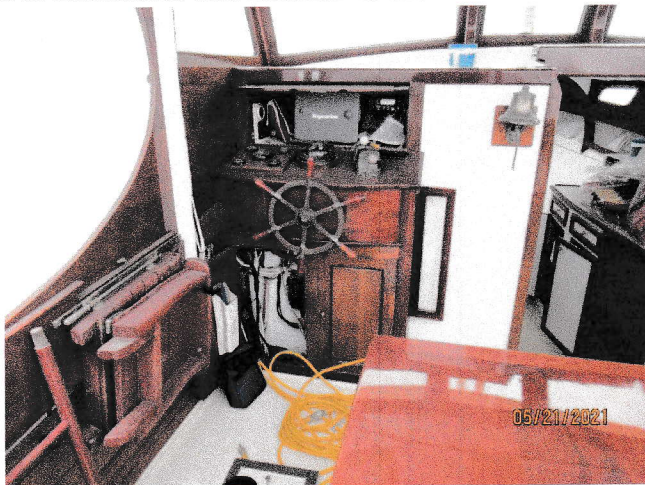
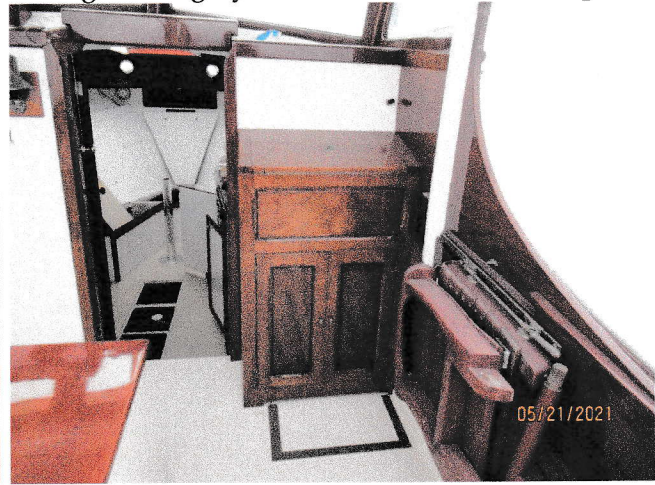
The pilothouse is open to the cockpit and is entered on each side of the tall insulated engine box with varnished mahogany top. Decking within the pilothouse is continuous with the cockpit deck. The helm is to port with electronics mounted in a locker at the helm. There are three (3) aft raking windows with safety glass and the outboard windows are larger and have electric wipers. The traditional hard top is supported by the front and side wings and has a radar, vhf antenna, remote spot light and handrails for going forward. The pilothouse is constructed of marine mahogany plywood painted white with highly varnished solid mahogany trim and doors. There is a wet bar/ice box to starboard and a mahogany folding helm seat to port and matching seat to starboard. The interior of the Pilothouse and coamings are highly varnished as are the cockpit ceilings.

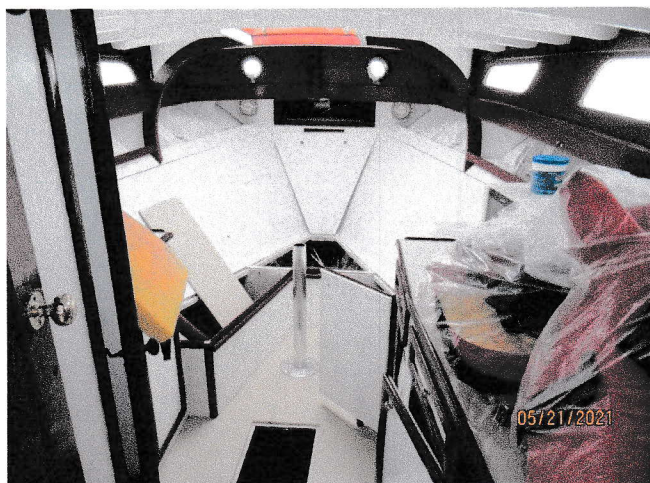
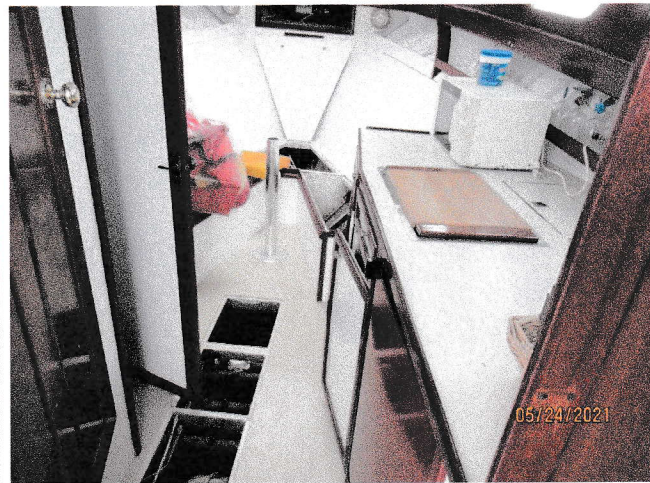
The interior is painted white with highly varnished trim and doors to yacht quality and is entered through the solid mahogany hinged in turning door and folding hatch slightly off on center to starboard.
