1974 33 Viking Boats Sloop Rigged Sailboat

"Compromise"

Underwriter's C&V Survey Report

Date Of Survey: April 19, 2025

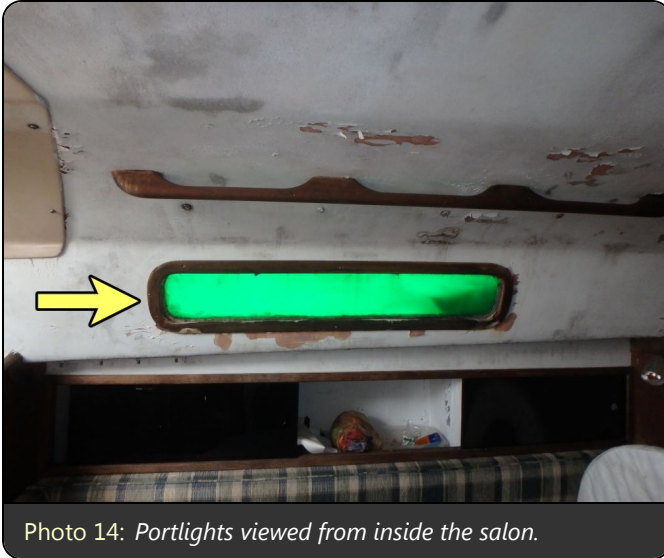
The boat had a total of four portlight – two in the salon area and two amidship in the head and forward salon area and a single hatch on the foredeck. The portlights were sealed with a plastic material and according to the owners it provides an effective way to keep moisture out and serves for their intended usage. There is water staining indicating some level of previous water intrusion on the inside of the portlight window frames and the surrounding areas.

Photo 14: Portlights viewed from inside the salon.

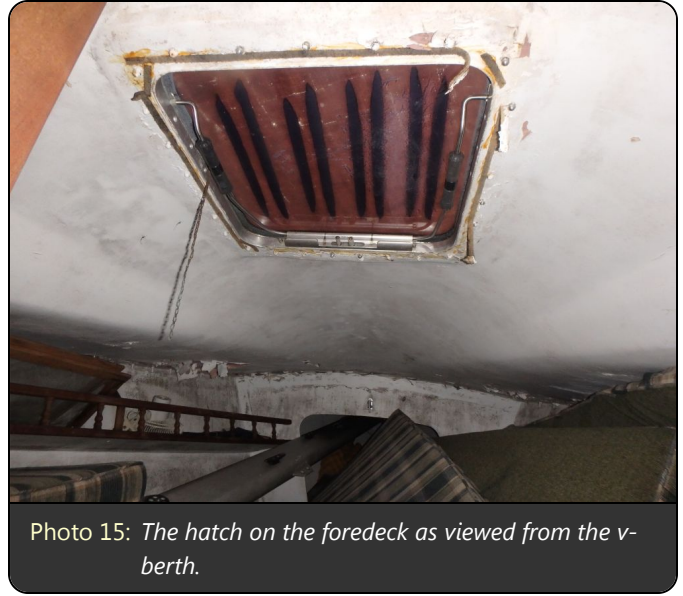
Photo 15: The hatch on the foredeck as viewed from the v-berth.

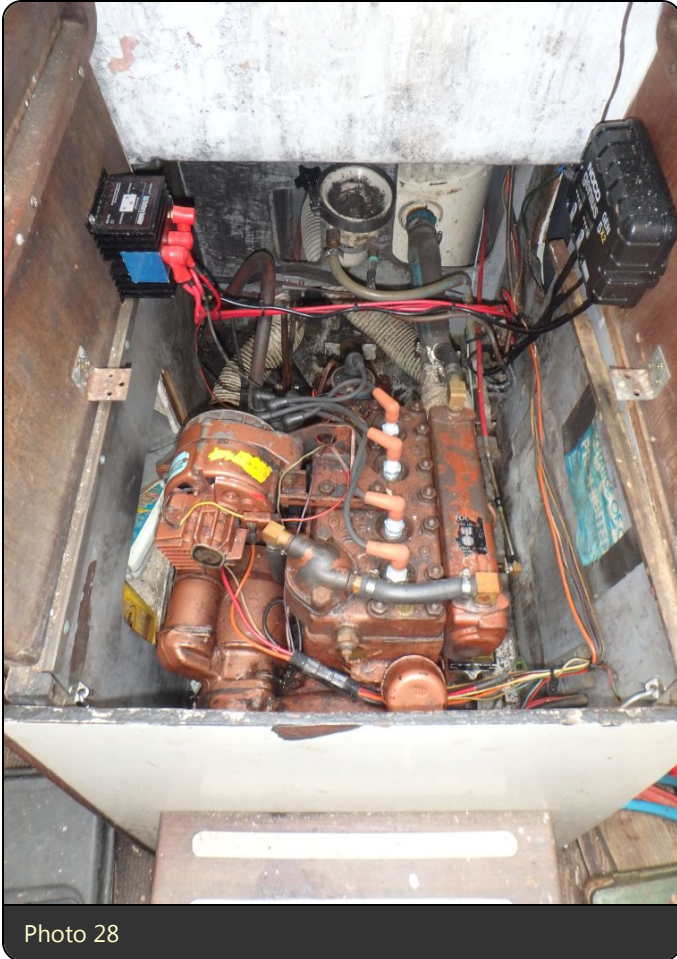
The engine used a raw water cooled exhaust with flex hose and a steel water lift muffler exiting the transom. The exhaust hose appeared to be "swollen" near the connection to the water lift muffler. Recommend to replace this section of hose.

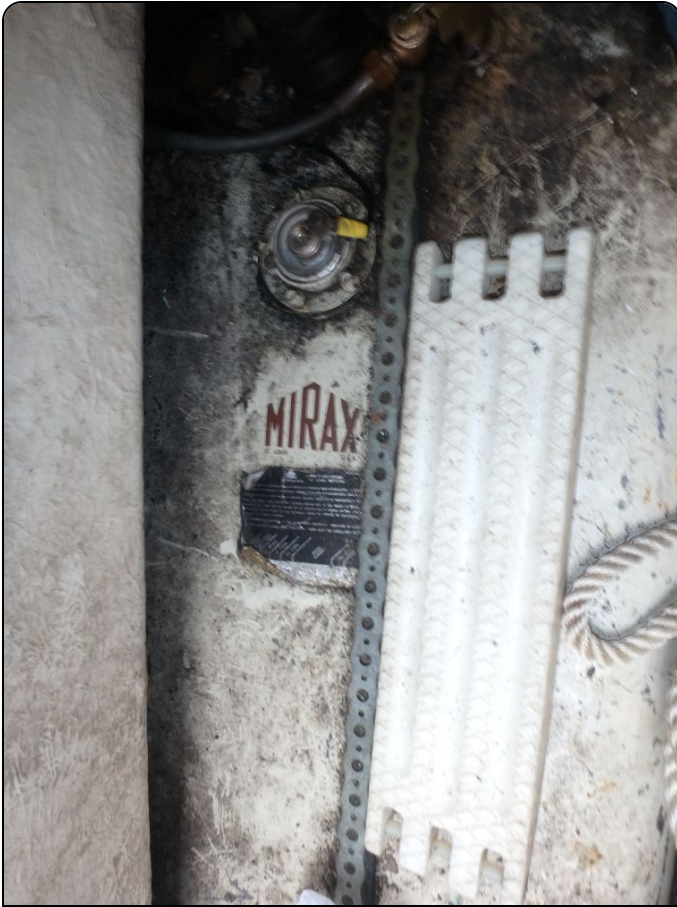
The fuel fill cap was stainless steel and was located on the port side of the vessel. The fuel tank could be accessed through the port side settee locker and was labeled as a Mirax fuel tank. It was encased in the fiberglass structure. The tank had a grounding wire properly attached and a ball valve seacock on the top of the tank with a hose leading to the fuel filter. Upon inspection the fuel fill hose appeared to be serviceable - no leaks or gasoline fumes were noticed during the inspection.

Photo 10 Fuel tank with grounding wire and seacock

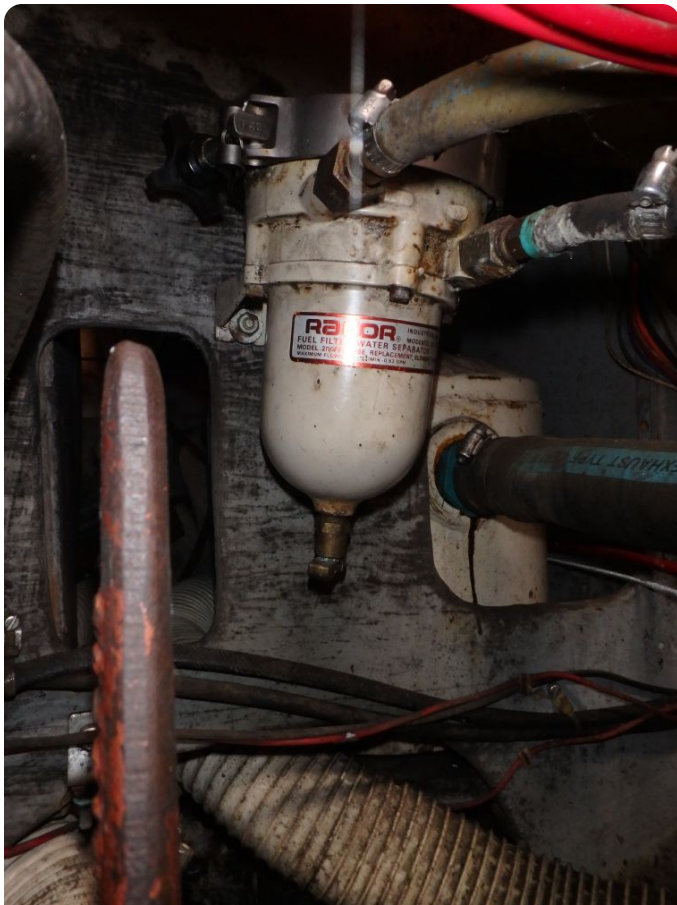
Photo 33:

A Racor 200F fuel filter was in the engine compartment. It's recommended to clean / replace the filter annually. While not an immediate need, this maintenance should be done this season.

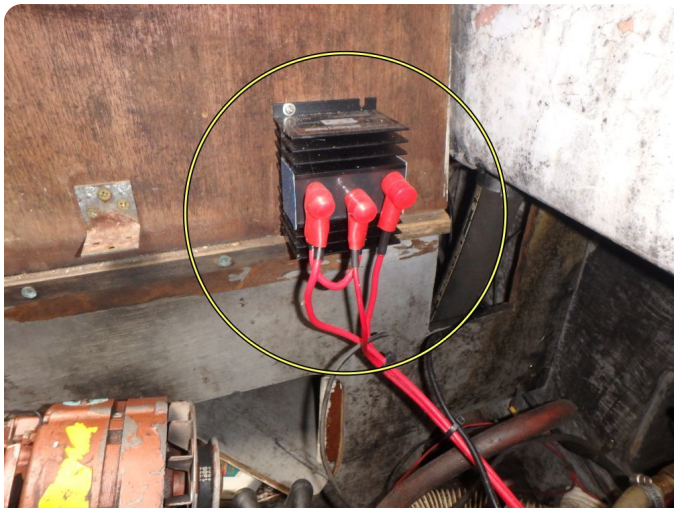
Photo 38:

There was a battery isolator in the engine compartment. It was properly mounted. The model and serial number were not legible.

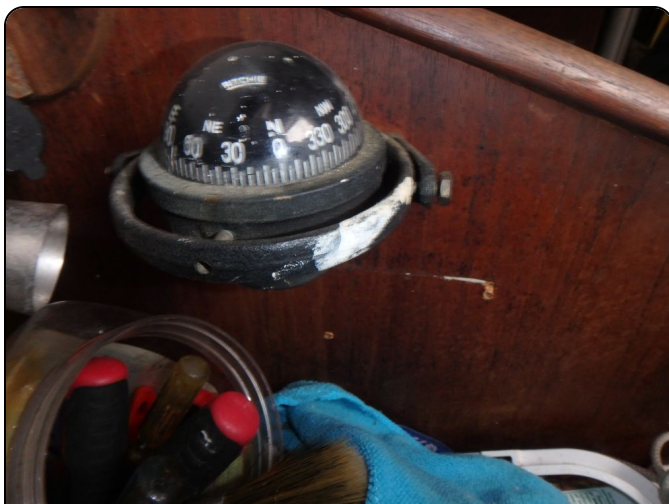
An AquaMeter compass was integrated into the steering pedestal in the cockpit. As observed, the compass had moderate to severe hazing on the glass/ plastic viewing bubble making it hard to read. An additional Ritchie brand compass was sighted in the cabin near the navigation station and appeared to move freely and function as intended.

Photo 45: *Compass in the cabin.*
