REPORT OF MARINE SURVEY

**Appraisal Inspection
of the vessel
"Forever And a Day! and a Night"
1994 Bayliner 3055 Ciera Sunbridge**

10/20/2022

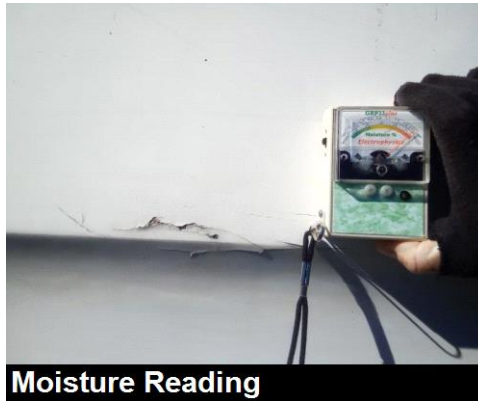
Moisture Reading

Most moisture meter readings on hull sides and surrounding thru hull fittings were relatively dry with normal comparative moisture meter readings. Moisture meter showed higher than normal moisture meter readings of more than 30% on a scale of 0-100 and possible delamination when same areas checked with percussion hammer. Suspect areas are: Starboard board hull side surrounding the impact area above the Bayliner logo. **RECOMMENDATION:** To determine more precisely the condition of laminate, examination of core samples is advised to determine actual condition of interior FRP material. Have the areas noted checked by a fiberglass/hull expert to determine extent of moisture and internal condition of FRP and or core material.

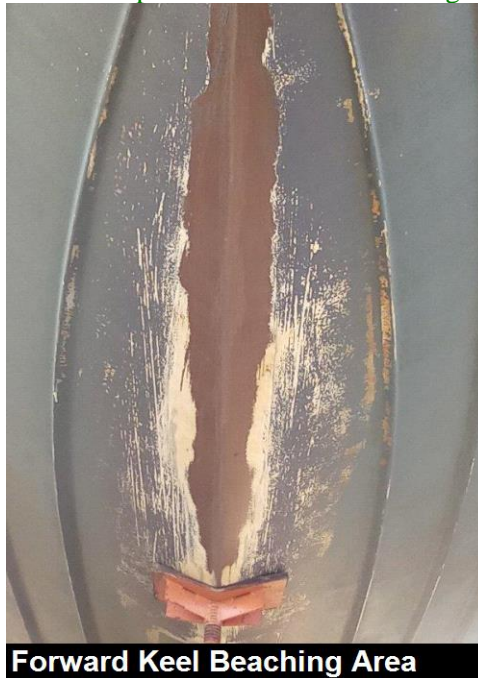
Forward Keel Beaching Area

Construction material: Molded fiberglass, with hard chines, with multiple molded in strakes on each side. No cracks or separation sighted on any portion of hull bottom.
Bottom paint: Anti-fouling bottom paint in good condition.
Stress cracks: None sighted.
Osmotic blistering: NO evidence of blisters was found on hull bottom during bottom inspection.
Moisture/Delamination: All random moisture meter readings on hull bottom and surrounding thru hull fittings were relatively dry with normal comparative moisture meter readings. No Delamination discovered when randomly testing with percussion hammer.
Grounding damage: None noted.
Strainers/Scoops/Screens: All strainers/screens are well secured to hull bottom. Clear of debris & zebra mussels.
Thru Hull fittings: Mushroom type bronze fittings for all below water line sea cock locations. Well secured to hull bottom.
Hull bottom drain plugs: Consider installation of fiberglass beaching shoe if planning to beach frequently to aide in the protection of the hull fiberglass.

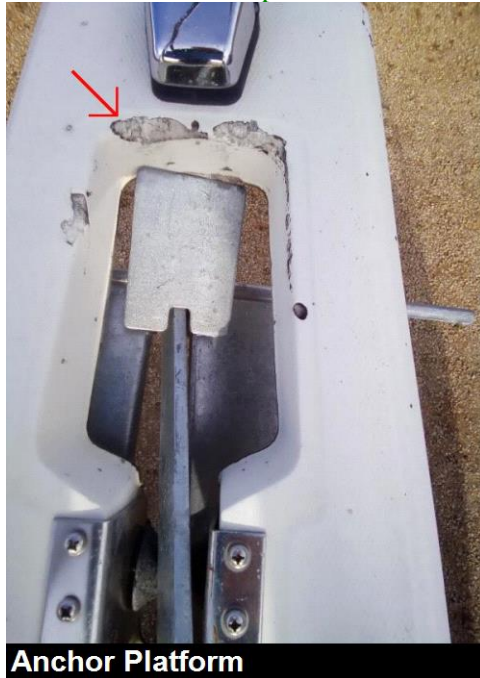
Anchor Platform

- Deck Surface:** Molded, cored fiberglass deck and side deck construction (core not sampled). White gel coat with molded in non-skid fiberglass surface. Good condition. Deck is solid under foot, no soft spots discovered and no visible cracks or chips sighted.
- Moisture/Delamination:** Moisture meter readings on top and side decks and surrounding thru deck fittings were relatively dry with normal comparative moisture meter readings. No Delamination discovered when randomly testing with percussion hammer.
- Anchor platform:** Fiberglass platform. Fiberglass chips or gouges sighted at anchor platform. Recommendation: Repair as needed to restore to original condition.

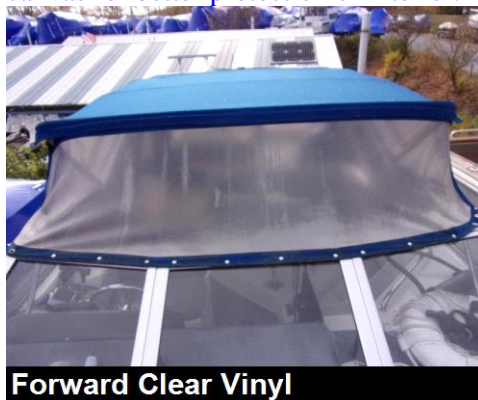
Forward Clear Vinyl

Cockpit area: Fiberglass non-skid with engine hatch cover.
Cockpit & Helm seating Adjustable/Swivel single helm seat. aft bench seat with storage under seat areas, "L" shaped vinyl covered seating on side of helm station. Padded cockpit vinyl seat cushions available and are in good condition.
Sole: FRP (fiber reinforced plastic) with molded in non-skid.
Moisture/Delamination: All moisture meter readings on sole were relatively dry with normal comparative moisture meter readings.
Scuppers/deck drain(s): Yes.
Canvas: Camper top canvas enclosure with stainless steel frame support. The plastic glass is not clear. Discolored/clouded/cracked in numerous places and near the end of it's expected life. Many areas the snaps cannot be secured due to age shrinkage. **RECOMMENDATION:** Renew all plastic canvas glass and re fit or replace all canvas for better protection of interior.

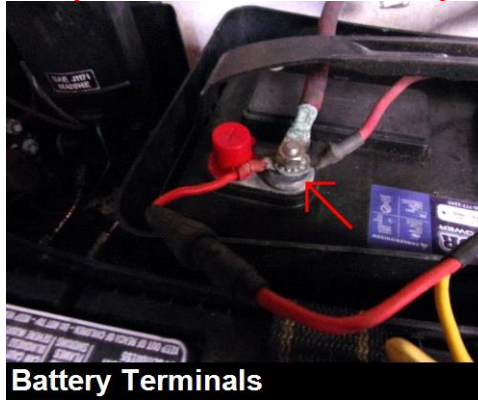
Battery Terminals

Battery Set One: Battery set has a total of one sized 27 lead acid that are type deep cycle that are located in the engine compartment which provide service to engine start. Positive terminal(s) not covered as required. **RECOMMENDATION:** Code of Federal Regulations - CFR33.183.420 mandates that positive terminals be protected against accidental shorting by the use of insulation barriers or sleeves or with battery case cover. Recommend compliance with Code of Federal Regulations.

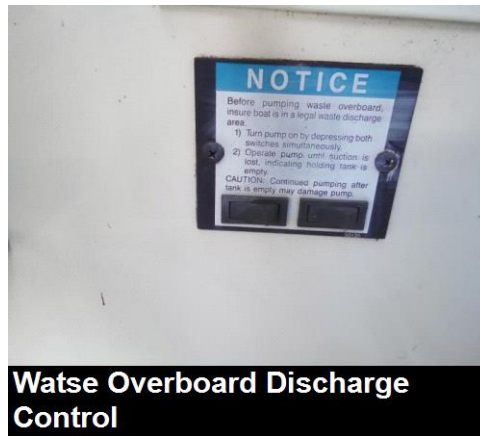
Marine Sanitation Device: Certification Type: MSD U.S.C.G. Type III. (Holding tank). Waste tank is connected to deck waste fitting for pump out. Waste tank appears to be also connected to an operational overboard discharge system in addition to the waste holding tank and deck pump out. This is in violation of USCG regulations for the Great Lakes and all inland waters. An operational waste overboard discharge system is illegal in Inland waters and the Great Lakes and can result in major fines. **RECOMMENDATION:** The overboard discharge system if connected must be disabled. USCG regulation 33CFR 159.7 requires securing the device by one of the following methods: 1) closing the seacock and removing the handle; 2) padlocking the seacock in the closed position; 3) using a non-releasable wire-tie to hold the seacock in the closed position; or 4) locking the door to the space enclosing the toilets with a padlock or door handle key lock.

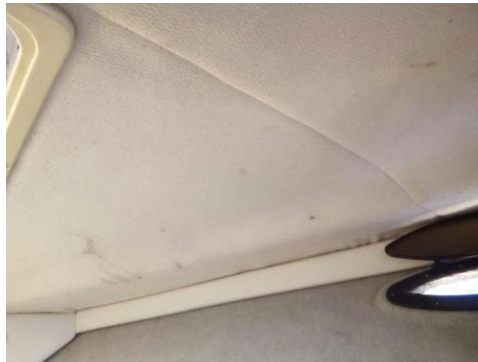
Style: Contemporary.
Cabin steps: Carpeted cabin entrance steps.
Sole: Carpeting installed throughout. Carpet needs cleaning.
Bulkheads/Trim: Vinyl covered.
Headliner: Padded cloth. Some staining noted.
Headliner above cabin entry steps is becoming dislodged from the ceiling area.
Recommendation: Monitor and renew as needed if condition worsens.

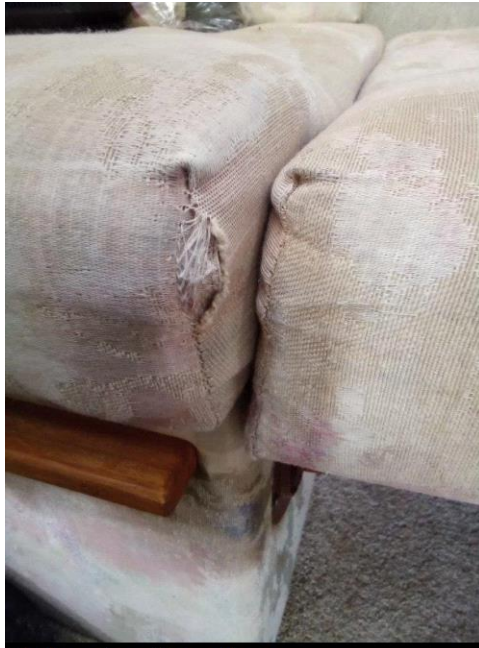
Salon Seating Area

Hatch screens: None sighted.
Framing Trim: Teak trim around all doors and counter tops.
Salon furnishings: Convertible dinette sleeper.
Light fixtures: 12 volt cabin lights throughout the vessel.
Seating: Full cushions, cloth covered. Worn areas or seam splitting sighted on cushions.
RECOMMENDATION: Cushions will need recovering in near future to restore to original condition.

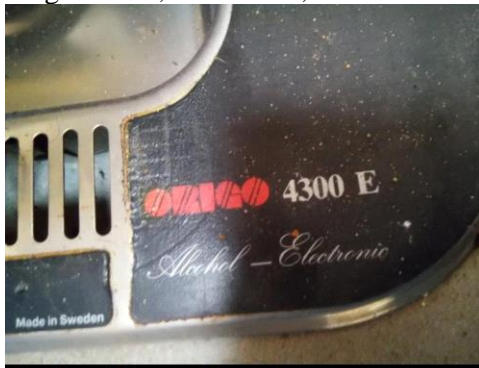
Galley Stove Model

- Location:** Starboard side, with Formica type surface counter top, and teak trim.
- Sink(s):** Single stainless steel deep well, with hot/cold faucet.
- Water system:** Pressurized hot and cold. Not tested. Water system was winterized.----- Re-test on board fresh water system after filling water tank with water.
- Stove:** Origo 4300E, two burner, alcohol/electric. Not tested.

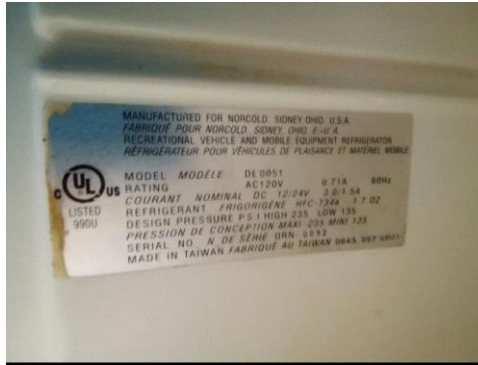
Refrigerator Label

- Refrigeration:** Norcold model DE-0051 with freezer. Door safety lock is installed and functional. Designed to operate on 110V or 12V power. Not tested. No AC or DC power available.

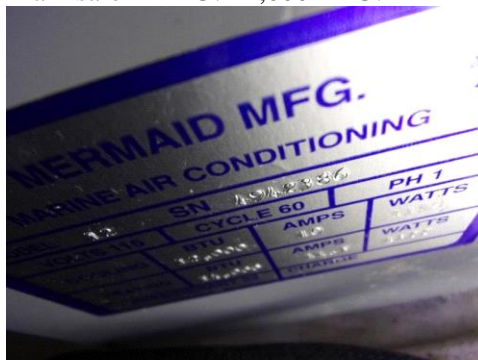
Air Conditioner Label

Manufacturer & Type: Mermaid Marine Air, 120 volt - reverse cycle.
Locations / BTU Capacity: Main salon- BTU: 12,000 BTU.

Hunter digital control. Not tested.
Air intake filters in need of cleaning. ----- Clean air intake filter to allow A/C unit to operate at maximum efficiency. Vent cover for filter is broken. Recommendation: Repair or replace as needed to restore full function.

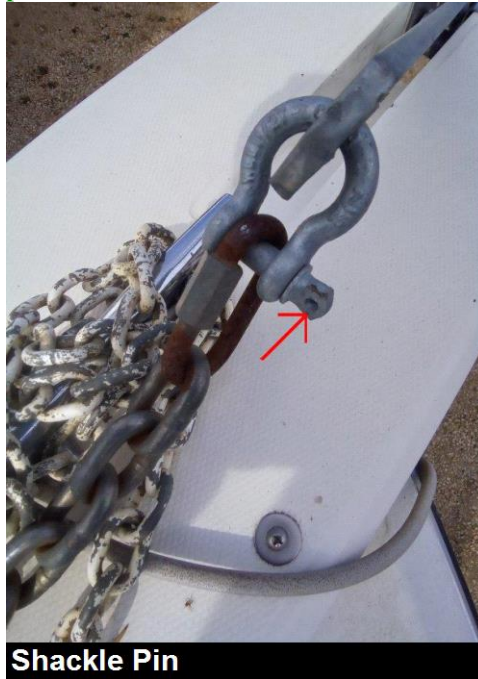
- Primary anchor:** Hooker type. Anchor/rode shackle pins are not properly seized----- Seize anchor rode shackles with galvanized or monel seizing wire from pin to shackle to help

prevent loss of anchor.
