1988 Cal 28 Sloop
Gin N Me Cricket

Report of Marine Survey

1988 Cal 28 Sloop

**Conducted by
Charles Ulrick**

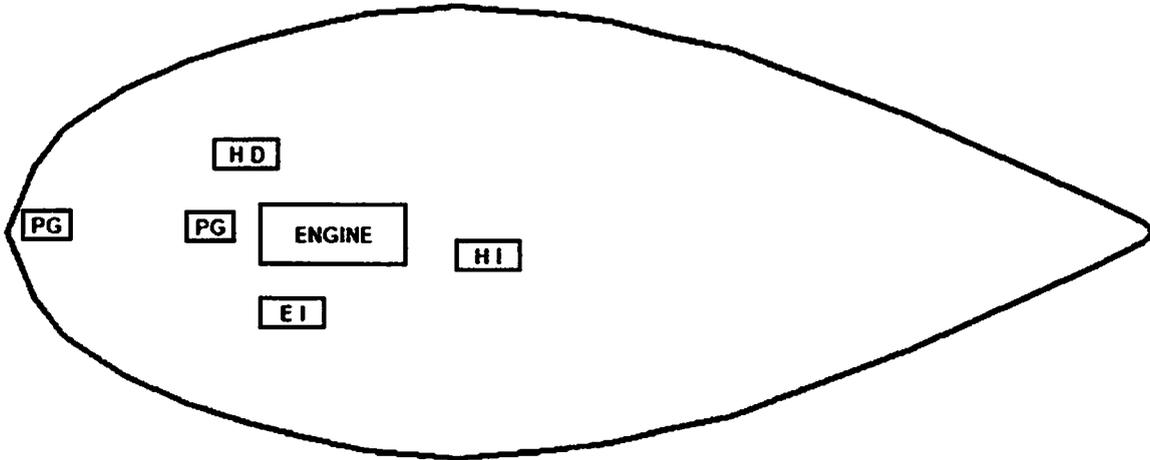
THRU-HULLS BELOW WATER LINE (DIAGRAM):

** Red Icon(s) with white text indicates inoperable item.
