### **Findings**

This surveyor was onsite at [REDACTED] in Milwaukee, WI on 7/21/2022 to inspect the referenced vessel for damages alleged to have occurred as a result of impact from handling or layup of the boat.

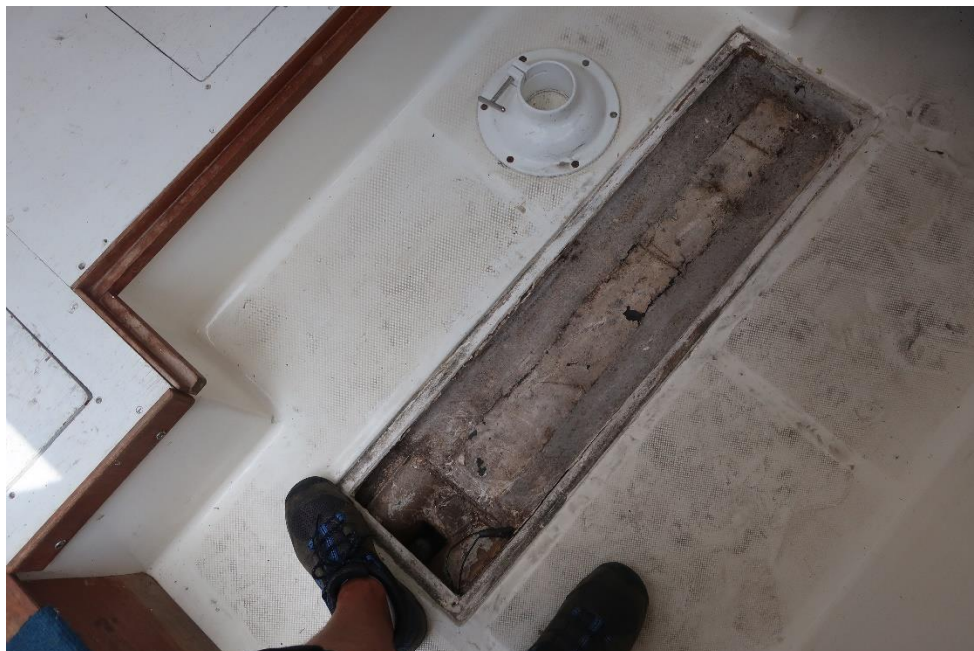
The keel pocket is full to the top with a filler material. It has not been determined if this is OEM, or added later in an attempt to seal leakage. It is not typical of modern boat construction. It is cracked indicating it would not prevent water from pushing up through the keel if full.
