## Captain Vic's Marine Services

CVMS-210526

M/V Wellcraft St Tropez 3200

### Condition and Valuation Survey

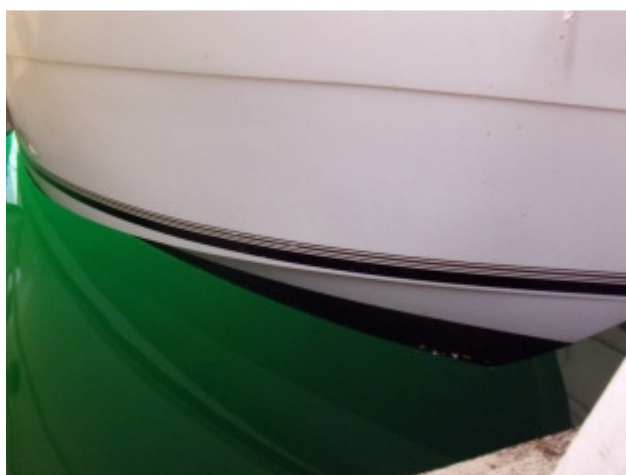
Stem Starboard Side Forward

Visual and percussion testing of the transom and topsides (hull) found them in good – serviceable condition with no evidence of voids, delamination or blistering. The flare and shear were fair and smooth to the eye with no evidence of impact or abrasion on the stem.

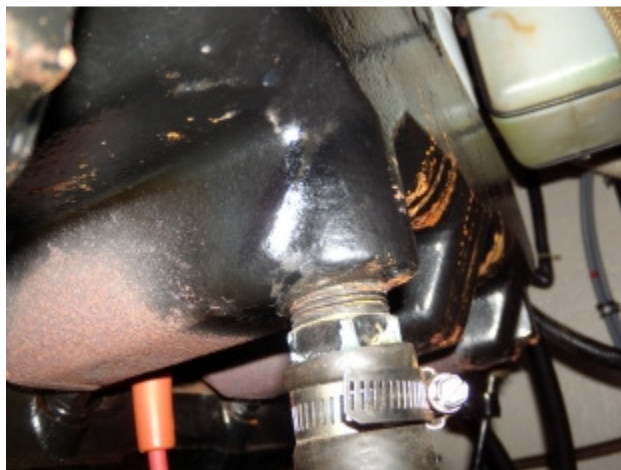
Underside of Port Main Engine Exhaust Manifolds

Wet type exhaust on the main engines exiting through inline mufflers to the port and starboard sides. The water cooled exhaust manifolds and risers appeared to be in serviceable condition. There was evidence of iron oxide corrosion (rust) from the riser to manifold gaskets. (\*) No evidence of cracking. Double all stainless steel hose clamps were sighted at all exhaust connections.
