**2014 Hurricane SunDeck 2000**

# **Report of Marine Survey**

November 25, 2022

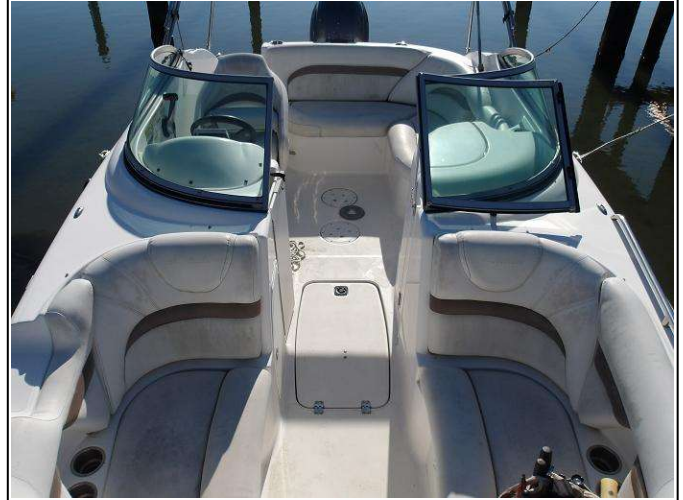
**Bow View**

**BOW PULPIT (BOW RAIL):** Low profile stainless steel rail system. Appears serviceable.

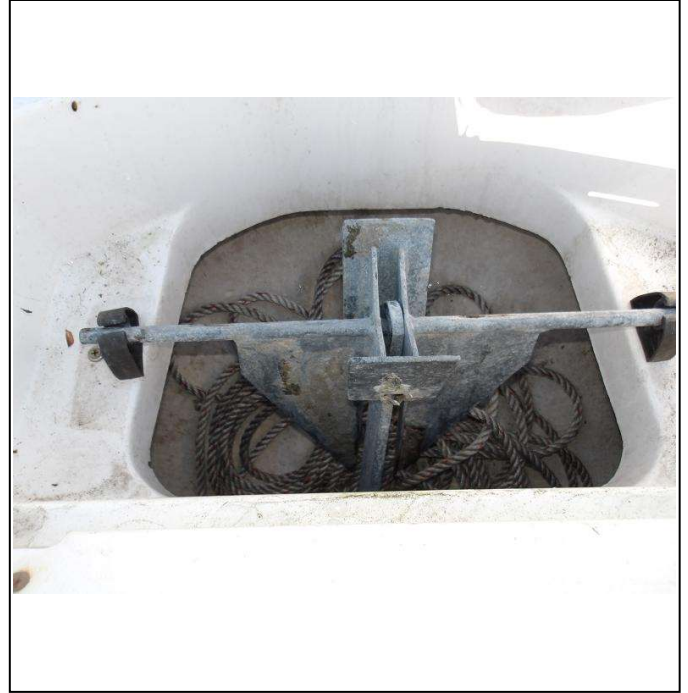
**Anchor Locker**

**TYPE:** Visible from the chain locker the hull to deck joint was of the deck overlap type, with screw stainless fasteners. Appeared serviceable where sighted.
