1997 Hunter 45CC
'GREAT ESCAPE'

Report of Marine Survey

1997 Hunter 45CC

July 09, 2023

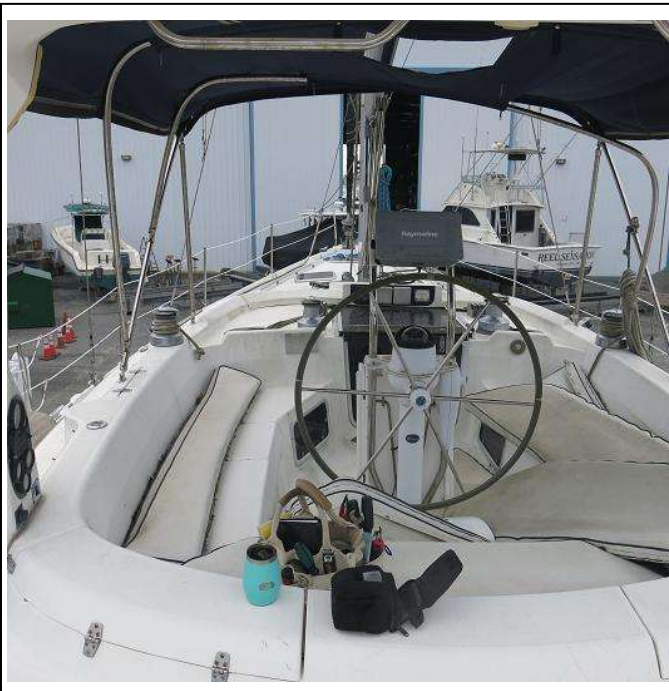
Cockpit

[B.2] Multiple stress cracks noted on fore and aft deck, cockpit and elevated moisture was detected.

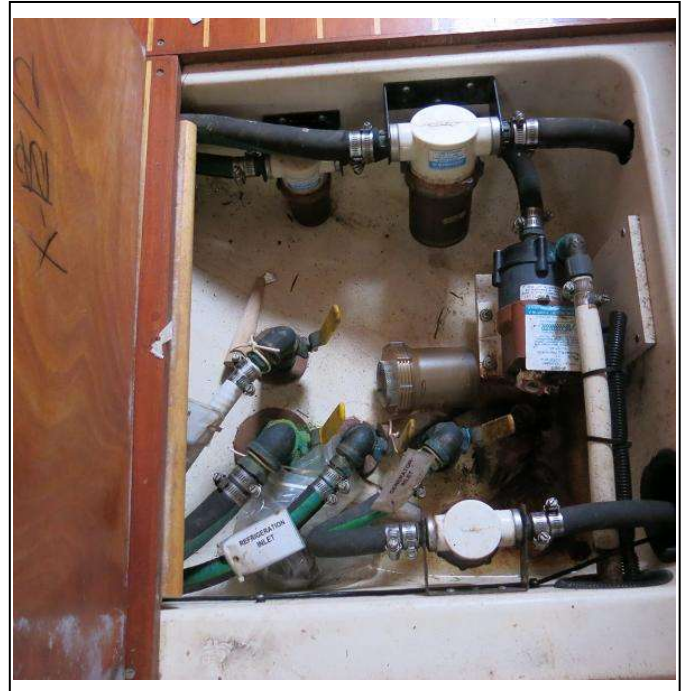
Aft Bilge

BILGE: A smooth brown gelcoat surface was used in the shallow bilge area, condition was generally dirty with excess bilge water.
