**DJC MARINE SURVEYORS
APPRAISAL REPORT
2000 LARSON 233 ESCAPE
September 30, 2023**

SCOPE OF APPRAISAL

DESCRIPTION OF VESSEL

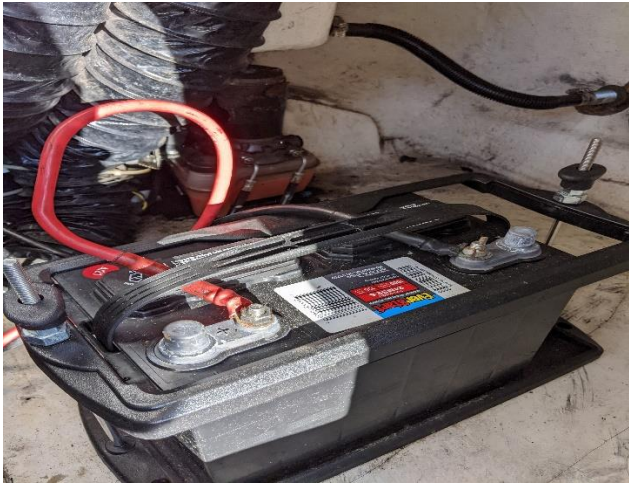
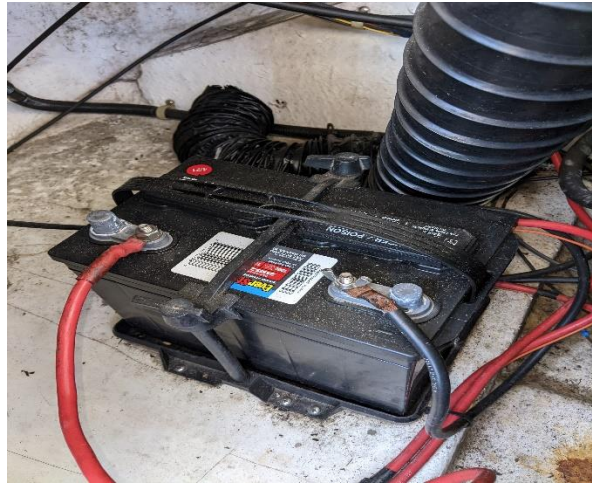
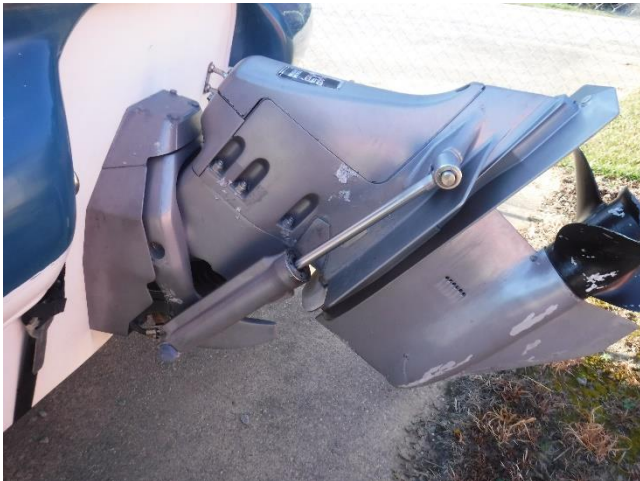
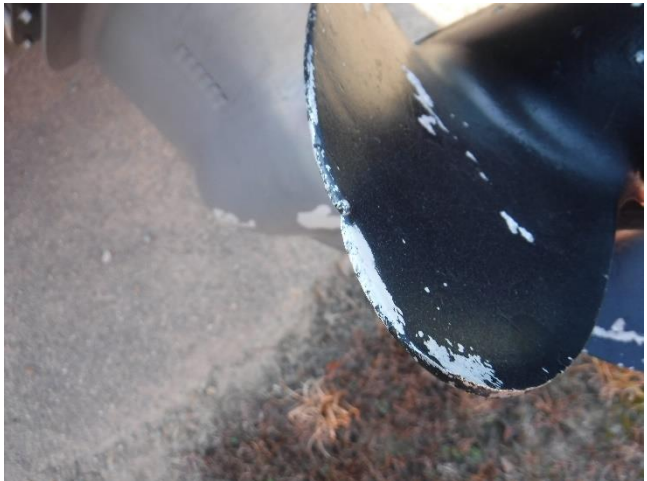
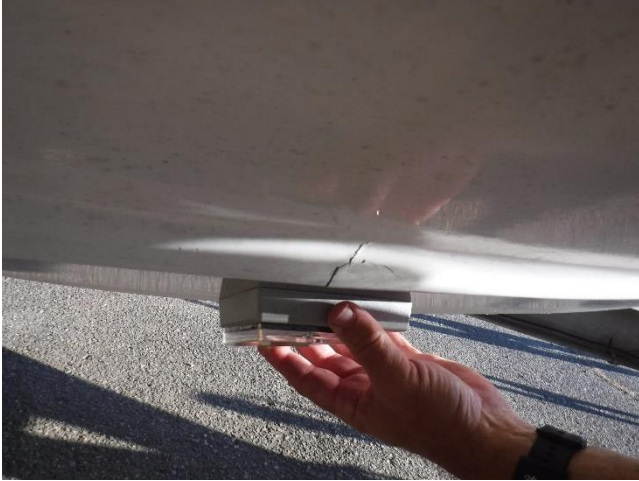
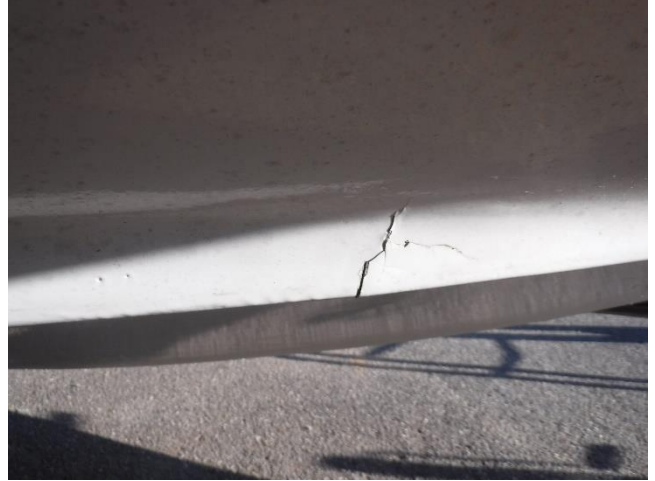
DAMAGE NOTED AND ITEMS OF NON COMPLIANCE

- 1. Elevated moisture readings starboard bow where there is roughly a 4" crack in fiberglass**
- 2. Cleat port side midship is loose**
- 3. There is no "Oil Placard" sighted**
- 4. Starboard battery reading 2.8V; batteries have wing nuts in use and are not protected against accidental cross contact**
- 5. Sink faucet is loose**
- 6. Starboard windshield aft is loose**
- 7. There is pinking on bow center cushion.**
- 8. Bow in deck hatch is loose at hinge.**
- 9. Propeller blade is bent.**

- 10. There is corrosion on stern drive as evidenced by bubbling and peeling paint
- 11. Rocker switch at helm not labeled as required.
- 12. Top is missing for trailer jack
- 13. U-bolts are corroded on trailer and bent starboard side aft.
- 14. Fire extinguisher is not mounted and is in the box.
- 15. Two scratches at bow but does not penetrate gelcoat.
